# Failure of tibial polyethylene insert locking mechanism in posterior stabilized arthroplasty

Emmanuel Thienpont

Received: 18 February 2012 / Accepted: 12 April 2012  
© Springer-Verlag 2012

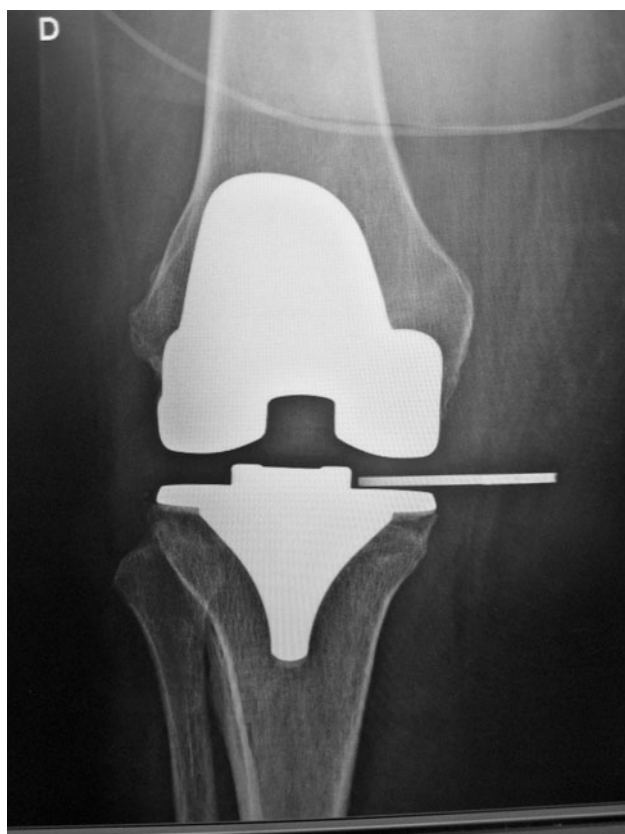
During the stance phase of gait, transverse plane translation and rotation can be measured [6]. Adduction moments are present due to the medial offset of the body centre of mass. For this reason, most of the compressive load across the knee is on the medial compartment. During walking, this creates an asymmetry of loading between the medial and lateral compartments [1]. This load can increase due to malalignment or unequal soft tissue balancing [1, 13]. This biomechanical mechanism explains why a locking bar would displace medially like in this case.

**Fig. 1** AP radiograph showing medial displacement of locking bar

parapatellar incision was performed. The position of the polyethylene was visually confirmed to be normal, without rotational malalignment, soft tissue or post impingement. The implant was well balanced in flexion and extension. A new locking clip was inserted and fixation of the polyethylene was confirmed. Standard postoperative closing was performed. Peroperative cultures were sterile. Her postoperative course was uneventful. Control radiographs 1 year postoperatively confirmed good position of the new locking clip. The patient was informed that her case was submitted for publication and she consented.

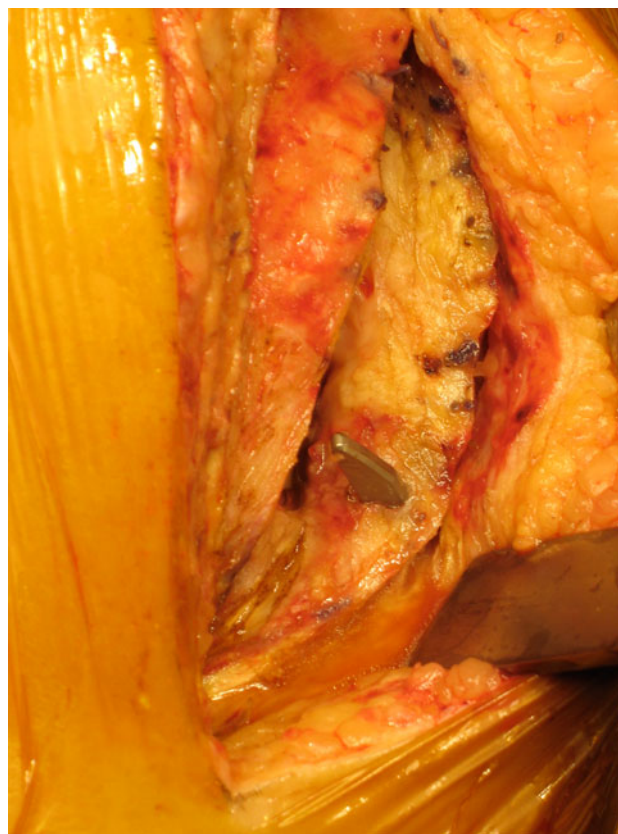
A 69-year-old woman underwent right total knee arthroplasty (Vanguard PS, Biomet, Warsaw, US) for degenerative arthritis through a subvastus approach in 2011. She had a left total knee arthroplasty 1 year before with the same implant design that was well functioning. The right side procedure was successful and she was able to leave the hospital after 3 days. Rehabilitation was going well and full extension and 135° of flexion were reached after 5 weeks. At 6 weeks, she felt a sudden onset of pain on the anteromedial side of the knee and a limitation of her range of motion to 100°. Just around that time she was scheduled for routine follow-up at the clinic. There was no history of trauma. A subcutaneous swelling and foreign body was palpated on the anteromedial side of the knee. An antero-posterior (AP) radiograph showed migration of the locking clip of the polyethylene insert towards the medial side (Fig. 1). Blood tests were normal. Surgical error was excluded during the complaint procedure with Biomet. The immediate postoperative radiographs were analysed by the company and confirmed the correct initial position of the locking clip. The patient was scheduled for an arthrotomy of the knee with removal and exchange of the locking clip. Intra-operatively, it was observed to have migrated through the medial capsule under the skin (Fig. 2). A quadsparring

**Fig. 2** Locking bar in medial soft tissues during arthrotomy
