## Excavations at Sissi V

Preliminary Report on  
the 2017-2019 Campaigns

## 6.1. The Sissi Court-Centred Building

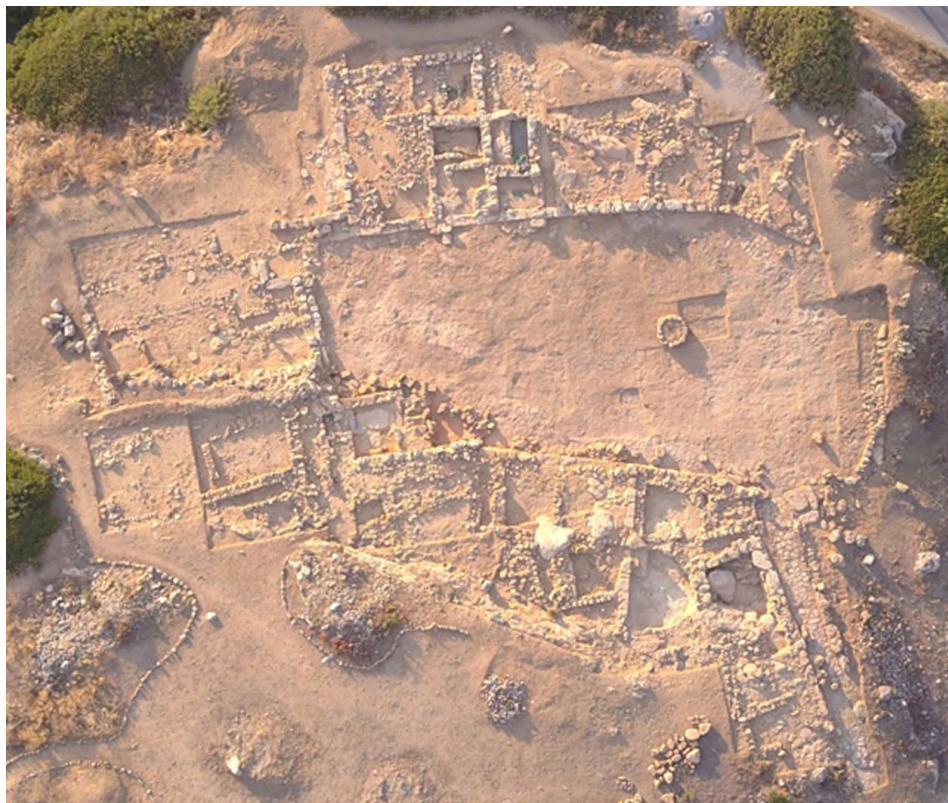
FIG. 6.1.1 AERIAL PHOTO OF COURT-CENTRED BUILDING (CCB) AFTER THE 2017 CAMPAIGN (NORTH AT LEFT) (©EBSA; N. KRESS)

The realisation that we were excavating a large monumental complex at Sissi only 4 km east of the palace at Malia was undoubtedly the greatest surprise of the 2011 and 2015 campaigns (*Sissi III*: 152-153; *IV*: 151-153). It was certainly not an objective that formed part of our original research project but it definitely added unsuspected angles of intra-regional comparison to our research. It also forced us to rethink the site in general as well as adapt our excavation strategy. Including the earlier work during 2008-2011 and 2015-2019, it has taken us all in all nine campaigns of six weeks (*i.e.* 270 days) with between six to 40 people to clear most of the complex. When excavations resumed in 2015, geophysical survey by A. Sarris alluded at the presence of a large court and suggested that this court was not only much larger than originally assumed but was also of an odd trapezoidal shape rather than rectangular as we expected (Driessen & Sarris 2020). Subsequent excavations confirmed the picture suggested by the georadar, including the presence of an obliquely set building to the south west (the *Basin Building*) and a Prepalatial village to the northwest on the Upper Terrace. Although some more tests are necessary, notably where the chronology of some walls of the Court-Centred Building is concerned, we think we have basically excavated the entire complex (figs 6.1.1, 6.1.2 & 6.1.3).

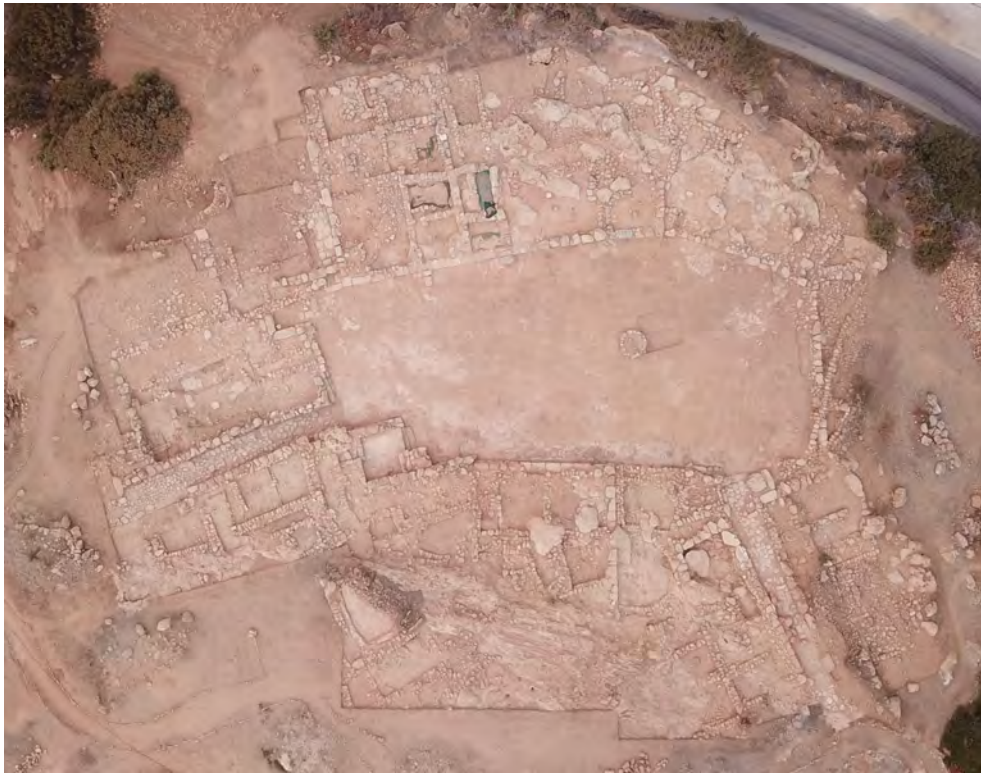
FIG. 6.1.2 AERIAL PHOTO OF COURT-CENTRED BUILDING (CCB) AFTER THE 2018 CAMPAIGN (NORTH AT LEFT) (©EBSA; N. KRESS)

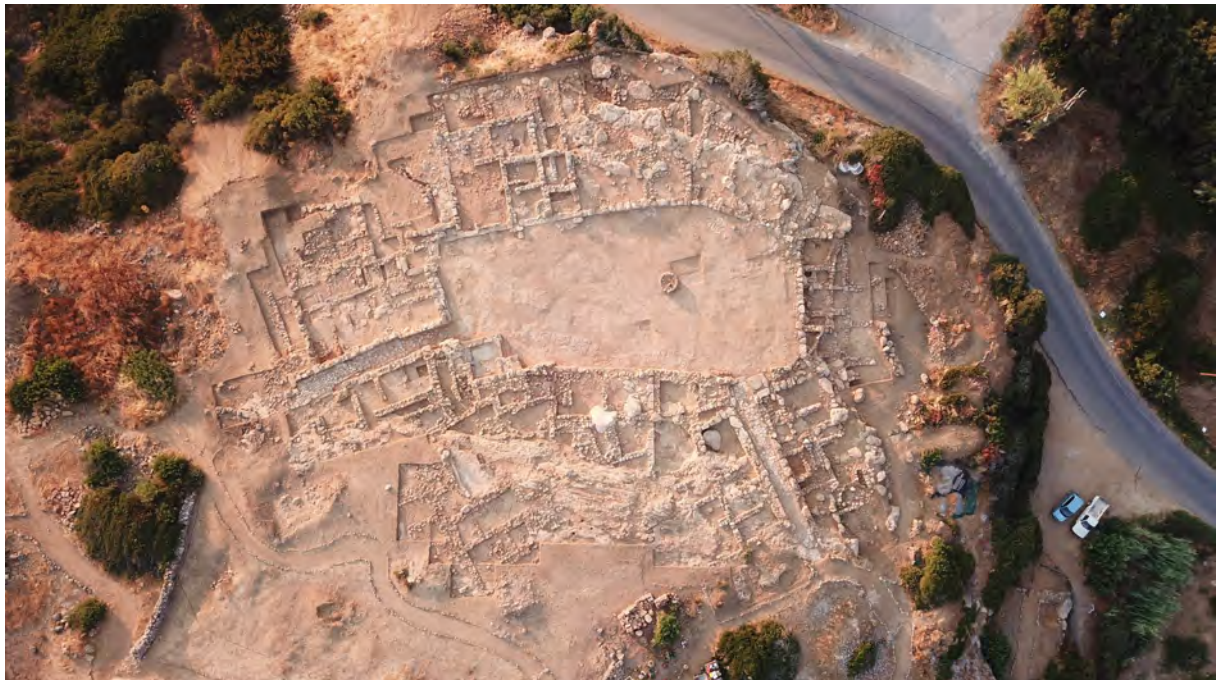
FIG. 6.1.3 AERIAL PHOTO OF COURT-CENTRED BUILDING (CCB) AFTER THE 2019 CAMPAIGN (NORTH AT LEFT) (©EBSA; N. KRESS)

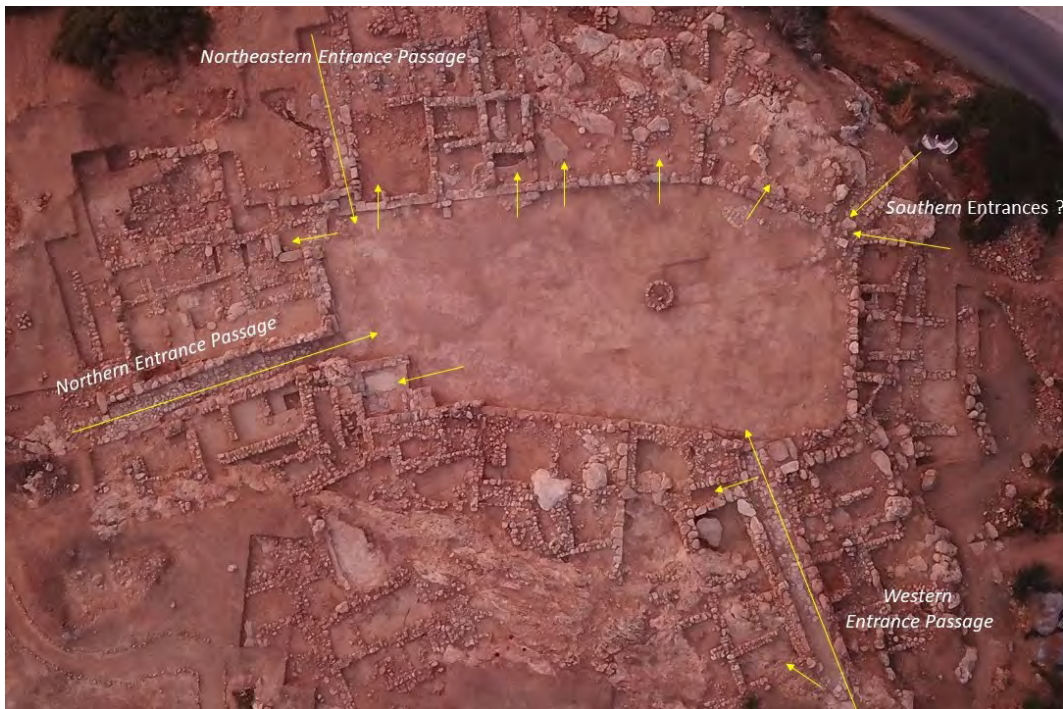
FIG. 6.1.4 SISSI CCB: ACCESS SYSTEM AND ENTRANCES; THE REMAINS OF THE PREPALATIAL EM IIA VILLAGE ARE VISIBLE AT BOTTOM LEFT (©EBSA; N. KRESS, J. DRIESSEN)

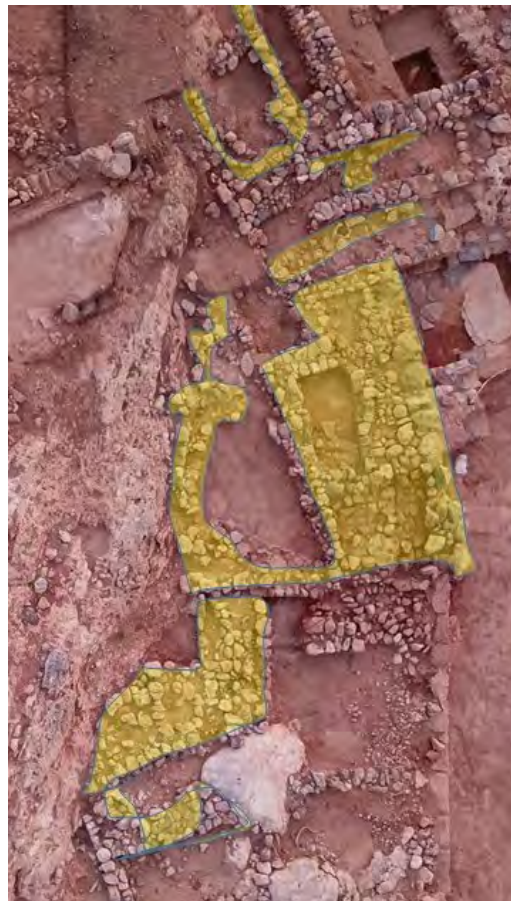
FIG. 6.1.5 AERIAL PHOTO OF THE NEOPALATIAL WEST AND NORTH-WEST WINGS WITH PREPALATIAL WALLS HIGHLIGHTED (©EBSA; N. KRESS, J. DRIESSEN)

The three ‘main’ palaces at Knossos, Malia and Phaistos each have a large west court, laid out since the mature Prepalatial period (already Driessen 2007). These were retained throughout the history of these buildings. Such a court is absent at Petras, Zakros and Galatas but partly present, although quite small, at Gournia. To find out whether a court existed at Sissi, we tested the Upper Terrace to the west and somewhat unexpectedly (although the georadar survey had shown its presence) came upon architectural remains dating back to the Prepalatial period (EM IIA) but nothing later (**fig. 6.1.4**). This conceivably opens the possibility that the area west of the Court Building at Sissi was already levelled and left free of constructions, at least following the Prepalatial period, similar to what we see at Knossos, Phaistos and Malia. The ample Prepalatial remains to the west of the CCB were not at all interfered with afterwards. These and the evidence from the West Wing are discussed by Quentin Letesson below. Most of the architectural remains of this EM IIA village are surprisingly well preserved and this despite their nearness to the surface and despite the presence of the CCB immediately to the east. This could indicate that the area was levelled and used as a court after EM IIA apart from the more eastern spaces that were incorporated or overbuilt when the CCB was constructed. The EM IIA village was found with its assemblages in place and since settlement deposits of this phase are still relatively rare on Crete, its study and publication will provide a welcome addition to our knowledge. The evidence found within the complex by both Letesson and Sylviane Déderix clearly shows that EM IIB deposits were resting against walls, later incorporated within the Neopalatial building (**fig. 6.1.5**).

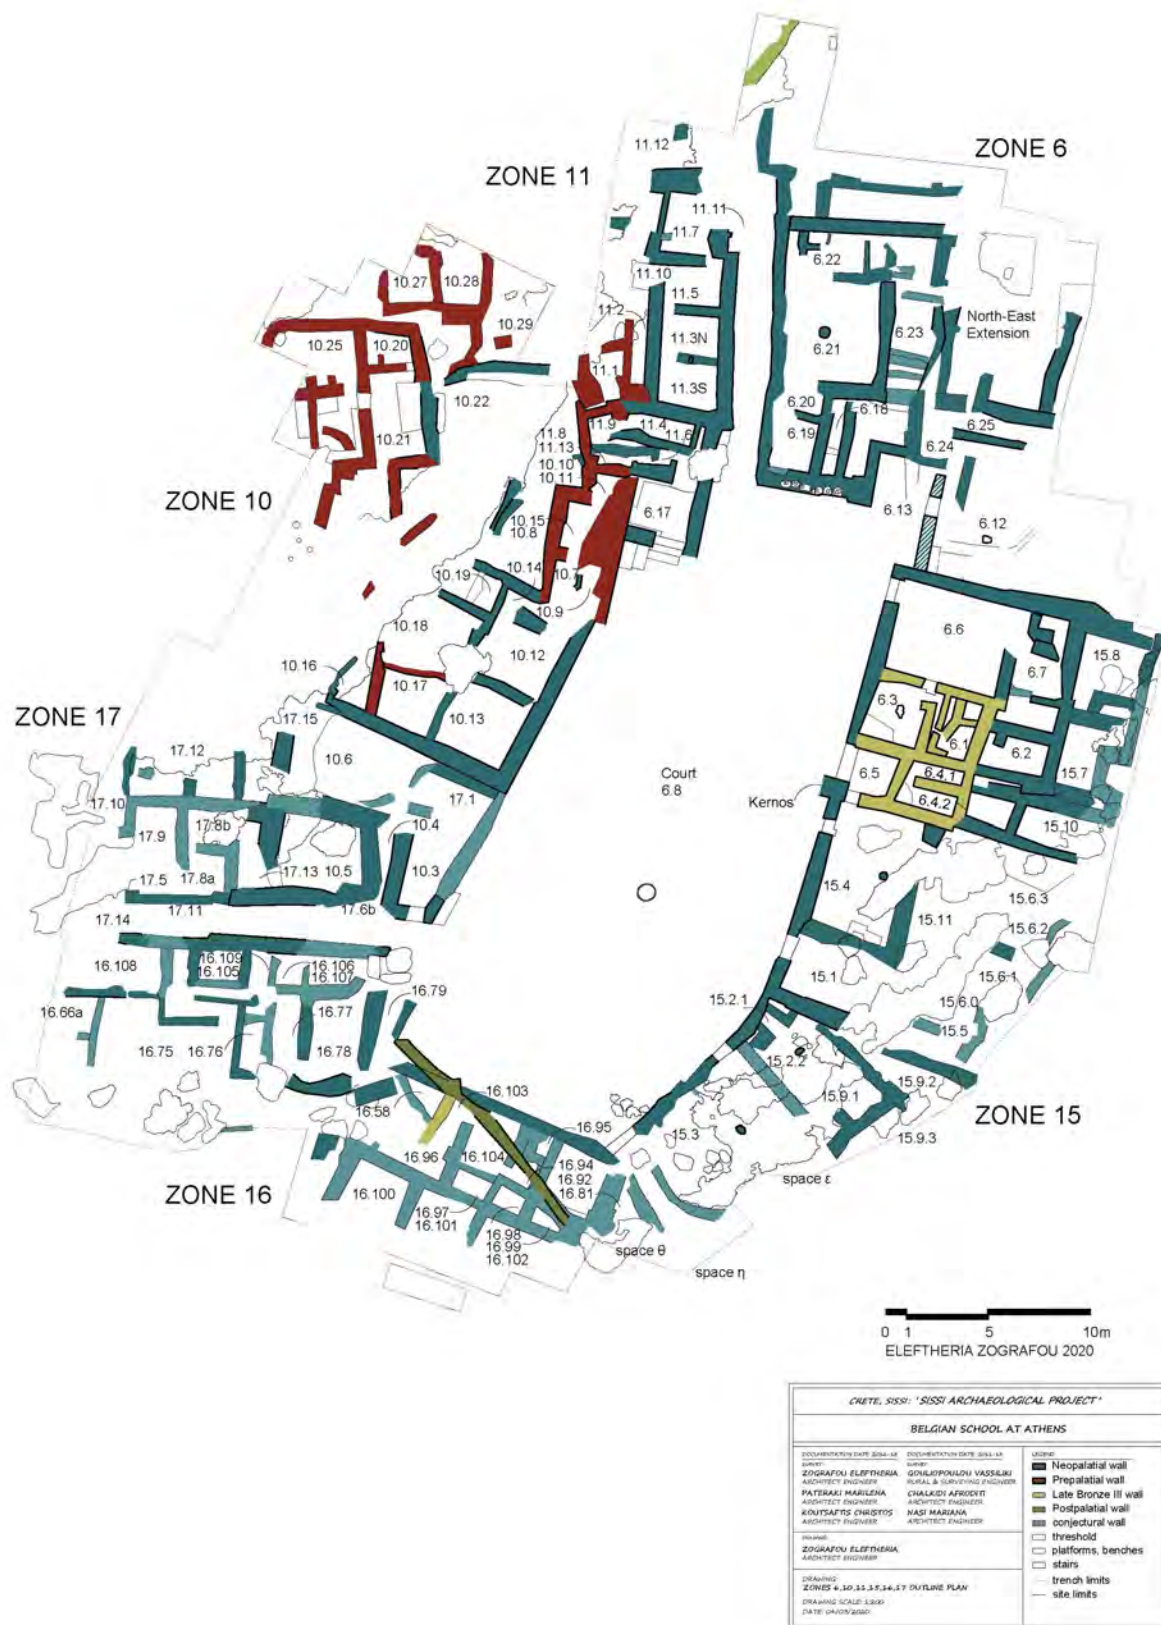
FIG. 6.1.6 SISSI COURT-CENTRED BUILDING: PRELIMINARY PLAN WITH PHASING (©EBSA; E. ZOGRFOU)

When the Neopalatial complex was constructed, most of the Prepalatial deposits and walls were simply left in place and incorporated (fig. 6.1.6). There seems hence to have been a deliberate intention to connect with an ancestral construction and the Neopalatial structure may have derived some of its social power from the inclusion of these Prepalatial remains.

The 2017-2019 campaigns have yielded considerable evidence for different architectural phases within the Neopalatial period (**fig. 6.1.6**). These may briefly be summarised but the details are given in the following chapters.

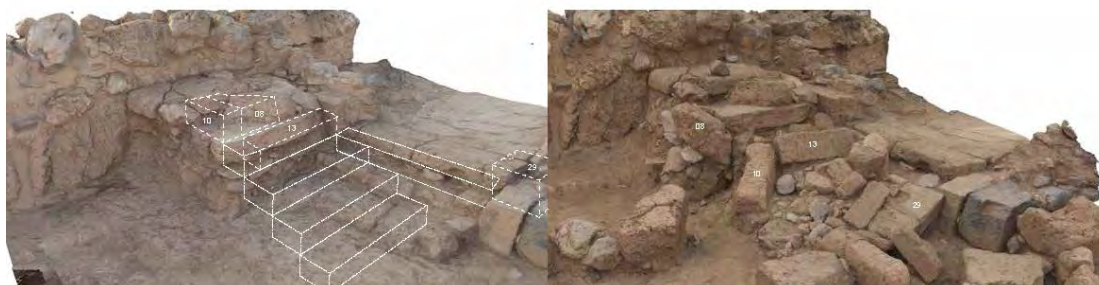
**FIG. 6.1.7** POTENTIAL RECONSTRUCTION OF THE ARCHITECTURAL MODIFICATIONS SOUTH OF SPACE 6.17 (©EBSA; E. ZOGRAFOU)

For a start, the prior existence of the large boulder façade F58 means that Space 6.17 forms a secondary addition (*Sissi IV*: 219-230) and that it is likely that, in a first Neopalatial phase, the boulder façade was entirely visible from the Central Court and left in place when the ashlar façade of the West Wing was constructed<sup>3</sup>. The addition of Space 6.17, accessible via a north-south, low staircase, reduced the width of the court in its north part with several metres. The elevated platform constructed against the south wall of Space 6.17 represents a third phase and this addition seems to have forced the builders to reduce the entrance to Space 6.17, following the construction of an east-west staircase, set on top of the earlier north-south steps. This staircase collapsed, however, but a potential reconstruction is given in **fig. 6.1.7**.

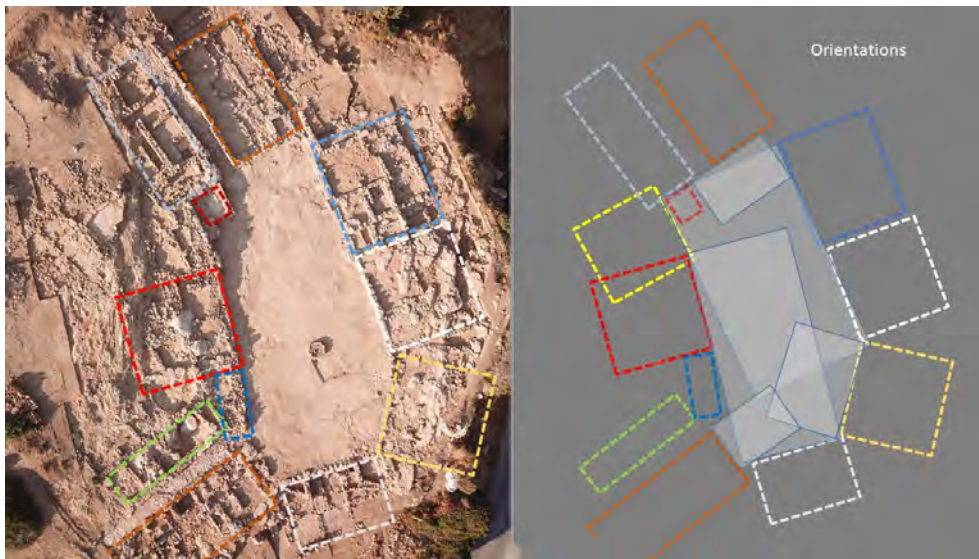
FIG. 6.1.8 CCB AT SISSI: CONSTRUCTIONAL UNITS AND VARIETY OF ORIENTATIONS. THE RIGHT SKETCH PLAN SHOWS THE DIFFERENT POTENTIAL ORIENTATIONS OF THE CENTRAL COURT ACCORDING TO THE CONSTRUCTIONAL UNITS (©EBSA; N. KRESS, J. DRIESSEN)

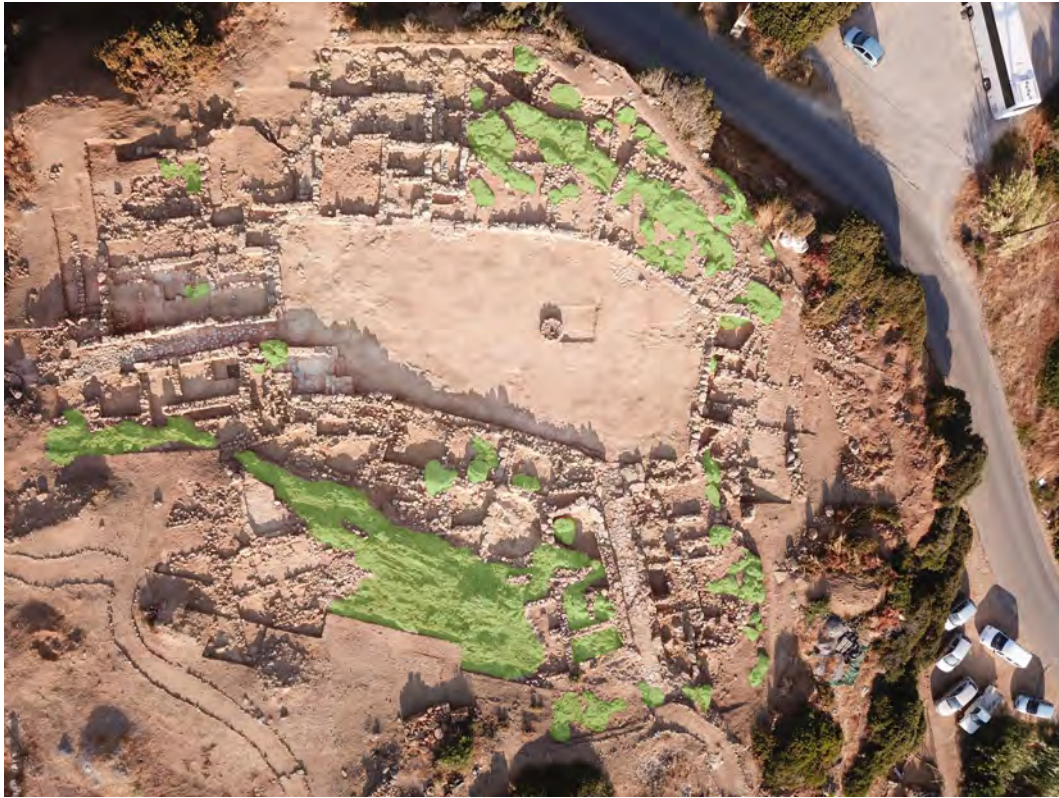
FIG. 6.1.9 CCB AT SISSI WITH MAIN BEDROCK OUTCROPS HIGHLIGHTED IN GREEN (©EBSA; N. KRESS, J. DRIESSEN)

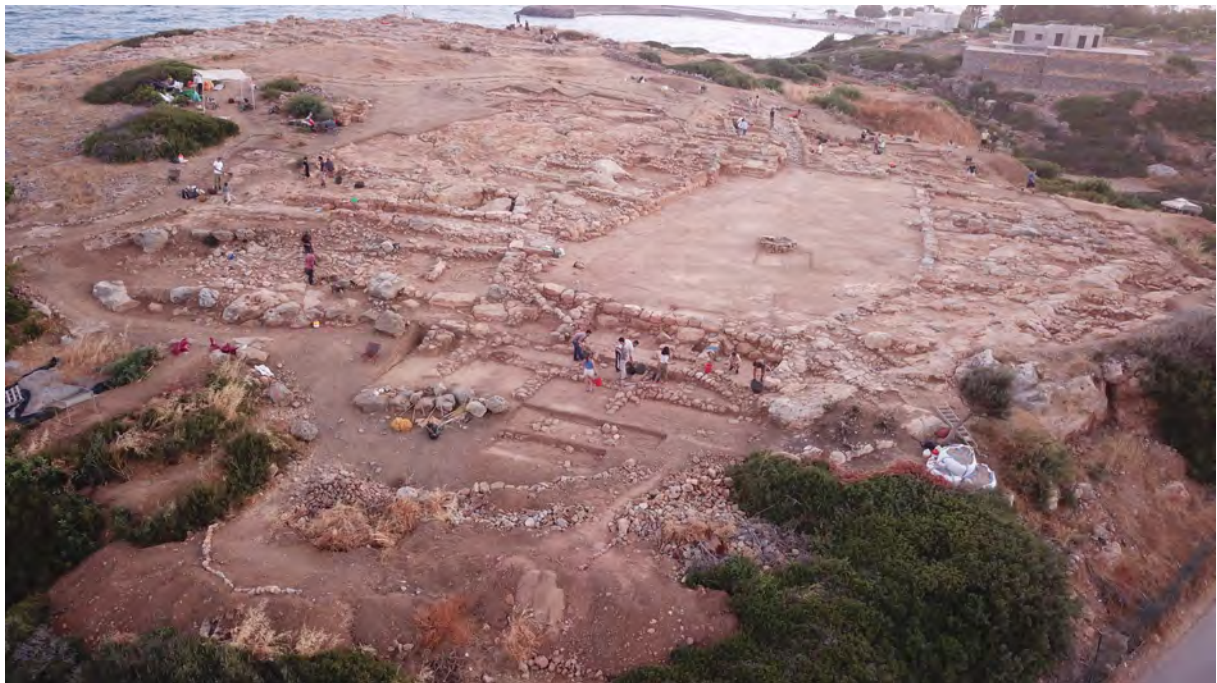
FIG. 6.1.10 OBLIQUE AERIAL VIEW FROM THE SOUTH OF THE CCB AT SISSI, SHOWING THE TERRACE WALL THAT SUPPORTS THE CENTRAL COURT AND THE CONSTRUCTIONS SOUTH OF IT (©EBSA; N. KRESS)

It is also likely that some of the southern parts of the West Wing were a later addition (**fig. 6.1.10**). While the differing orientation of the *Basin Building* may have been necessitated by a prior existing road, the wall construction that faces the Central Court east of the *Basin Building* consists of boulders while the façade of the original West Wing is in sandstone ashlar. Moreover, some of the walls north-east of the *Basin Building* were actually built against this ashlar façade, showing that they were additions. Similar observation can also be made for the East Wing, where the southern part seems clearly to represent a later modification.
