# **EFFECTIVENESS OF SOIL AND WATER CONSERVATION TREATMENTS ON SOIL AND CATCHMENT RESTORATION**

Doctoral Dissertation presented by

**PABLO M. BORJA**

December 2016

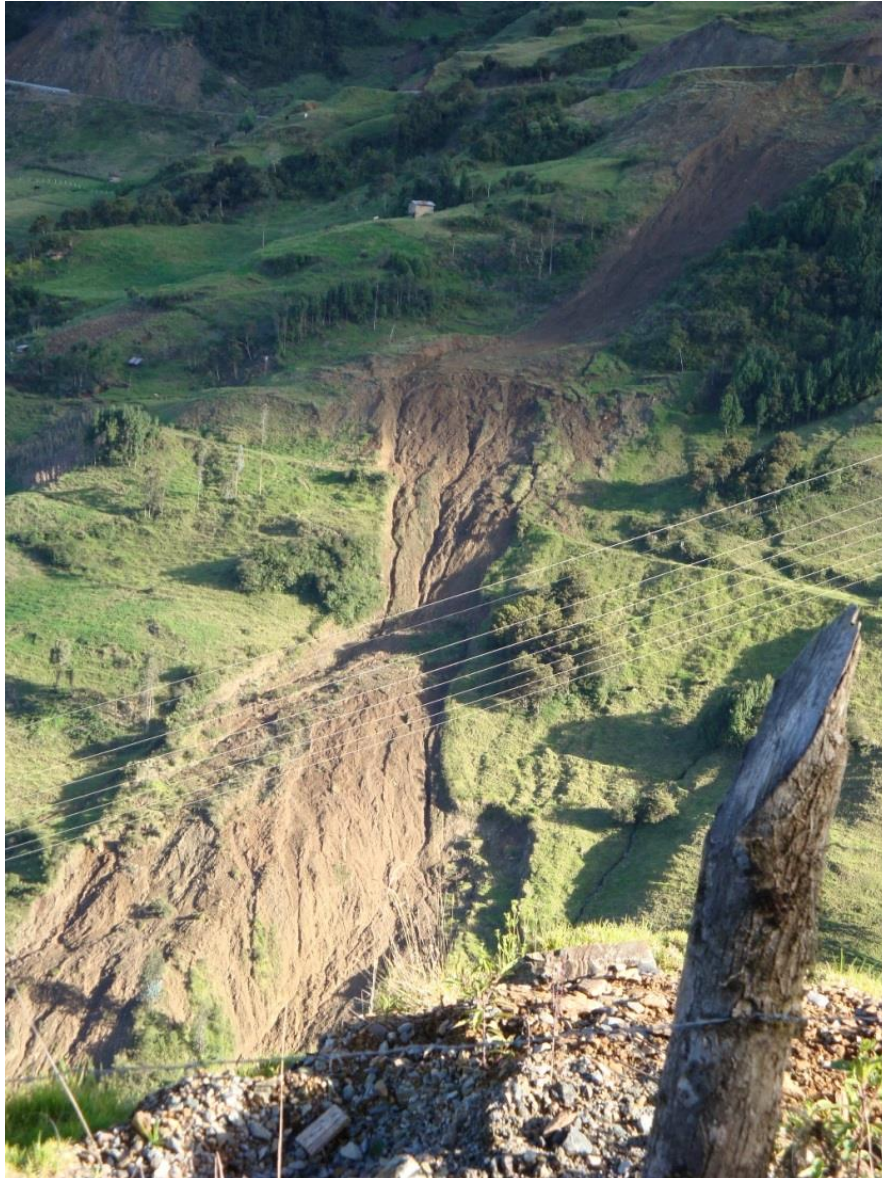
Figure 1: Photograph illustrating the magnitude of mass movements in the tropical Andes Mountains. After the mass movement, gully erosion actively contributes to the mobilization of loose material on the landslide scar (Photo by Marie Guns, 2013; Llavircay catchment, Southern Ecuadorian Andes).

In the tropical Andean mountains, mass movement and soil erosion by water (Figure 1) are the dominant processes that transport soil material downslope (Guns and Vanacker, 2013; Vanacker and Govers, 2007a). Water erosion is an important process of land degradation (Poesen et al., 2003), and leads to the development of extensive rill and gully networks and the formation of so-called badlands. This is particularly the case in areas that have been or are used for agricultural production (Figure 2). When the protective native vegetation cover is removed, the soil becomes rapidly exposed to the effects of erosive rainfall (Inbar and Llerena, 2000; Molina et al., 2007). The rapid generation of surface runoff results in the formation of gullies that further enhances soil degradation by destroying the soil layer and exposing the parent material by action of water (Harden and Scruggs, 2003). Gully erosion causes considerable soil losses and produces large volumes of sediment (Poesen et al., 2003). The off-site effects of soil erosion in tropical mountains are multifold: increasing costs for hydropower installations due to a reduced water storage capacity (Harden, 1993), pollution of water reservoirs and dams that are used to supply drinking water (Harden, 1993), and siltation of irrigation infrastructure.

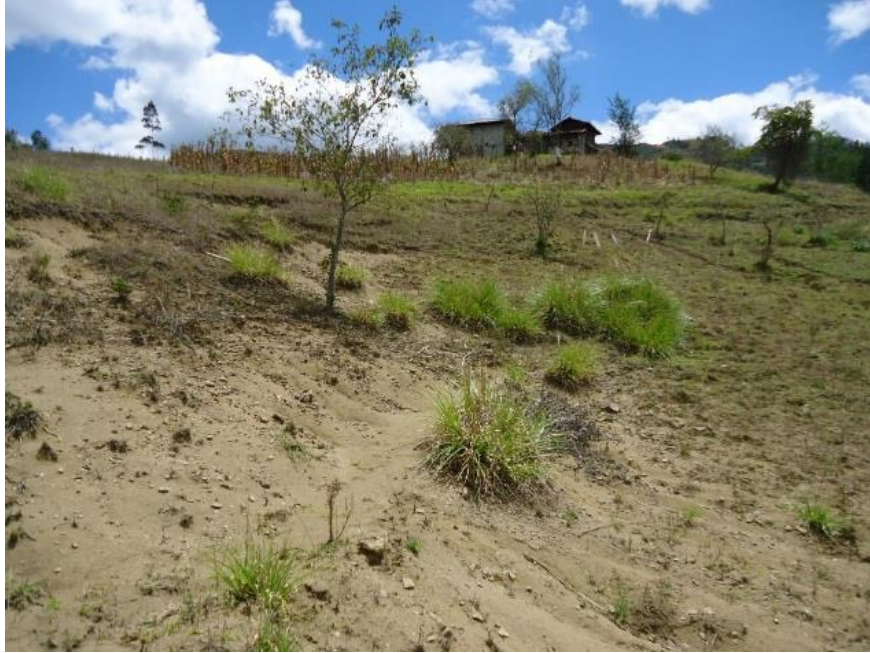
Figure 2: Photograph illustrating hotspots of water erosion (Photo by Pablo Borja, 2013).

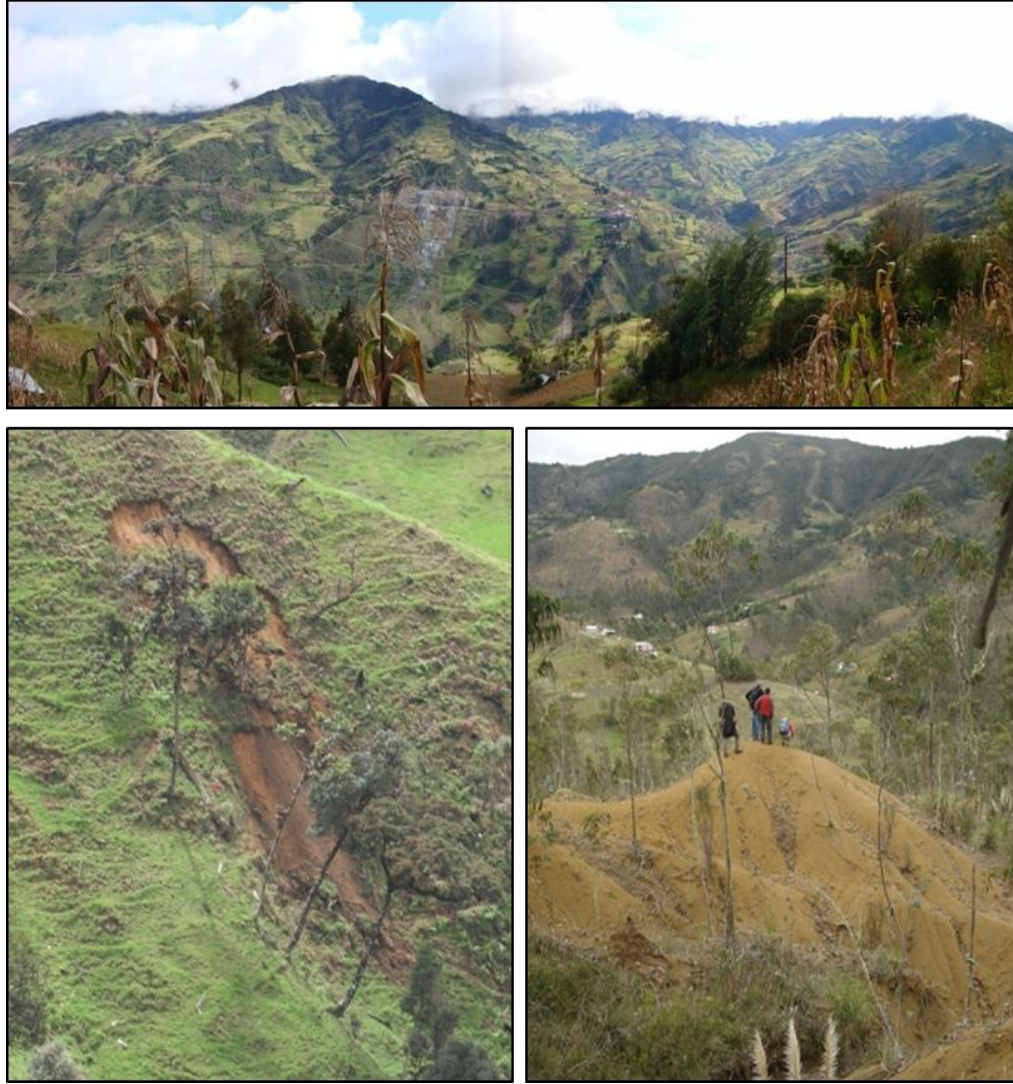
Figure 5: Panoramic view on the study area, located in the southern Ecuadorian Andes. The two main sources of sediment in the area are shown in the pictures below. Lower left: landslide activity in overgrazed pastures, and lower right: active gully erosion in badlands.

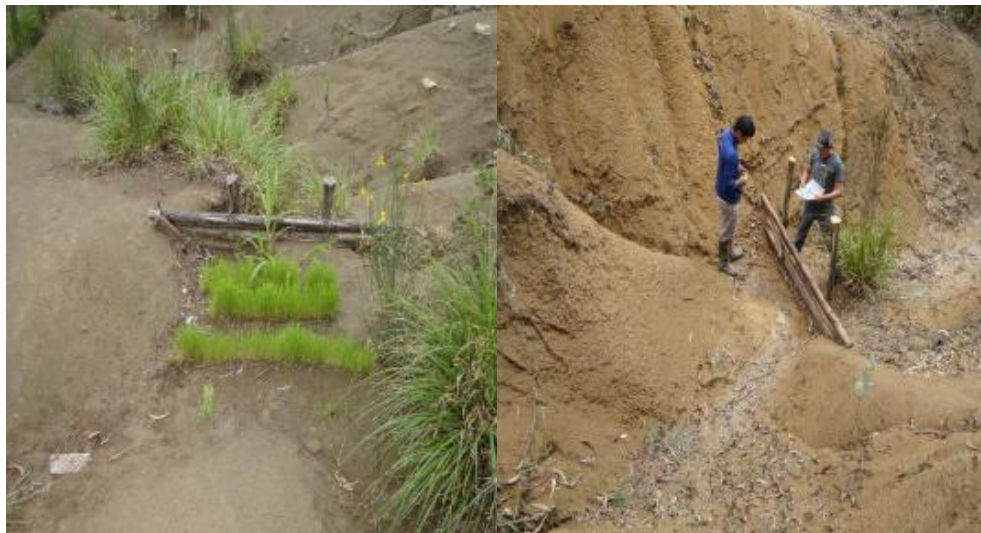
Figure 8: Construction of check dams in the active gully channels of the micro-catchments AI and DI (photo: Pablo Borja, 2012).

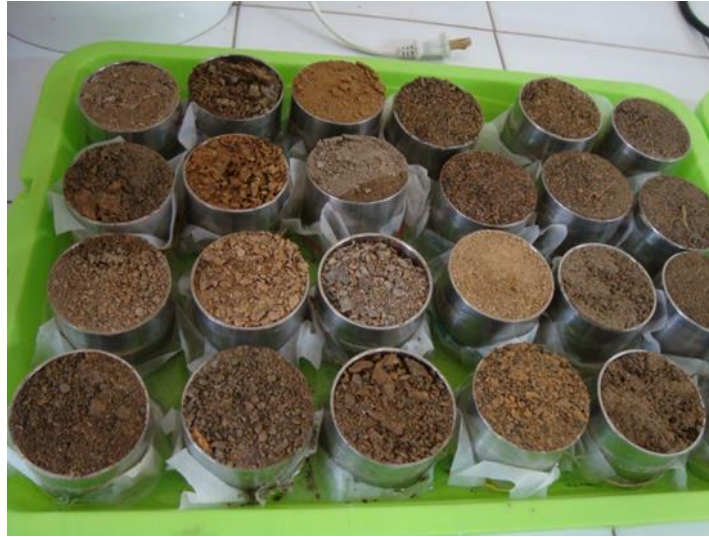
Figure 13: Undisturbed soil samples taken in Loreto catchment. The samples illustrate the variability in organic matter content of the topsoil material.

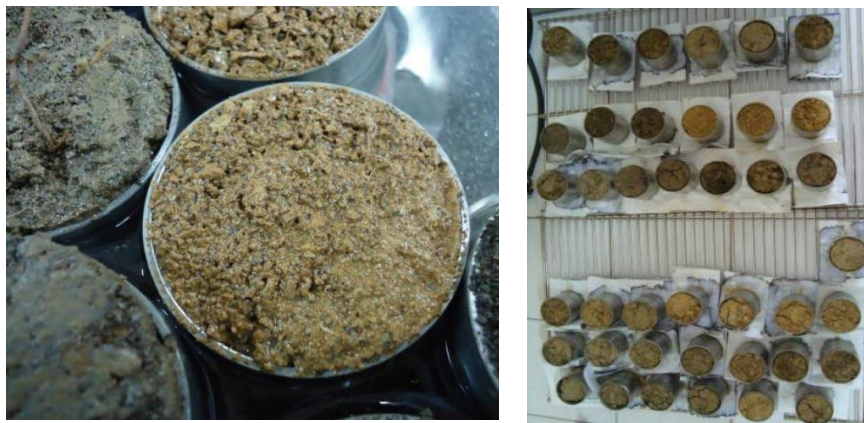
Figure 14: Analysis of soil physical properties at the laboratory of Soil Sciences at the Faculty of Agricultural Engineering, Universidad de Cuenca.

Undisturbed soil core samples were collected in rings of 100 cm<sup>3</sup> (3 replicates) for analysis of bulk density (BD) and saturated soil water content by volume ( $\theta_{sat}$ ). To determine the saturated water content, 100 cm<sup>3</sup> of soil material was weighted before and after saturation (saturated on saturation mat for 5 days) and finally oven dried (105 °C for 24 h, Figure 13 and Figure 14):

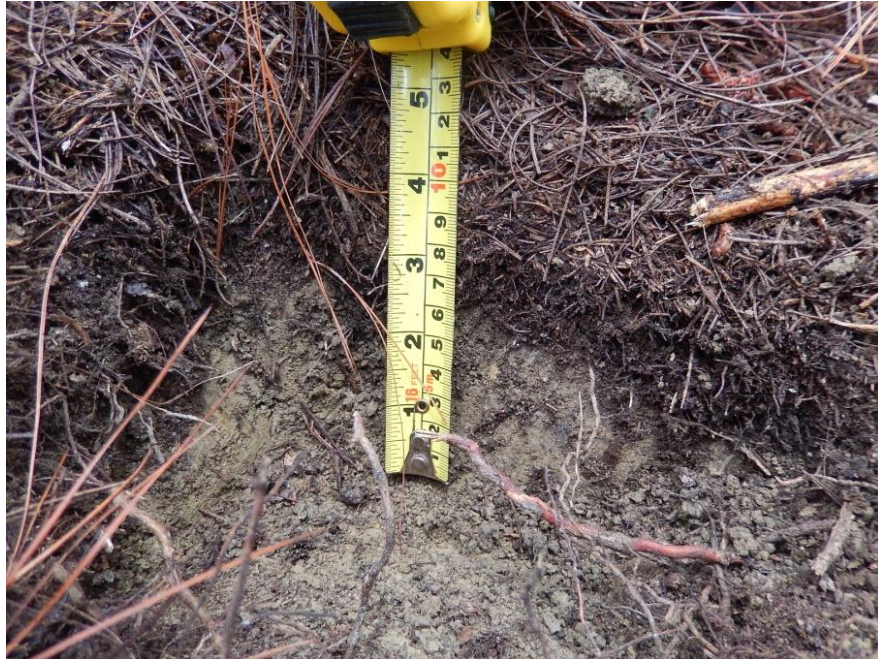
Figure 22: Incipient soil development in the restored catchment (Zone B). This picture is taken from a plot inside the *Pinus* forest (Photo taken by Pablo Borja, Loreto catchment, 2013).

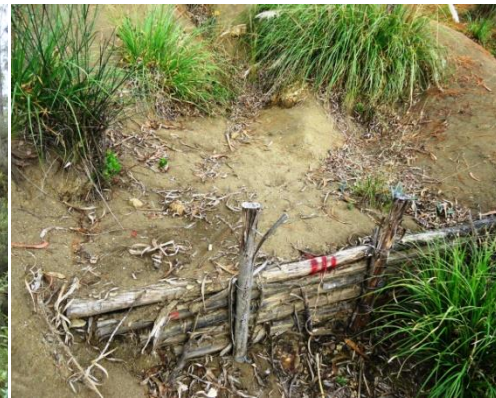
d) wooden dams for sediment control

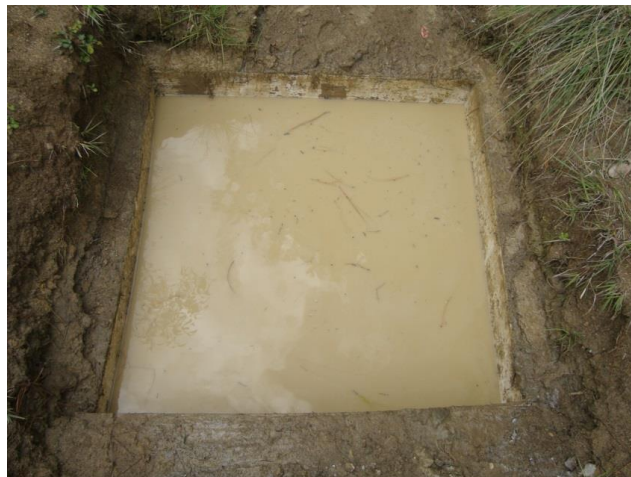
Figure 27: An example of a sediment trap that was constructed at the outlet of the micro-catchment to estimate the sediment export.

About 2 m downstream of the hydraulic weir, a sediment trap of 0.5 m<sup>3</sup> was constructed in the gully channel. As the velocity of the flow drops sharply when the runoff water enters the sediment trap, the majority of the sediment load is deposited in the trap. The volume of sediment that accumulated in the traps was measured on a regular basis (i.e. weekly during the rainy season) to have first estimates of the sediment export. However, we cannot exclude that during high intensity rainfall events, when the total runoff volume is much larger than the volume of water that can be stored in the trap, the reduction of the flow discharge is not sufficient to trap efficiently the fine fraction of the sediment load. Therefore, the sediment traps allow to have a first estimate of sediment export, that represent minimum sediment export rates during extreme events.

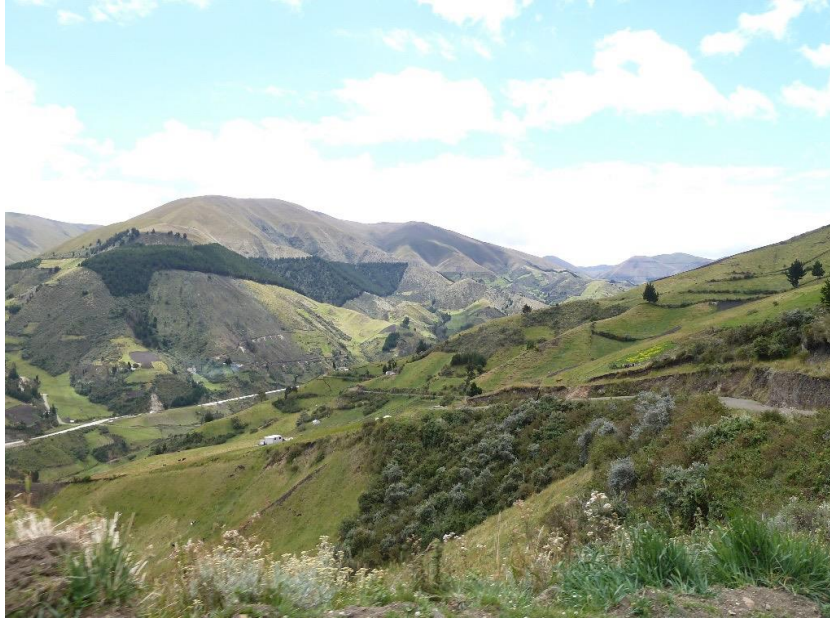
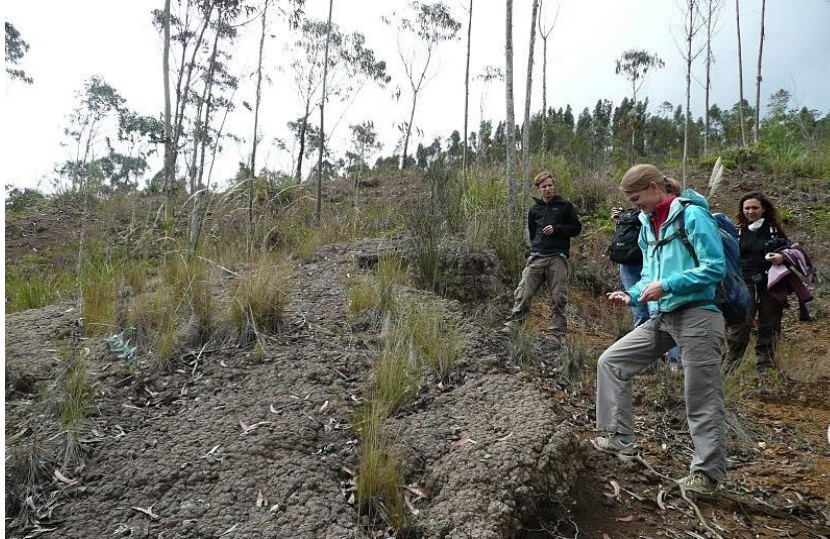
Figure 39: Difference in environmental impact between forest plantations in high-altitude native grasslands (upper panel) and in highly degraded environments (lower panel).

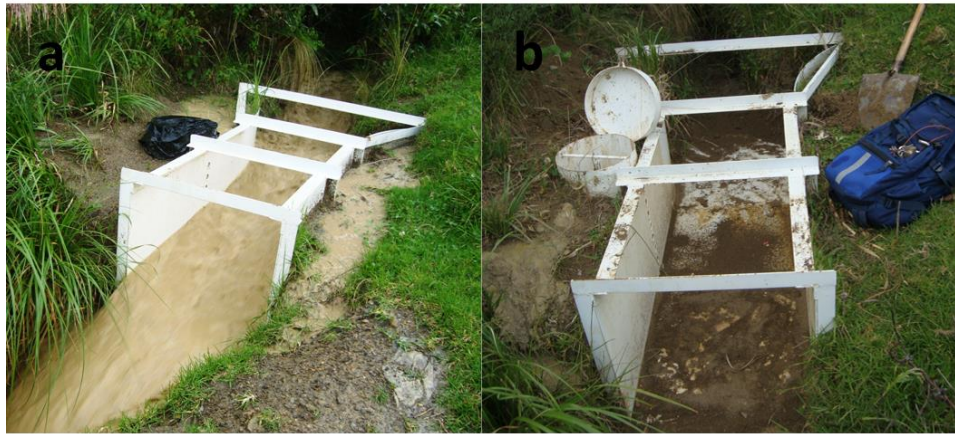
Figure 41: Flume in AI micro-catchment: a) during and b) after an event.
