# Core versus Surface Sensors for Reinforced Concrete Structures: A Comparison of Fiber-Optic Strain Sensing to Conventional Instrumentation

**Abstract:** High-resolution distributed reinforcement strain measurements can provide invaluable information for developing and evaluating numerical and analytical models of reinforced concrete structures. A recent testing campaign conducted at UCLouvain in Belgium used fiber-optic sensors embedded along several longitudinal steel rebars of three reinforced concrete U-shaped walls. The resulting experimental dataset provides an opportunity to evaluate and compare, for different types of loading, the strain measurements obtained with the fiber-optic sensors in the confined core of the structural member against more conventional and state-of-the-practice sensors that monitor surface displacements and deformations. This work highlights the need to average strain measurements from digital image correlation techniques in order to obtain coherent results with the strains measured from fiber optics, and investigates proposals to achieve this relevant goal for research and engineering practices. The longitudinal strains measured by the fiber optics

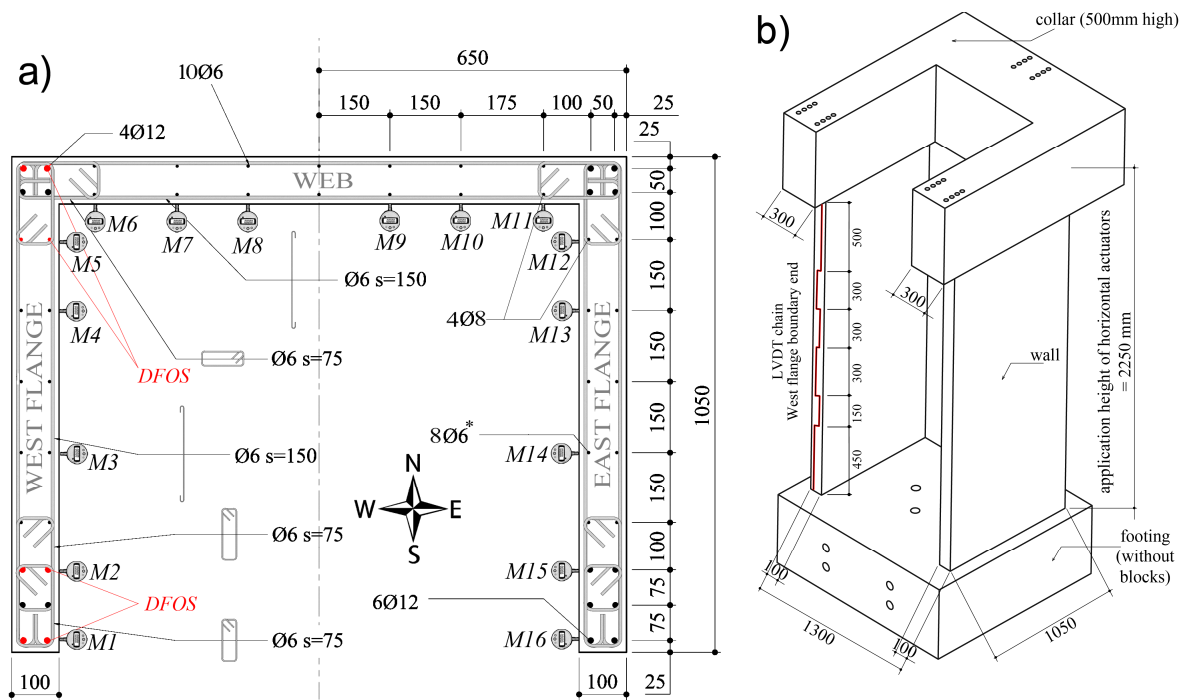
**Figure 1.** (a) Cross-section and reinforcement layout with indication of DFOS rebars and micrometer instruments (M1–M16, clockwise from boundary end of west flange); and (b) Elevation view of wall units with indication of the LVDT chain on the west flange boundary end.

Each wall unit had DFOS bonded to a total of eight longitudinal rebars located in the west flange as indicated by the red dots in Figure 1a. DFOS were implemented using the LUNA optical distributed sensor interrogator 4-channel ODiSI 6104 Series system. Polyimide-coated single-mode sensing fiber was employed. Although nylon-coated fiber-optical cables have been shown, in one prior investigation, to produce more reasonable strain results in RC beams [18], the polyimide-coated fibers that were used here were chemically bonded to the fiber-optic core [11] and do not exhibit slip at the locations of sudden strain change [27], which can result in more accurate strain measurements in the areas of localized deterioration [12]. For all fiber-optic cables, the spatial resolution was set to 0.65 mm with a sampling rate of 3.125 Hz. This small gauge length of 0.65 mm and the sampling frequency used to measure and record the strains from the DFOS potentially influenced the signal-to-noise ratio in the recorded data [3]. Thus, as practiced in other research, the DFOS strain data presented herein has been filtered using a moving average over a length of approximately 10 mm to reduce noise levels [3,28]. The testing of the three U-shaped wall units was performed at the LEMSC laboratory, which has a heating, ventilation, and air-conditioning (i.e., HVAC) system that helps to regulate the

A total of 16 digital Mitutoyo micrometers were used to measure the vertical displacement of the concrete wall surface along the interior perimeter at the base. The micrometers, labelled M1 through to M16 in Figure 1a, were strategically placed at the locations corresponding to the approximate placement of some of the longitudinal reinforcing steel bars. The vertical displacements were measured over a distance of 60 mm from the base, as shown in Figure 6. Two different types of micrometers were used: the round Digimatic indicators (M3, M4, M7, M8, M9, M10, M13, and M14 in Figure 1a) have a range of 12.7 mm and were placed more centrally, where vertical elongation was expected to remain lower; the other micrometers (M1, M2, M5, M6, M11, M12, M15, and M16) had a greater range of 25.4 mm and were placed in the boundary regions, where vertical elongation was expected to be higher. The placement of these micrometers provides an opportunity to compare their measured vertical displacement, captured on the inside surface of the wall, to that calculated from the DFOS bonded to the rebars (i.e., M1, M2, and M5 in Figure 1a).

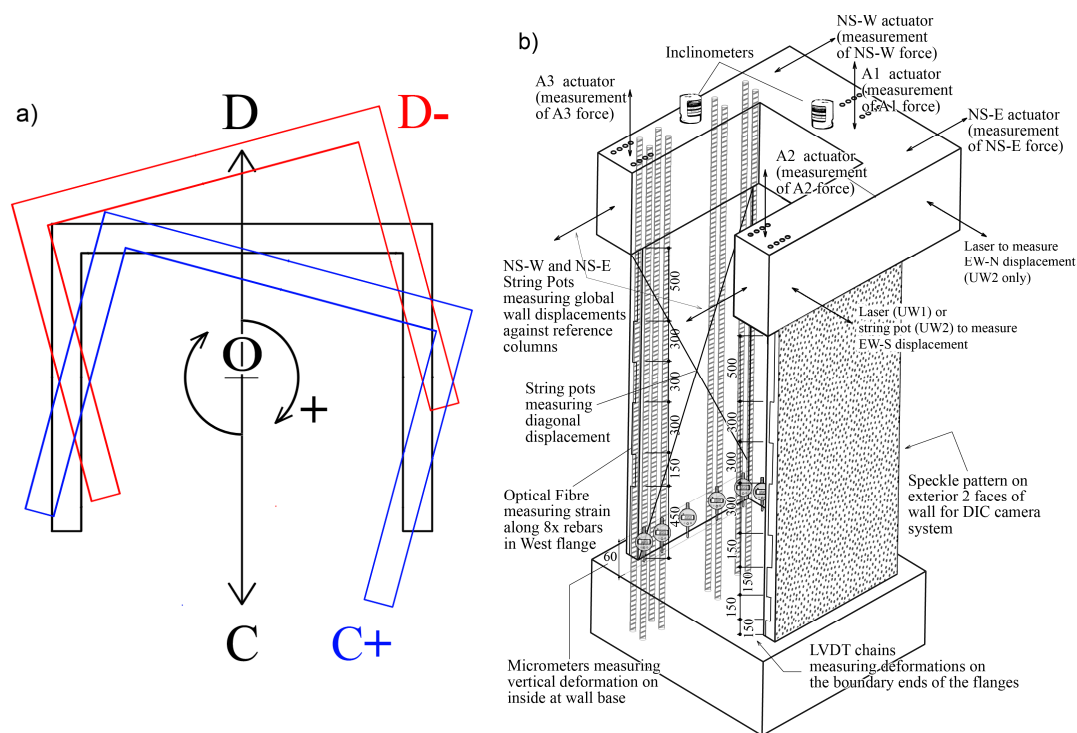
**Figure 2.** (a) Wall cross-section with the different loading positions; and (b) The different measurement instrumentation devices (not to scale; dimensions in mm).

The different testing positions of the walls are depicted in Figure 2a. The first wall, UW1, was subjected to in-plane bending about its minor axis, loaded to positions D and C. The second specimen, UW2, was subjected to a reverse-cyclic twist about its vertical axis, loaded to positions O+ (i.e., clockwise twist in Figure 2a) and O− (i.e., counterclockwise twist in Figure 2a). The third specimen, UW3, was subjected to a combination of in-plane bending and twisting, loaded to position D− (i.e., position D with counterclockwise twist, red cross-section in Figure 2a) and C+ (i.e., position C with clockwise twist, blue cross-section in Figure 2a). All wall specimens were subjected to a pre-compression axial load ratio of 5%, which was held constant throughout testing.

A 3-dimensional schematic illustration of the primary sources of instrumentation used to record data during the test is given in Figure 2b. The instrumentation depicted in Figure 2b includes Distributed Fiber-Optic Sensors (DFOS), linear variable differential transformers (LVDTs), a speckle pattern to capture the surfaces' deformations using Digital Image Correlation (DIC), and micrometers. The specifics of these instruments are given in the following sub-sections.

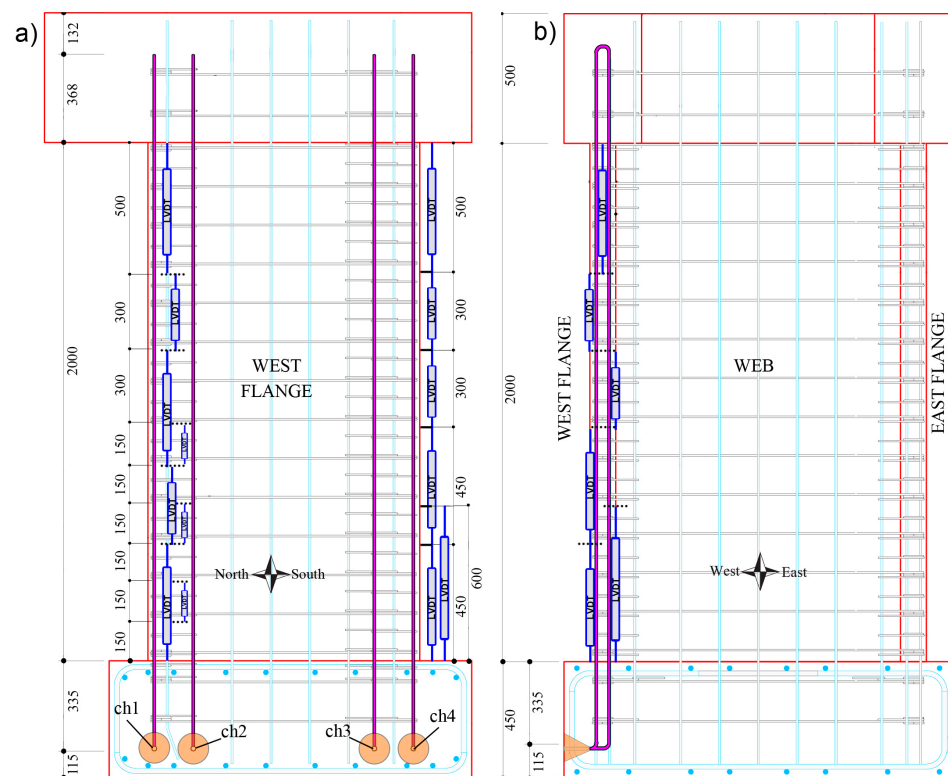
**Figure 3.** Location of the longitudinal rebars instrumented with fiber-optic sensors (purple, full opacity rebars): (a) Elevation view of the wall from the west with fiber-optic channels (“ch”) 1, 2, 3, and 4; and (b) Elevation view of the wall from the south. The LVDT chain to the south, along the boundary end of the west flange, and to the north, along the corner of the west flange-web intersection, is also depicted.

As only four channels were available with the interrogator, one fiber-optic cable was utilized to measure the strains of two longitudinal rebars simultaneously. As such, the two layers of the longitudinal reinforcement across the thickness of the wall were welded together in the foundation and in the head. Figure 3 illustrates the structural drawings of the longitudinal rebars bonded with DFOS, which are shown to have a rounded segment welded in the collar (head) of the wall, whereas a straight steel bar segment is used to join the two rebars at the base.

Three LVDT arrays were attached to each of the wall units to measure the average axial strain of the concrete surface along the corresponding base length of each LVDT. The LVDT arrays were located on the surface of the two boundary ends of the flanges, depicted in Figure 2b, and on the west flange towards the web (denoted here as the west flange-web intersection). For the research undertaken and presented in this paper, only the two chains of LVDTs located on the west flange (on the intersection with the web and on the boundary end) will be used, since they correspond to wall regions that are monitored simultaneously by DFOS. The locations of the LVDT arrays to the north (i.e., flange-web intersection) and south (i.e., boundary end) and the corresponding base lengths of each LVDT are illustrated in Figure 3a. It is worth noting that two LVDTs were used within the wall thickness at the base of the boundary end (to the south), one interior and another exterior (relative to the center of the wall) with base lengths of 600 mm and 450 mm, respectively (Figure 3b).

This section compares the average strains calculated from the two arrays of LVDTs, located on the west flange towards the north (i.e., flange-web intersection) and south (boundary end), with the channels 1 ("ch1") and 4 ("ch4") of the DFOS system (Figure 3), respectively.

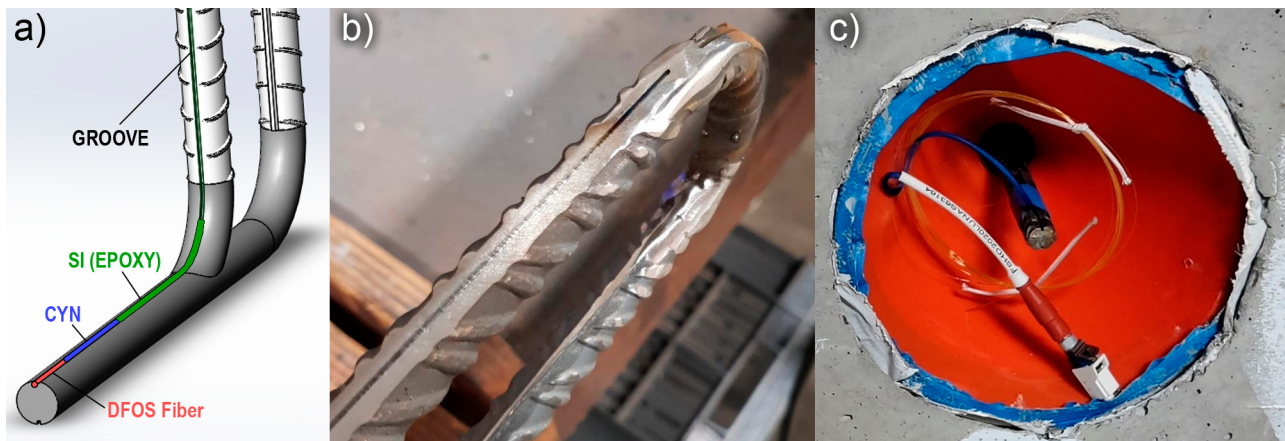
**Figure 4.** (a) Graphical representation of the bonding technique to the rebars and welded segment used in the foundation; (b) Groove made along the longitudinal rebar, showing the rounded and welded segment used in the head to join the two parallel rebar layers; and (c) the connector and termination of the fiber-optic cable was protected in the concrete footing using a plastic orange cone.

A small groove (i.e., slit of 1 mm width and depth) was cut along the rebar (Figure 4b), which has been widely practiced in previous research for attaching the DFOS to steel reinforcement and helping to prevent a premature failure of the fiber [11,17,29–31]. Ideally, the groove is milled along the longitudinal rib of the rebar as to not affect the cross-section or the bond from the transverse ribs. However, this could not be practiced in the experiments herein due to laboratory equipment limitations, and instead, the groove was milled along the rebar as shown in Figure 4b. After some initial trials, a general-purpose adhesive (“Loctite 401”, cyanoacrylate technology, or “CYN” in Figure 4a) was used to bond the fiber into the groove of the bar, which has also been successfully used in the literature for this purpose [3,11,18,32]. Some researchers have concluded that applying a thin layer of protection between the optical fiber and the concrete can achieve more reasonable strain profiles and, more importantly, help to achieve measuring strains after concrete cracking has occurred [18,33]. Thus, a silicone-based epoxy (“SI” in Figure 4a) was also used to

provide a coating of protection between the glued-fiber and the concrete. Figure 4c shows an orange plastic cone that was used to house the end of the rebar. The cone was attached to the rebar using heat-shrink tubing to protect the connection point and termination (i.e., the strain relief region) of the fiber during the preparation of the steel cage and pouring of concrete.

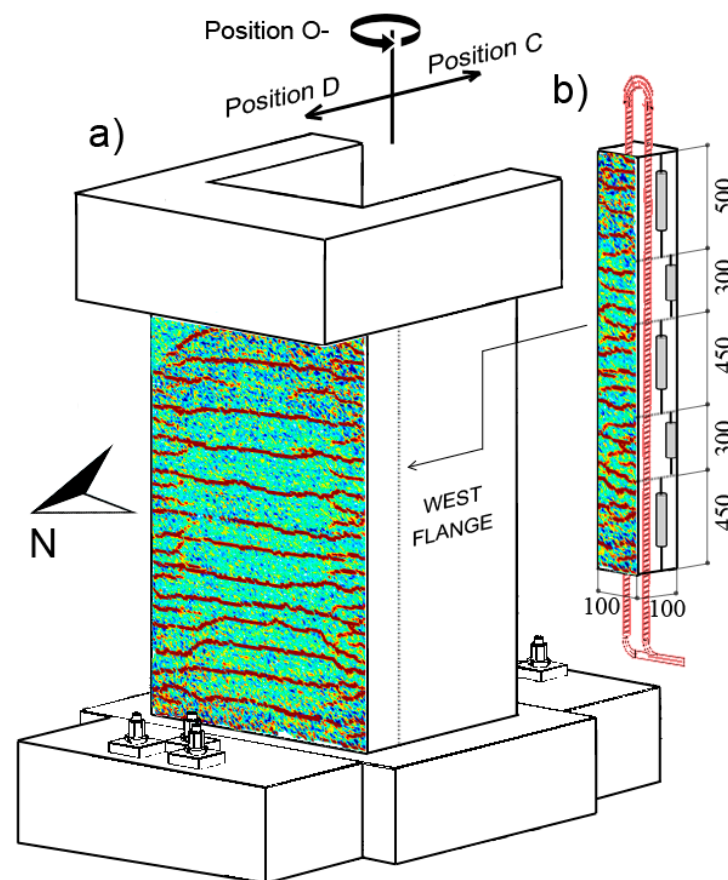
**Figure 5.** (a) 3-dimensional representation of the RC U-shaped wall units with foundation blocks and DIC strain results on the surface of the web; and (b) Corner-region “column” of the west flange-web intersection ( $100 \times 100 \text{ mm}^2$  cross-section) with DIC surface, embedded DFOS sensors (Channel 1), and LVDT chain, used in the current research.

A speckle pattern for digital image correlation (DIC) measurements was applied on two outside surfaces of the wall units. For this research, only some of the DIC results for the web region of the wall, depicted in Figure 5a, will be used. The speckle pattern covered the full height of the wall units from the base to its height of 2 m. The speckle pattern was applied by a stencil or stamp roller to produce a random pattern of black dots with an approximate diameter of 2.5 mm. Two three-dimensional DIC systems were installed, where 2 sets of two high resolution (12 megapixel) cameras recorded monochrome (i.e., black and white) images at a frequency of 0.2 Hz (i.e., every 5 s) during testing. This frequency was decreased to 0.1 Hz and 0.05 Hz for later loading stages that required a longer testing time to achieve large displacements and rotations. The images were processed using Istra 4D [39], where the strain field was exported into tab-separated values to be further processed and analyzed in MATLAB [40]. An example of the strain output in the form of a heatmap is shown in Figure 5a (strain values not indicated). For this research investigation, only the strains captured by the 100 mm × 2000 mm surface, depicted in Figure 5b, corresponding to the web boundary towards the west will be used. The northwestern wall corner “column” of 100 mm × 100 mm × 2000 mm (Figure 5b) provides an ideal opportunity to compare the LVDT chain and DIC surface measurements of the web to the internal strain measurements determined by the DFOS bonded to the two rebars, as is also depicted in Figure 5b.

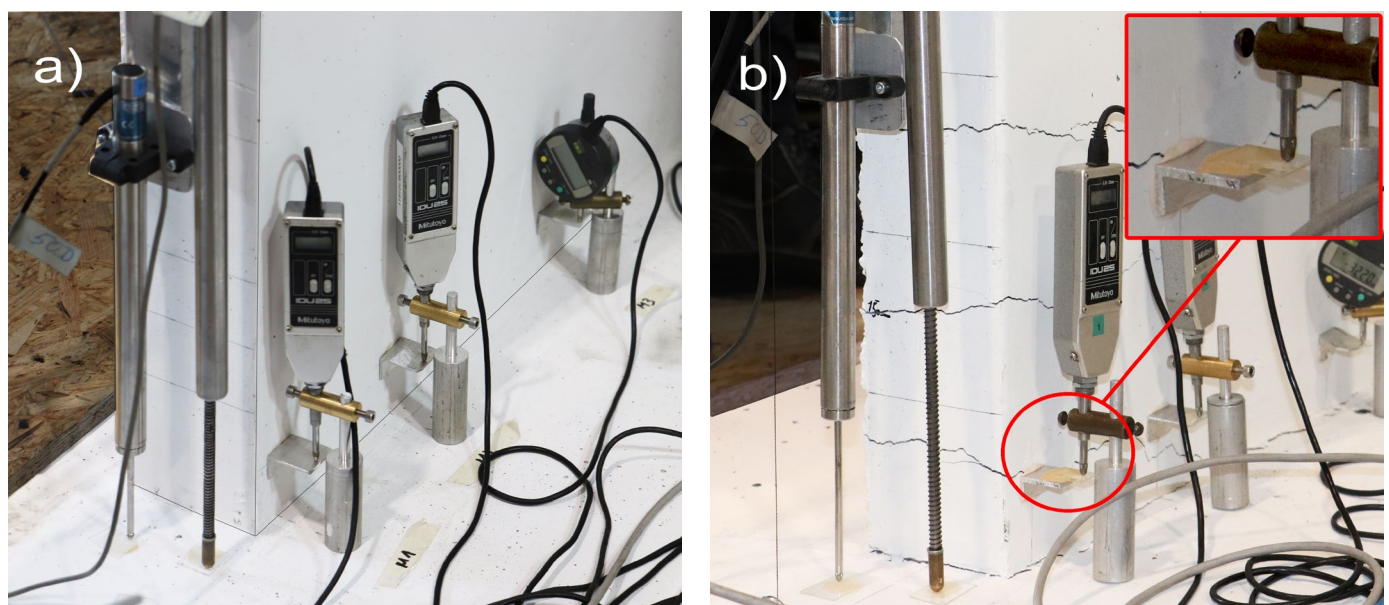
**Figure 6.** Photos of the inside edge of the west flange with micrometers (M1, M2, and M3) and base LVDTs attached close to the exterior and interior faces of the flange boundary end (a) Before testing of UW1; and (b) At LS34 of UW3 (position C+) showing flexural-shear crack running through attachment point of M1.

Test unit UW3 was subjected to a combination of reverse-cyclic torsional rotation and translation simultaneously, corresponding to positions D– and C+ (Figure 2a). The corresponding  $\Delta_v$  measurements from the micrometers of UW3 are presented in Figure 16, which can be compared to the calculated anchorage slip using the DFOS strains. The comparisons between the core and surface sensors look reasonable up to load stage 13. At the end of LS 13 (Position D–), an increase in the measured  $\Delta_v$  by M1 and M2 (Figures 16c and 16b, respectively) can be observed, with respect to that computed from the DFOS. For each LS that follows corresponding to a wall push to Position D– (i.e., LS 16–17, 19–20, and 22–23 in Figure 16), a significant increase in the measured anchorage slip can be observed from the micrometers M1 and M2 in comparison to the computed  $\Delta_v$  from channels 3 and 4 of the DFOS. One explanation for this increase of the anchorage slip measured by the two micrometers (M1 and M2) for when the west flange boundary end is in tension (position D–) is that a flexural crack has formed and runs through the application points of the two micrometers along the inside of the flange. Photos from the experiment support this (Figure 6b), where it is possible that the concrete surface crack affects the attachment of the micrometer to the wall, causing some small uplift. As discussed in the previous paragraph for UW2, another possible explanation for these discrepancies is the obvious increase in vertical deformation as measured by the micrometer if a strain gradient across the thickness is present, which was likely, due to the imposed rotation to the wall. For example, comparing the measured strain profiles for the interior and exterior rebars from Ch4 of the DFOS for wall unit UW3 confirms that a strain gradient was present (e.g., Figure 9a). The offset distance of the micrometer from the wall surface would inherently amplify the actual anchorage slip in the presence of strain gradients through the wall thickness. Furthermore, potential slip between the tip of the micrometer and the glass plate (see Figure 6b), which was glued to the metal plate for attachment to

the wall, would only have exacerbated this behavior. On closer inspection, the glass plates were not used to support the tip of these micrometers for testing unit UW1 (i.e., compare Figure 6a with Figure 6b). While there were less discrepancies between the comparisons of the micrometer measurements and the calculated DFOS anchorage slip, the loading imposed to UW1 meant that there was negligible strain gradient through the thickness, which also made comparisons of these instruments more favorable. Another observation in Figure 16a is the larger  $\Delta_v$  as measured by micrometer M5 in comparison to the DFOS at position D- (i.e., LS 10, LS 13, LS 16, etc.). One possible explanation for this was provided in the previous paragraph regarding the same observation with unit UW2 (i.e., the twisting applied causes the neutral axis to be skewed diagonally across the thickness of the wall). One last curious observation is the increasing residual vertical deformation by M5 after LS 18 (Figure 16a), which results in a larger measured anchorage slip by the micrometer in comparison to that calculated by the DFOS. The DFOS strains corresponding to the interior rebar in this region confirm that, at the beginning of LS 18, the rebars were performing pre-yield (max strain of 2.364 mm/m). Thus, the residual deformation is unlikely to be a result of inelastic behavior from the reinforcing steel. Instead, it is again possible that flexural cracks have formed close to the fixation of the micrometer on the surface of the wall. If these cracks cannot close all the way, it is possible that the micrometer does not return to an anchorage slip measurement ( $\Delta_v$ ) of zero on return to centering the wall (at position O).

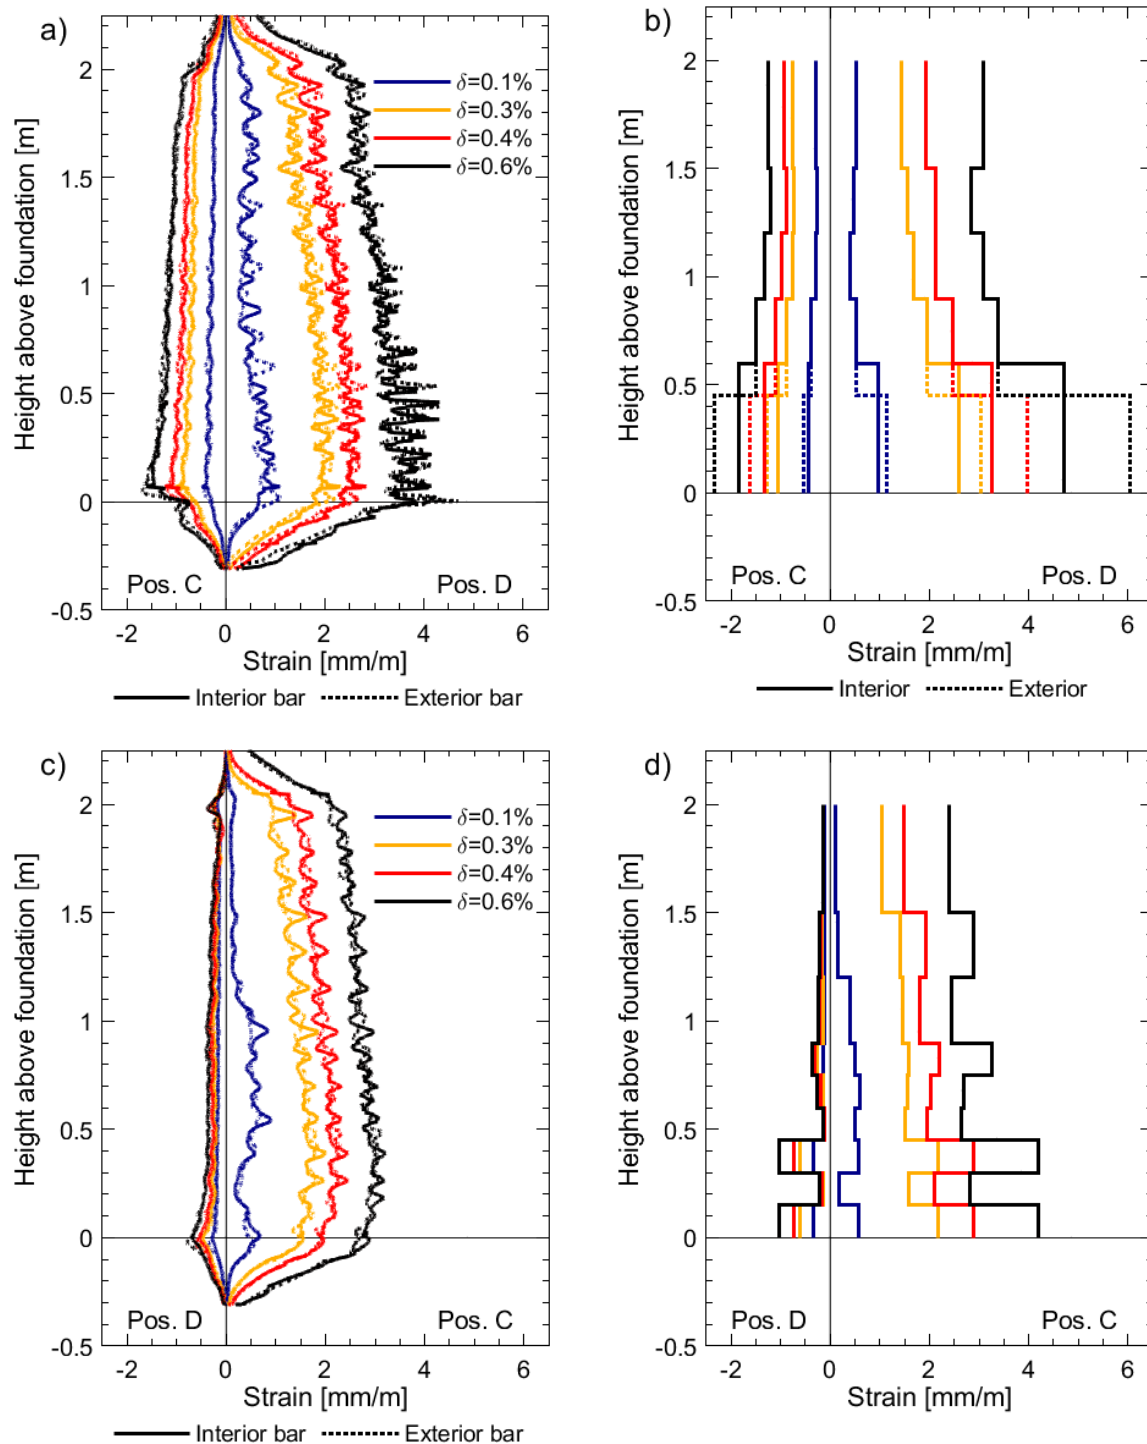
**Figure 7.** Longitudinal strain profiles for unit UW1 subjected to pure flexure at different imposed drifts: (a) Channel 4 of the DFOS; (b) chain of LVDTs located on the west flange boundary end; (c) Channel 1 of the DFOS; and (d) chain of LVDTs located on the west flange-web intersection.

Figure 7 presents the strain profiles derived from DFOS and LVDTs for specimen UW1, which was subjected to in-plane bending about its minor axis (positions C and D, Figure 2a) at different imposed drifts. Both of the LVDTs at the base of the boundary end, i.e., the exterior and interior LVDTs pictured in Figure 6, with base lengths of 450 mm and 600 mm, respectively, were used to derive the base strains in Figure 7b. As expected, the base strain for the 450 mm LVDT is larger than for the 600 mm LVDT, since the contribution of the strain penetration in the foundation is unsurprisingly more significant than the

wall deformation between the heights of 450 mm and 600 mm. As is well known in the structural and seismic design and analysis of RC structures, strain penetration effects can contribute to a significant amount of the overall lateral displacement capacity [41]. Additionally, it can be observed that the LVDT tensile strains at the base are, in general, greater than those measured on average by the DFOS. For example, in Figure 7b, when the wall is pushed towards position D and the west flange boundary end is in tension, the base strain determined from the exterior bottom LVDT (450 mm base length) is approximately 6 mm/m for a drift ( $\delta$ ) of 0.6%, whereas ch4 of the DFOS measures an average strain of 3.6 mm/m (Figure 7a) over the same base length of 450 mm. It is interesting to note that the DFOS on the exterior rebar outputs a strain at the foundation wall interface crack of 4.6 mm/m, attaining a local minimum of 3.3 mm/m at mid-crack spacing above (i.e., at a height of approximately 40 mm); such variation will increase for walls UW2 and UW3, as it will be shown. In reality, recalling that the DFOS results correspond to a moving average over a length of approximately 10 mm, the peak strain of 4.6 mm/m hides, in fact, a larger local strain of 6.1 mm/m. The discrepancy between base LVDT measurements and DFOS can again be explained due to the effects of strain penetration, which are not considered in the LVDT-derived strain outputs. Had strain penetration effects been considered, they would increase the required effective base length for strain computations. In fact, without the strains from the DFOS, which clearly capture the strain penetration into the foundation, it is very difficult to determine the contribution to the LVDT strain output coming from deformations inside the foundation. Other investigations have proposed methods aiming at approximately removing deformation contributions in RC members from outside the gauged region [42]. Please also refer to Section 3.3. LVDT chains, such as those used here at the extreme compression and tension fiber regions of the wall, are used in most wall tests to determine average curvatures along the wall height [43]. However, without consideration of strain penetration effects, it is inevitable that base curvatures are overestimated using these LVDT average strains. Previous researchers have recommended that the base length of the lowest instrument in the LVDT chain be sufficiently small, such that it only extends over the base crack between the wall and foundation [43]. However, even when using a sufficiently small base length, the resulting strains and curvatures from the LVDTs will not be accurately represented without defining a meaningful base length that includes the strain penetration [44]. The average strains determined by the LVDTs higher up the wall from the base appear to provide more reasonable estimates in comparison to the DFOS strain profiles in Figure 7.

The measured strain profiles for the interior and exterior longitudinal rebars (along the thickness) are almost identical, which was expected with the type of loading subjected to unit UW1. In addition to the gradual change of strain along the wall height, local strain peaks can be observed from the DFOS in Figure 7a,c, which correspond to the location of flexural cracks. Using the tensile strain profile from channel 4 of the DFOS for  $\delta = 0.6\%$  (Figure 7a, position D), the average spacing of these strain peaks (crack spacing) was calculated to be 68 mm, which is approximately the spacing of the stirrups ( $\approx 75$  mm), corroborating previous observations in beams [13].

In comparison to the DFOS strain profiles, the resulting LVDT strain profiles appear to be very dependent on where the surface sensors are placed. A good example is shown in Figure 7d, where two peaks in tensile strain can be observed at a height of approximately 0.85 m and 1.35 m from the foundation. In comparison to the gradual and smooth DFOS strains in Figure 7c, these peaks of tensile strain calculated from the LVDTs are likely caused by asymmetric inclusion of concrete surface cracks in the gauged areas.

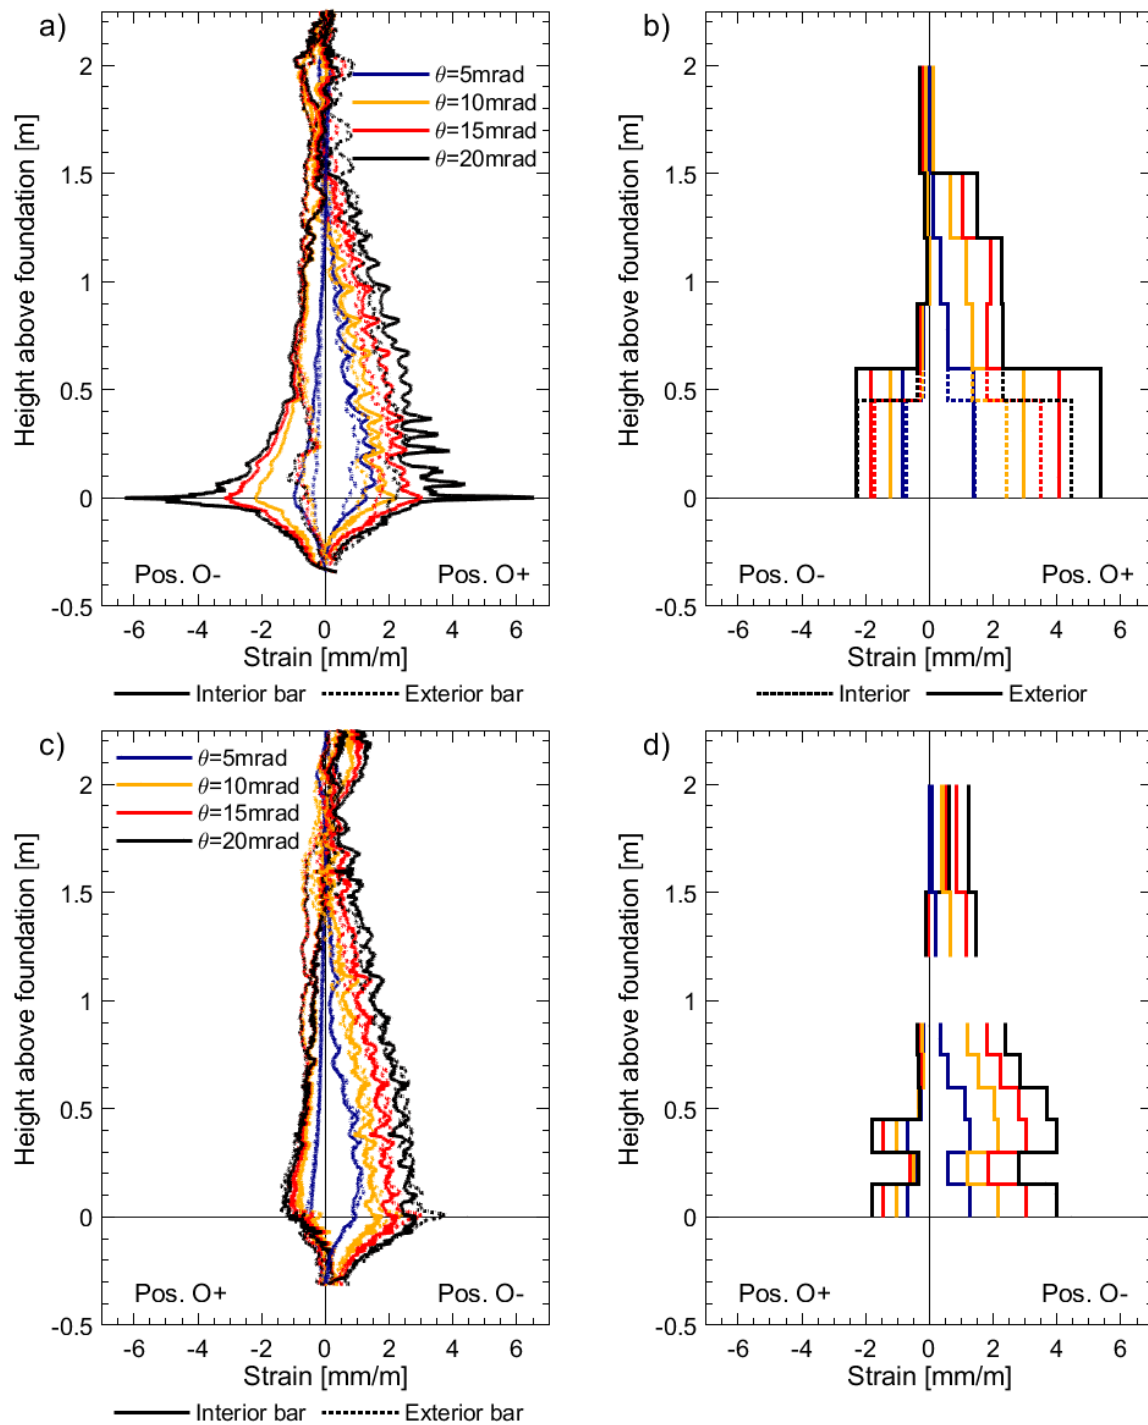
**Figure 8.** Longitudinal strain profiles for unit UW2 subjected to pure torsion at different imposed twists: (a) Channel 4 of the DFOS; (b) Chain of LVDTs located on the west flange boundary end; (c) Channel 1 of the DFOS; and (d) Chain of LVDTs located on the west flange-web intersection.

Figure 8 presents the strain profiles derived from DFOS and LVDTs for specimen UW2, which was subjected to a reverse-cyclic rotation about its vertical axis (positions O+ and O−, Figure 2a). Unfortunately, one of the LVDTs on the face of the west flange-web intersection, from a height between 900 mm and 1200 mm, malfunctioned, and hence there is a loss of information in Figure 8d. Many of the same comparisons observed for UW1 in the previous paragraphs can be made here with respect to the results in Figure 8 for

UW2. However, unlike the loading imposed to UW1, the rotation applied to UW2 resulted in a strain gradient across the flange thickness, and hence a difference in the DFOS strain profiles was measured for the interior and exterior rebars, particularly for the west flange boundary end in Figure 8a. This difference in strain, which is due to the combination of circulatory and warping torsion [45] of the flange, is not captured with the array of LVDTs, although there is clearly some difference in tensile strains calculated by the two base LVDTs in Figure 8b. Thus, the LVDT surface instrumentation, in comparison to the DFOS, is unable to capture the detailed information about the behavior of the wall with regards to strain gradients across the thickness of the wall. Figure 8a,c also clearly show the existence of a steep moment gradient along the flange height, which can only be very insufficiently captured by the LVDTs. It is hence not surprising that the peak strain measured by channel 4 of the DFOS at the foundation wall interface, which takes a value of 6.5 mm/m, is larger than the average strain of 5.4 mm/m given by the bottom LVDT, unlike what happened for UW1. The strains measured by the DFOS attached to the interior bar in the boundary end of UW2 capture the compression at the head of the wall and tensile strains at the base when loaded to position O+ (Figure 8a). Such distribution is not captured by the LVDT array in the boundary end (Figure 8b), and instead, the average strains at the top of the wall, over a base length of 500 mm, are close to zero. As explained in the data paper [19], it is postulated that the application of the axial load to the walls, which was distributed evenly to three vertical actuators, is responsible for the partial warping restraint, corresponding to this observed behavior. It is worth mentioning that while it was possible to place two LVDTs at the base of the boundary end, two layers of LVDTs could not be achieved along the full height of the west flange boundary end because of the small thickness of 100 mm.

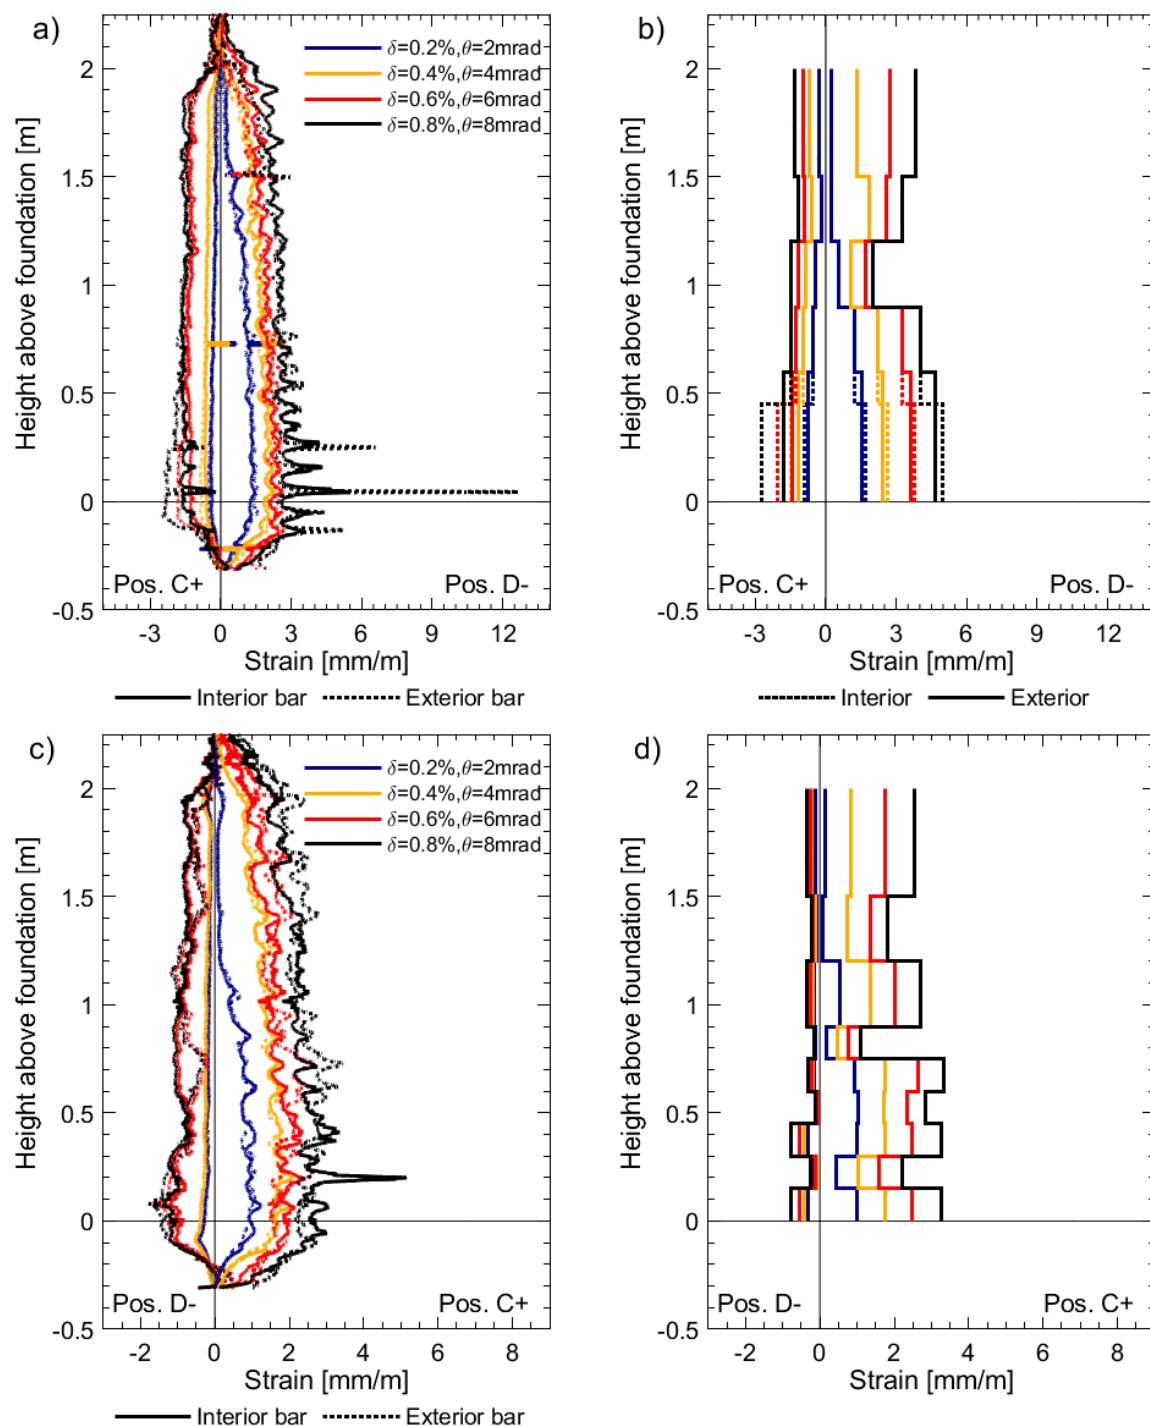
**Figure 9.** Longitudinal strain profiles for unit UW3 subjected to a combination of flexure and torsion: (a) Channel 4 of the DFOS; (b) Chain of LVDTs located on the west flange boundary end; (c) Channel 1 of the DFOS; and (d) Chain of LVDTs located on the west flange-web intersection.

Figure 9 presents the strain profiles derived from the DFOS and LVDTs for specimen UW3, which was simultaneously subjected to both an in-plane translation and twist (positions D- and C+, Figure 2a). Some of the observations for the comparisons made between the LVDTs and DFOS strains for UW1 and UW2 are consistent with the strain profiles in Figure 9. for UW3. For this wall unit, a drift ( $\delta$ ) and simultaneous rotation ( $\theta$ ) of 0.8% and 8 mrad, respectively, result in DFOS tensile strains in the boundary end rebars greater than yield ( $>2.9$  mm/m) at position D- (Figure 9a). For the exterior bar, in particular, a peak tensile strain of 12.6 mm/m was attained in the first crack above the foundation wall interface. This peak strain value contrasts with local minima of 4.4 mm/m and 3.9 mm/m at mid-crack spacing below and above, respectively (i.e., at a depth of  $-50$  mm and height of 156 mm from the foundation level). It is likely that the very large reported values of measured tensile strains by the DFOS do not exactly correspond to actual strains inside the steel rebars. In fact, at the abovementioned level of loading, some information loss in the regions close to the localized strain peaks may occur. As suggested by Brault and Hoult [18], inaccuracy in the strain readings from the DFOS once plasticity occurs is likely to be caused by one or a combination of factors: (i) After deterioration of the bond between the concrete and the steel reinforcing, pinching of the fiber occurs, which affects the light transmitting through the fiber optic core; (ii) Significant crack openings with the potential to shear the surface of the fiber; and (iii) Large strain gradients, which result in measuring difficulties for the interrogator (i.e., analyzer) [46]. For the results herein, it is unlikely that the first two factors accounted for the inaccurate readings. As the loading imposed is reverse-cyclic, the wall returns to its centered position (i.e., position O), where the strains decrease, and the strain information returns as the optical fiber is still intact. However, a net positive strain is measured by the DFOS within these regions of the localized plasticity from previous load stages. These localized peaks in tensile strain from the DFOS continue to the next load stage, at position C+, when the flange end is in compression (Figure 9a). It is possible that the rebar in these localized areas has, on the previous load cycle, yielded in tension, deformed inelastically, and attains permanent damage that results in residual tension for the next load cycle. However, it is also possible that the reverse-cyclic tension-compression yielding of the rebar across these localized cracks has caused the fiber-optic cable to buckle, something that has been postulated to occur in previous experiments using DFOS in RC

beam-column joints [13]. Another explanation for this net-tension reading by the DFOS is due to thermal effects from plastic deformation of the rebars at these localized areas, which has not been accounted for in these experiments.

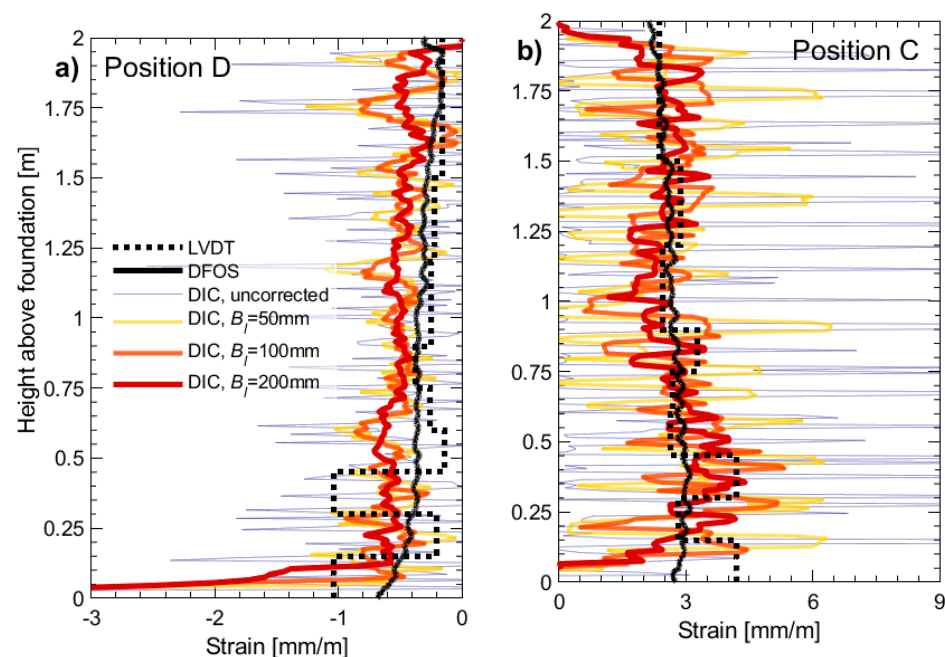
**Figure 10.** DIC strains profiles for the web-West flange intersection of wall unit UW1 at: (a) Position D (compression); and (b) Position C (tension) at  $\delta = 0.6\%$ . A moving average was used to smooth the DIC profiles using different span base lengths ( $B_l = 50$  mm, 100 mm, and 200 mm). The strain profiles are compared to the profiles measured from the average of the DFOS strain profiles (black solid lines) and LVDT strains (black dashed lines).

For the above reasons, in the initial part of this section, the authors use DIC and DFOS results from one wall specimen to recommend a base length value. Figure 10 presents the longitudinal DIC strain values of UW1’s boundary column of the flange-web intersection in tension and compression (position C and position D, respectively, for a drift  $\delta$  of 0.6%). The average of the longitudinal strains determined across the 100 mm width of the boundary column (Figure 5b) was computed, whereas different base lengths ( $B_l$ ) were used to take a moving average vertically: (i) No moving average (“uncorrected”); (ii)  $B_l = 50$  mm; (iii)  $B_l = 100$  mm; and (iv)  $B_l = 200$  mm. The latter of these values represents an upper limit, equivalent to  $2.0 \times$  the thickness of the wall ( $2.0t_w$ ). The 50 mm and 100 mm were chosen based on  $0.5 \times$  and  $1.0 \times$  the thickness  $t_w$ . For reference, the DFOS strains (average of the two rebars, black solid line) and calculated strains from the LVDT array (black dashed line) are superimposed in these figures. As mentioned previously in Section 3.1, the loading applied to UW1 resulted in closely resembling DFOS strain profiles between the two layers of rebars, which justified taking the average to result in a single profile here. The “uncorrected” DIC strains, with no applied moving average, show peaks of large tensile strains (Figure 10b), which correspond to the local strains captured across small, open flexural cracks at the surface of the concrete. The average of the spacing between the tensile peaks (or crack spacing) is 64.7 mm, which is close to the designed spacing of the transverse confinement (= 75 mm). While many factors ultimately determine the crack spacing of a RC member in tension [9], the spacing of the transverse reinforcement is a primary factor. Interestingly, the average spacing distance between the “uncorrected” DIC compression strain peaks (Figure 10a) is 31.9 mm, approximately half of the spacing distance between the tensile peaks. In this case, it is likely that compression strain peaks from the DIC coincide with the location of cracks closing, as well as the concrete in between the cracks, whereas the reinforcing bar in compression exhibits a smooth strain profile (as indicated with the DFOS strains). If it is assumed that the reference strains from the DFOS and LVDTs are more reliable indicators of the strain profile, the DIC tensile strains with  $B_l = 200$  mm appear to provide better estimates representative of the compression and tensile strain profiles. There is a clear difference of DFOS measured strains and the DIC calculated strains at the base of the wall in both compression and tension (Figure 10a and 10b, respectively). Firstly, when the boundary column under consideration is in tension (Position C, Figure 10b), the tension at the base is not adequately captured by

the DIC technique due to strain penetration not being considered [47]. The uncorrected DIC strains at the very base of this column have been ignored for the purposes of deriving the corrected DIC strain profiles due to the unrealistically high concreated strain values, which, in some cases, will result in a poor estimate of the base tensile strain. Secondly, when the boundary column is in compression (Position D, Figure 10a), it is expected, under the current flexural loading, that compressive strains in the concrete surface, captured by DIC, would be greater than the compression in the steel bars, captured by the DFOS, which are embedded at some 25 mm from the surface of the boundary column. For large drift levels towards Position D, the neutral axis is located somewhere in the web of the wall (see Figure 1a for the wall segment definitions). Therefore, the web surface of the wall captured by the DIC, or in this case, the surface of boundary column under consideration, represents the extreme compression fiber region (for loading towards position D), which is expected to experience greater compression strains than the rebars closer to the neutral axis.

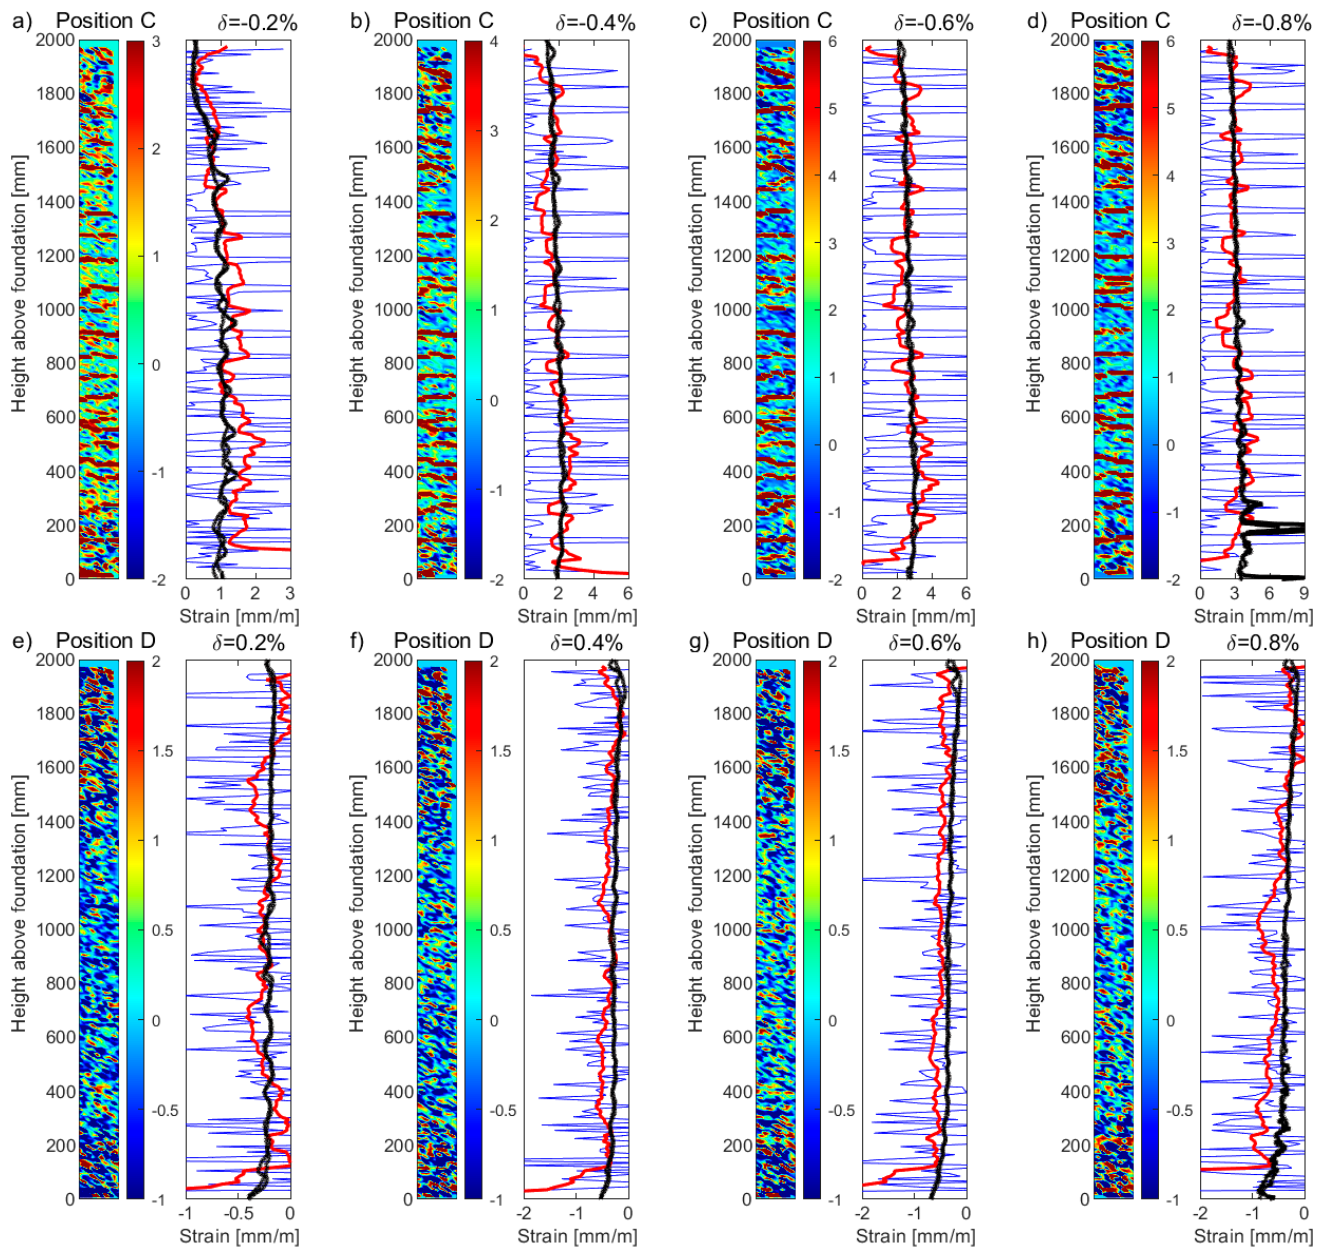
**Figure 11.** DIC and DFOS longitudinal strain profiles for the west web-flange intersection of wall unit UW1 subjected to flexure, in tension (Position C): (a)  $\delta = -0.2\%$ ; (b)  $\delta = -0.4\%$ ; (c)  $\delta = -0.6\%$ ; (d)  $\delta = -0.8\%$ , and in compression (Position D); (e)  $\delta = 0.2\%$ ; (f)  $\delta = 0.4\%$ ; (g)  $\delta = 0.6\%$ ; and (h)  $\delta = 0.8\%$ . The thin blue lines are the uncorrected strains determined from the DIC data, whereas the thick red lines are the corrected strains (i.e., moving average over 200 mm) determined from the DIC data. The solid black lines are the strain measurements from the DFOS (i.e.,  $2 \times \Phi 12$  rebars, Channel 1). A heatmap is provided next to each plot, representing the uncorrected, raw DIC strain (in units of mm/m).

Figures 11a–d and 11e–h present the DIC tensile and compression strain profiles, respectively, from the surface of the boundary column for unit UW1, subjected to in-plane bending, for four different levels of drift ( $\delta$ ): 0.2%, 0.4%, 0.6%, and 0.8%. Drift levels greater than this were found to cause some information loss in channel 1 of the DFOS. A heatmap is presented to the left side of each plot, representing the uncorrected, raw DIC strain data (in units of mm/m) for the entire  $100 \times 2000$  mm<sup>2</sup> surface of the boundary column (illustrated in Figure 5b). The right side of each figure plots the uncorrected DIC strains (blue thin lines), where the average of the longitudinal DIC strains across the 100 mm width of the boundary column have been computed for each vertical increment. Superimposed in these plots are the corrected (vertical moving average with  $B_l = 200$  mm) DIC strains (red thick lines) and the strain profiles measured from the DFOS bonded to the two  $\Phi 12$  mm rebars (black solid lines). Note again that for the loading applied to UW1 (i.e., in-plane loading to position C and D, Figure 2a), the resulting DFOS strain profiles of these two rebars were essentially the same. Overall, the corrected DIC strains provide more representative estimates for these drift levels, assuming that the reference strains from the DFOS are more reliable indicators

of the strain profile. Due to the fact that the DIC technique captures the tensile strains across the cracks of the concrete surface, slightly larger tensile strain oscillations can be observed in comparison to the smoother DFOS strains occurring in the section core. This smoothness is due to the bond stress transfer that occurs between the steel rebar and the surrounding cover concrete (recall that the fiber-optic cables are placed on the outside of the steel rebar, to the east and to the west for the exterior and interior bar, respectively—see Figure 4a,b), of which only the surface manifestation of this phenomenon is captured by the DIC. Several other factors could have contributed to the limited discrepancies of strain profiles observed between the surface and core measurements, with the most obvious being the difference in the location of the surface plane (i.e., the web of the wall, Figure 5) captured by the DIC and the location of the embedded rebars with DFOS in the boundary column, some 25 mm from the web surface. Furthermore, local bending of steel reinforcement has been shown to produce variations in the magnitude of the resulting strain measurements [52], where, for this study, the fiber-optical cables are located on the outside of the rebar. Other factors include the strain “transfer effect”, which could result in the strains determined by the sensors being different from the strains of the host structure (i.e., the steel rebar) [15,53,54]. While the authors took a number of precautions to reduce these strain transfer effects [55] (e.g., see Section 2.2.1, consideration of adhesive type, engraving a small groove, fiber bonded directly to the reinforcement [3], etc.), these effects cannot be completely ruled out.
