# Core versus Surface Sensors for Reinforced Concrete Structures: A Comparison of Fiber-Optic Strain Sensing to Conventional Instrumentation

**Abstract:** High-resolution distributed reinforcement strain measurements can provide invaluable information for developing and evaluating numerical and analytical models of reinforced concrete structures. A recent testing campaign conducted at UCLouvain in Belgium used fiber-optic sensors embedded along several longitudinal steel rebars of three reinforced concrete U-shaped walls. The resulting experimental dataset provides an opportunity to evaluate and compare, for different types of loading, the strain measurements obtained with the fiber-optic sensors in the confined core of the structural member against more conventional and state-of-the-practice sensors that monitor surface displacements and deformations. This work highlights the need to average strain measurements from digital image correlation techniques in order to obtain coherent results with the strains measured from fiber optics, and investigates proposals to achieve this relevant goal for research and engineering practices. The longitudinal strains measured by the fiber optics

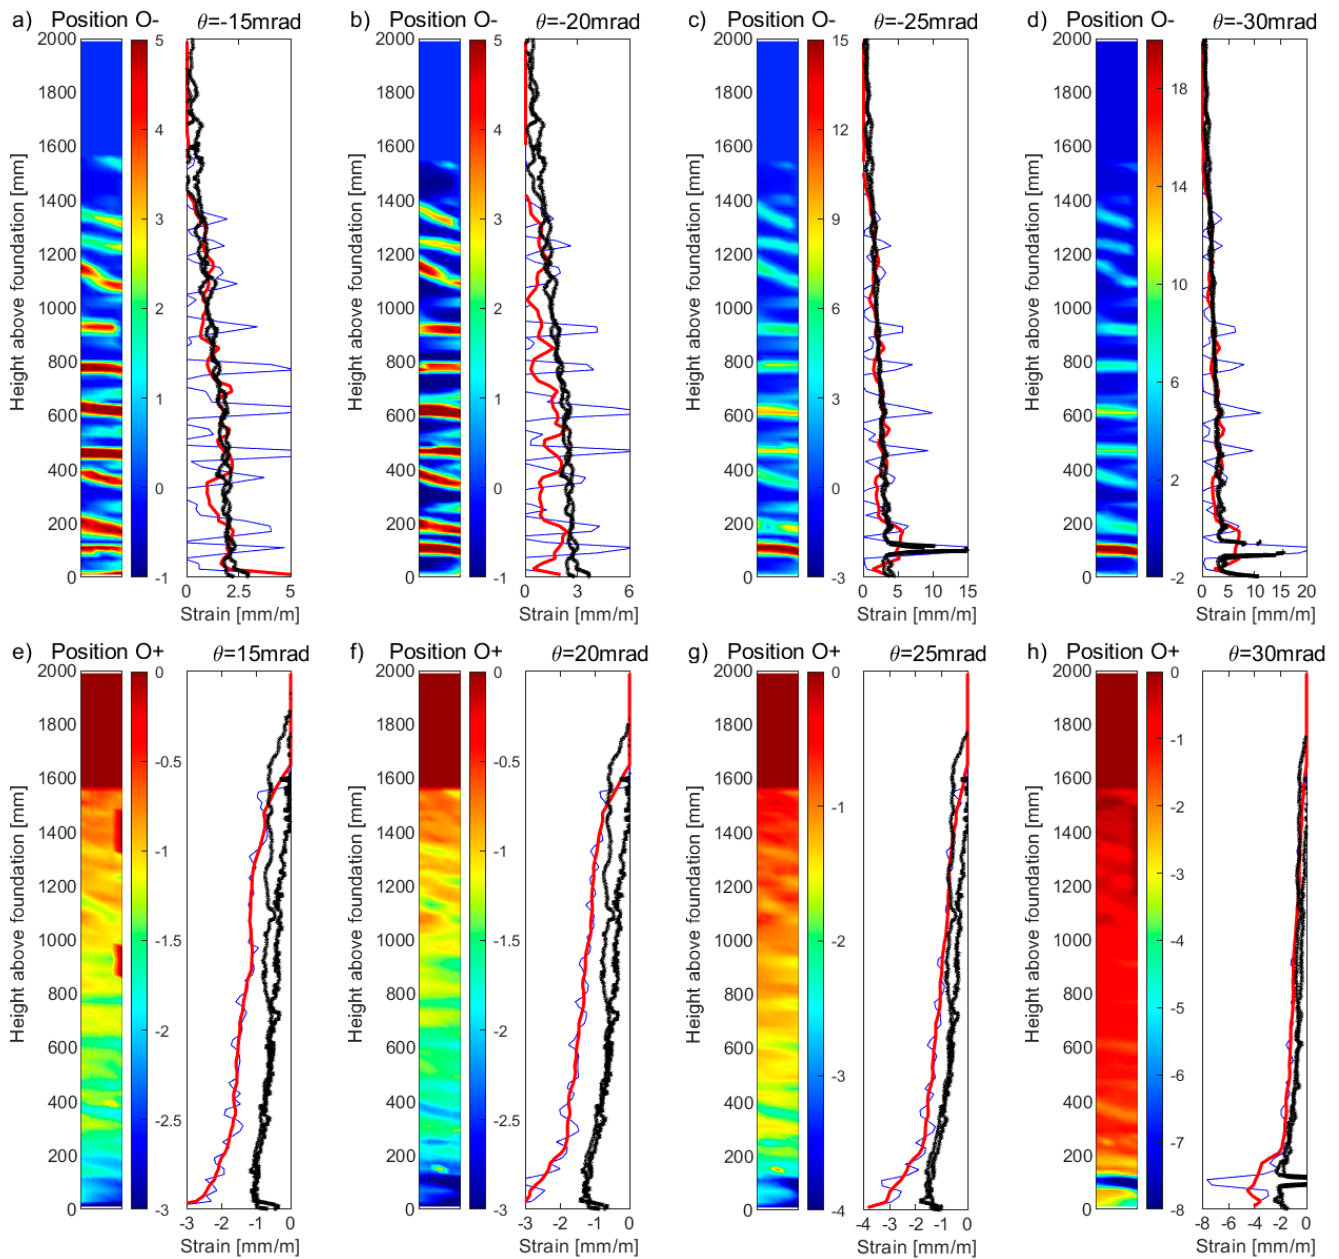
**Figure 12.** DIC and DFOS longitudinal strain profiles for the west web-flange intersection of wall unit UW2 subjected to torsion, in tension (Position O−): (a)  $\theta = -15$  mrad; (b)  $\theta = -20$  mrad; (c)  $\theta = -25$  mrad; (d)  $\theta = -30$  mrad, and in compression (Position O+); (e)  $\theta = 15$  mrad; (f)  $\theta = 20$  mrad; (g)  $\theta = 25$  mrad; and (h)  $\theta = 30$  mrad. The thin blue lines are the uncorrected strains determined from the DIC data, whereas the thick red lines are the corrected strains (i.e., moving average over 200 mm) determined from the DIC data. The solid black lines are the strain measurements from the DFOS (i.e.,  $2 \times \Phi 12$  rebars, Channel 1). A heatmap is provided next to each plot, representing the uncorrected, raw DIC strain (in units of mm/m).

For the boundary column of unit UW2, which was subjected to a reverse-cyclic torsional rotation, Figures 12a–d and 12e–h present the DIC tensile and compression strain profiles, respectively, for four different rotation ( $\theta$ ) levels: 15 mrad, 20 mrad, 25 mrad, and 30 mrad. This type of loading caused slight differences in the DFOS strain profiles of the two longitudinal rebars, represented by the black thick lines. While the rather gradual gradient of the strain profiles measured from channel 1 of the DFOS system for UW2 meant that strains greater than yield could be achieved, rotation levels greater than 30 mrad started to cause some information loss in this channel. The latter can be observed at the base of the boundary column in Figure 12c,d, where loss of DFOS data occurs for strains greater than 10–15 mm/m, corresponding to the limits given in the technical dataset for the LUNA system used (see Section 2.2.1). Note that the DFOS in both layers of the rebars measured the localized strain increase at the same location. Interestingly, the uncorrected (raw) DIC strain peak towards the base in Figures 12c and 12d compare reasonably well to the strain peak measured with the DFOS, corresponding to where the information loss occurs. These strain levels also cause a noticeable net-tension strain measurement in the DFOS at the next load stage in compression, presented in Figure 12h with the black thick lines. Note that the DFOS in both layers of the rebars measured this localized net-tension in strain measurement. A list of possible explanations for this was included in Section 3.1, with a possibility of this reflecting a real, localized phenomenon. However, the maximum DIC compression strains appear to concentrate at approximately 100 mm from the base in Figure 12h, which is the same location of the maximum tensile strains in the previous load stage in Figure 12d. Thus, it is also possible, and maybe more likely, that this level of rotation ( $\theta = -30$  mrad) has caused the DFOS to be pinched or buckle, resulting in a false reading of strain at this location. This explanation appears to be consistent with the reasons given in Zhang et al. [13], where the phenomenon was observed for DFOS bonded to rebar embedded in a RC beam-column joint that was reverse-cyclically tested. Overall, the corrected DIC data in Figure 12a–d (red thick lines) appear to reasonably represent the strain profiles for all levels of rotation considered in comparison to the tensile strain profiles measured by the DFOS. These results also show that the recommended correction, using a simple moving average with a base length  $B_l$  of 200 mm, can be applied to DIC data of high, medium, and low resolution, with the latter of these represented by the DIC data attained for unit UW2. For example, while a clear smearing effect of the uncorrected DIC data could be observed in Figure 11 for UW1, the effects are less prominent in Figure 12 for UW2, particularly for the compression strain profiles in Figure 12e–h. Thus, it appears that the recommended correction method for DIC strains has its greatest effect when the

resulting vertical grid spacing is much less than the base length  $B_l$  recommended here of 200 mm. However, the corrected DIC compression strain profiles in Figure 12e–h appear to overestimate the compression strain profiles of the rebars measured by the DFOS. Similar to the DIC and DFOS results for UW1 in Figure 11e–h, the large compression strains could be expected, given that the DIC is measuring the compression strains of the concrete surface, representing the extreme compression fiber region; instead, the DFOS are attached to the longitudinal rebar embedded at some cover distance away from the surface.

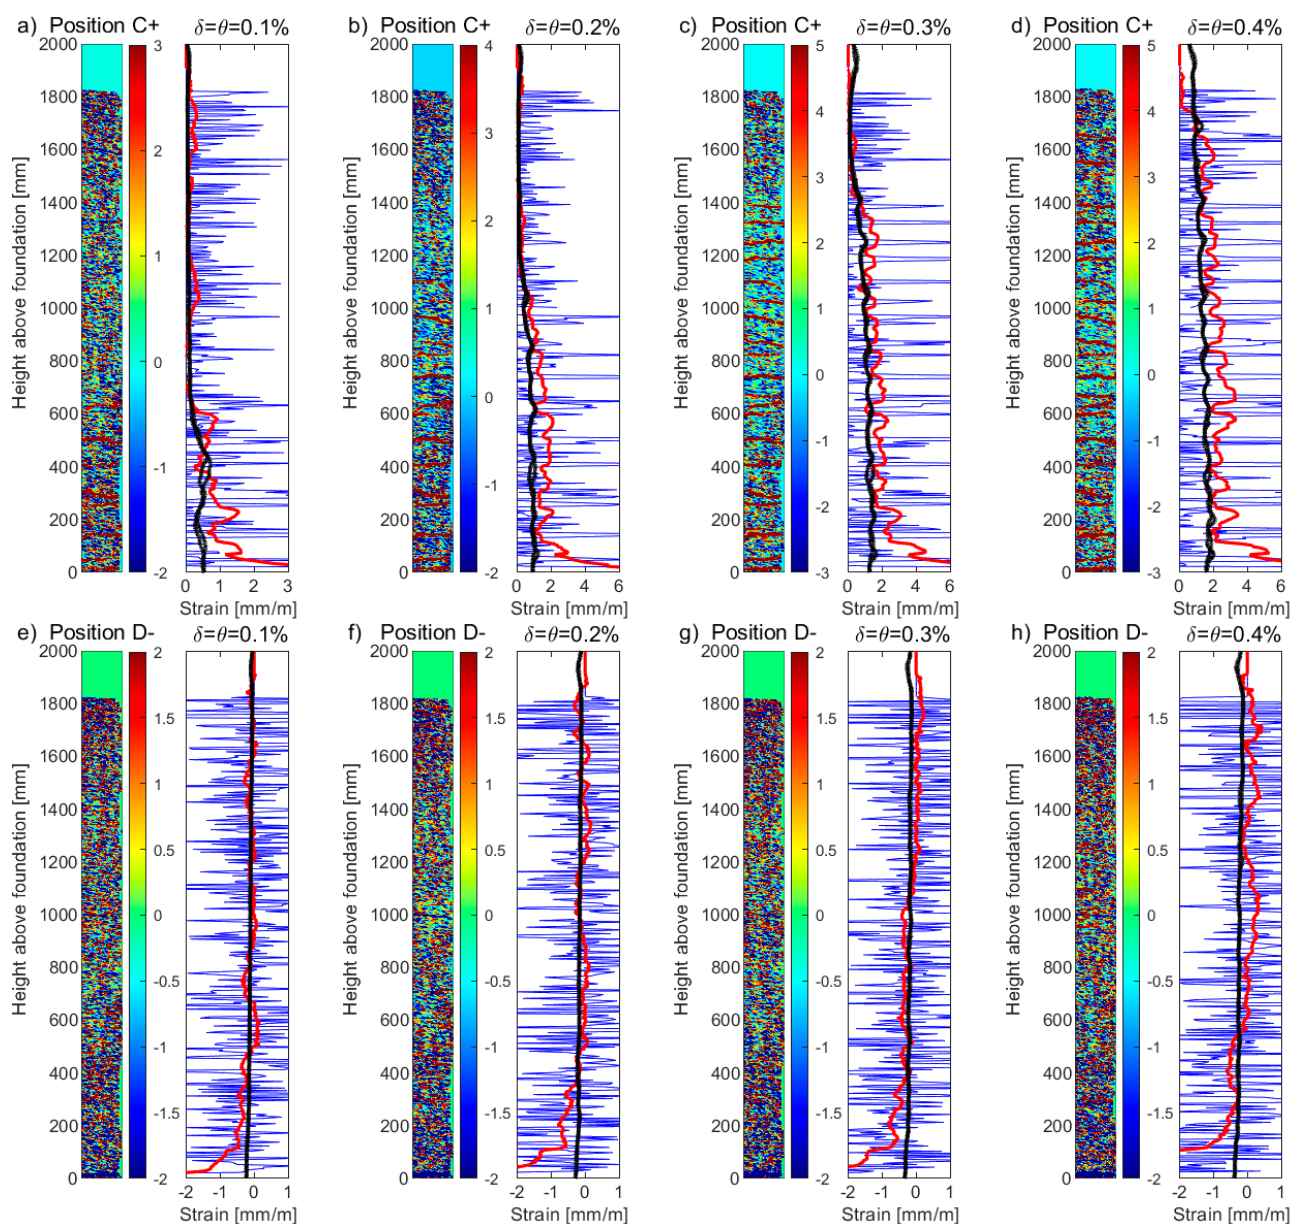
**Figure 13.** DIC and DFOS longitudinal strain profiles for the west web-flange intersection of wall unit UW3 subjected to flexure and torsion, in tension (Position C+): (a)  $\delta = -0.1\%$ ,  $\theta = 1$  mrad;

(b)  $\delta = -0.2\%$ ,  $\theta = 2$  mrad; (c)  $\delta = -0.3\%$ ,  $\theta = 3$  mrad; (d)  $\delta = -0.4\%$ ,  $\theta = 4$  mrad and in compression (Position D); (e)  $\delta = 0.1\%$ ,  $\theta = -1$  mrad; (f)  $\delta = 0.2\%$ ,  $\theta = -2$  mrad; (g)  $\delta = 0.3\%$ ,  $\theta = -3$  mrad; and (h)  $\delta = 0.4\%$ ,  $\theta = -4$  mrad. The blue thin lines are the uncorrected strains determined from the DIC data, whereas the red thick lines are the corrected strains (i.e., moving average over 200 mm) determined from the DIC data. The solid black lines are the strain measurements from the DFOS (i.e.,  $2 \times \Phi 12$  rebars, Channel 1). A heatmap is provided next to each plot, representing the uncorrected, raw DIC strain (in units of mm/m).

The DIC data attained from the web of UW3 had the highest resolutions of all three wall units with a resulting vertical grid spacing of 5 mm (Figure 2a). This is compared to a vertical grid spacing of 10 mm and 20 mm for UW1 and UW2, respectively. Wall unit UW3 was subjected to both a reverse-cyclic torsional rotation and a translational push-pull, simultaneously (i.e., position C+ and D− in Figure 2a). The uncorrected and corrected DIC tensile and compressive strains for the web boundary column of UW3 are presented in Figures 13a–d and 13e–h, respectively, for four different drift-rotation ( $\delta$ - $\theta$ ) levels:

$\delta = 0.1\%$  and  $\theta = 1$  mrad,  $\delta = 0.2\%$  and  $\theta = 2$  mrad,  $\delta = 0.3\%$  and  $\theta = 3$  mrad, and  $\delta = 0.4\%$  and  $\theta = 4$  mrad. The high-resolution, uncorrected DIC data in Figure 13 (blue thin lines) results in high-frequency peaks of tensile and compressive strain, which make it difficult to interpret without processing the data using, for example, a moving average (red thick lines). In comparison to the DFOS strain profiles in Figure 13 (black dashed lines), the corrected DIC strain profiles compare reasonably well. Larger DIC tensile strains can be observed at the base of the boundary column (i.e., Figure 13d), which is a consequence of this surface instrumentation method not being able to measure the strain penetration into the foundation, similar to the observations for the LVDTs in Section 3.1. There is also some small, but noticeable, positive (tensile) surface strains in Figure 13h from above mid-height, calculated from the corrected (red thick line) DIC data, which is not measured by the DFOS (black thick lines). It is worth noting that this type of strain gradient was similarly illustrated in the data paper [19] and measured by the DFOS for UW2 (i.e., pure rotation), particularly for the rebars of channel 4 in the west flange boundary end.

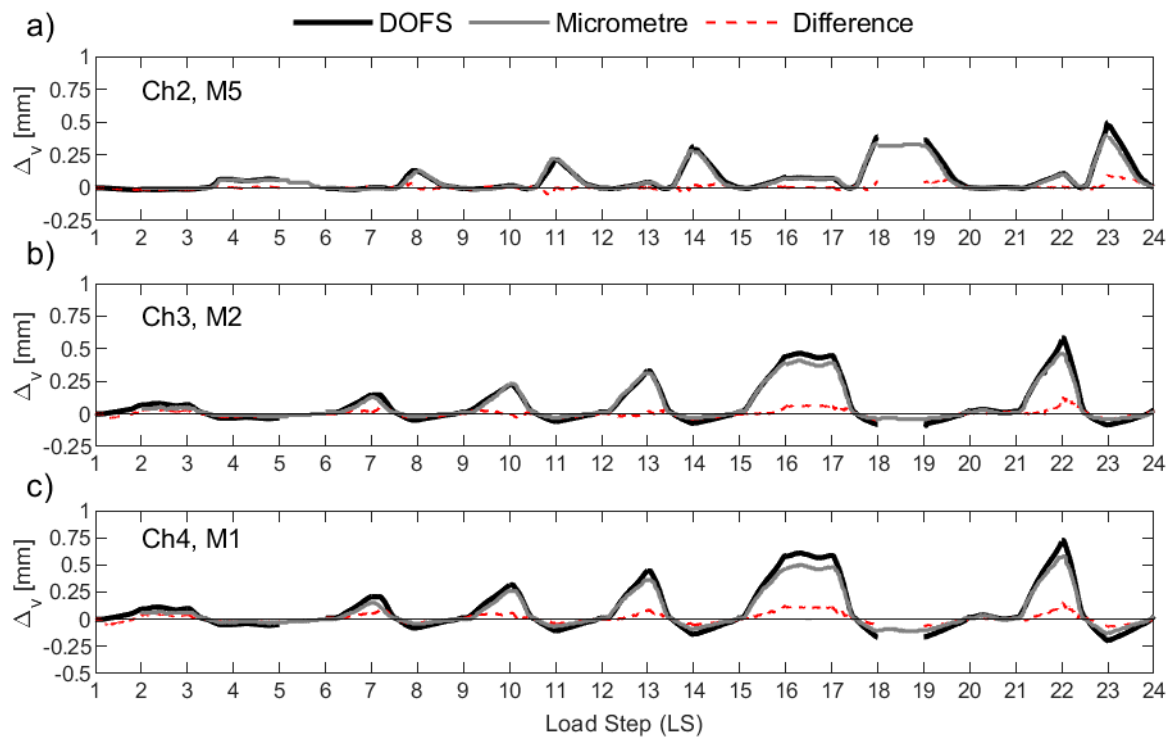
**Figure 14.** Anchorage slip ( $\Delta_v$ ) calculated from the distributed optical fiber sensor (DFOS) strain profiles compared to the micrometers for unit UW1 subjected to in-plane flexure: (a) DFOS Channel 2, Micrometer 5; (b) DFOS Channel 3, Micrometer 2; and (c) DFOS Channel 4, Micrometer 1.

Figure 14 plots the resulting  $\Delta_v$  for UW1 as calculated with the DFOS strains (black solid line) and as measured from the micrometers (grey solid line), where the difference between the two is also indicated in the figure (red dashed line). Load stage (LS) numbers 5 and 18 were not recorded by the DFOS system due to instrumentation errors, and hence, the data is not present in Figure 14 for these two LS. It is worth noting that for UW1, the measurement point of the three micrometers was found to be below the bottom-most flexural wall crack; this crack should be distinguished from the base crack at the foundation wall region. Overall, the anchorage slip calculated from the DFOS from all three channels and for the LS range considered here reasonably matches the measurements from the three micrometers, albeit there are some small differences for some load stages. As wall unit UW1 was loaded in-plane parallel to the flanges, strain gradients across the thickness of the two wall flanges (see Figure 1a for segment definition) are expected to be unimportant (at least until out-of-plane deformations are developed during the last load stages), and are mainly attributable to inevitable small construction and loading asymmetries. In fact, the DFOS strain profiles from the two rebars across the thickness show negligible variations. Thus, the small differences in  $\Delta_v$  that are observed in Figure 14 between each pair of instruments are instead likely to be due to the slip of the rebar from the concrete, where the micrometers are only able to measure a fraction of the vertical deformation at the surface.

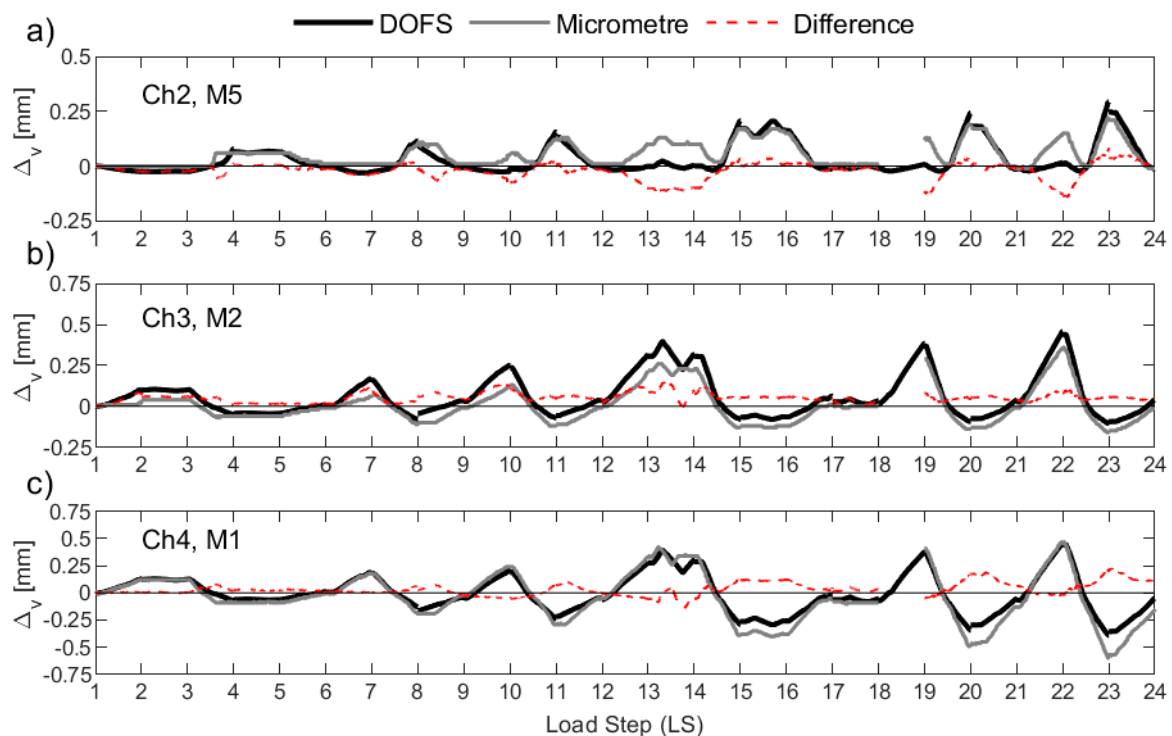
**Figure 15.** Anchorage slip ( $\Delta_v$ ) calculated from the distributed optical fiber sensor (DFOS) strain profiles compared to the micrometers for unit UW2 subjected to torsion: (a) DFOS Channel 2, Micrometer 5; (b) DFOS Channel 3, Micrometer 2; and (c) DFOS Channel 4, Micrometer 1.

Wall unit UW2 was loaded in reverse-cyclic rotation, and, due to a combination of warping and circulatory torsion, a strain gradient was observed through the thickness of the flanges with the DFOS strain profiles. It was therefore interesting to compare the anchorage slip as measured by the micrometers and calculated with the DFOS strains. The results are shown in Figure 15, and they are largely consistent with those observed for UW1, subjected to in-plane flexure. However, channel 4 (i.e., “Ch4” in Figure 15c) of the DFOS, located at the outermost region of the flange boundary end, provides reasonable estimates in tension (i.e., positive  $\Delta_v$  values), but lower estimates in compression compared to the micrometer measurements. This observation could be a product of the lower bond depth used to calculate the DFOS  $\Delta_v$  as well as the strain gradient across the thickness of the wall, where larger tensile and compressive strains are expected towards the inside of the wall. In fact, as shown in Figure 6b, the offset distance from the attachment of the metal plate to the wall and the application of the tip of the micrometer will amplify the anchorage slip, as measured by the micrometer, due to the strain gradient across the thickness of the wall. Channel 3 of the DFOS (Figure 15b), which was bonded to rebars also located within the boundary end of the west flange, was found to produce higher values of the anchorage slip throughout the LS range in comparison to the measurements for M2, but only in tension. In compression, micrometer M2 measured larger values of displacement compared to the computed  $\Delta_v$  from Ch3. Regarding the west flange-web intersection (see Figure 1a), channel 2 of the DFOS is shown to compare reasonably well with micrometer M5 in Figure 15a. Within this latter comparison, it is noted that there are at least two LS levels that produce some discrepancies between the different sensors: at LS 12–13 and LS 21–22, when the wall is rotated to position O+ (Figure 2a), Figure 15a shows micrometer M5 measuring a positive (tensile)  $\Delta_v$ , whereas the value calculated from Ch2 of the DFOS is insignificant and close to zero. A possible explanation is that, at this wall position (O+), the warping of the wall is likely to cause a distribution of longitudinal strains across the wall flange at the base, but with a diagonal neutral axis (across the thickness) close to the position of this rebar and micrometer (Ch2 and M5 in Figure 15a). On further investigation, it was found that, at these two LS levels, Ch2 of the DFOS indicate that a large portion of the development length of the interior rebar into the foundation was in tension, contrasting the exterior rebar, which measured compression strains throughout its profile. This further suggests a complicated strain gradient through the thickness, and into the foundation, due to the loading imposed with the neutral axis, at these LS levels, within the vicinity of these two rebars. In fact, the two following LS levels that rotate the wall to position O- (i.e., LS 14–15 and LS22–23) also show the micrometer return to a measured  $\Delta_v$  of close to

zero before increasing in positive (tension) anchorage slip again, further substantiating the diagonal neutral axis theory.

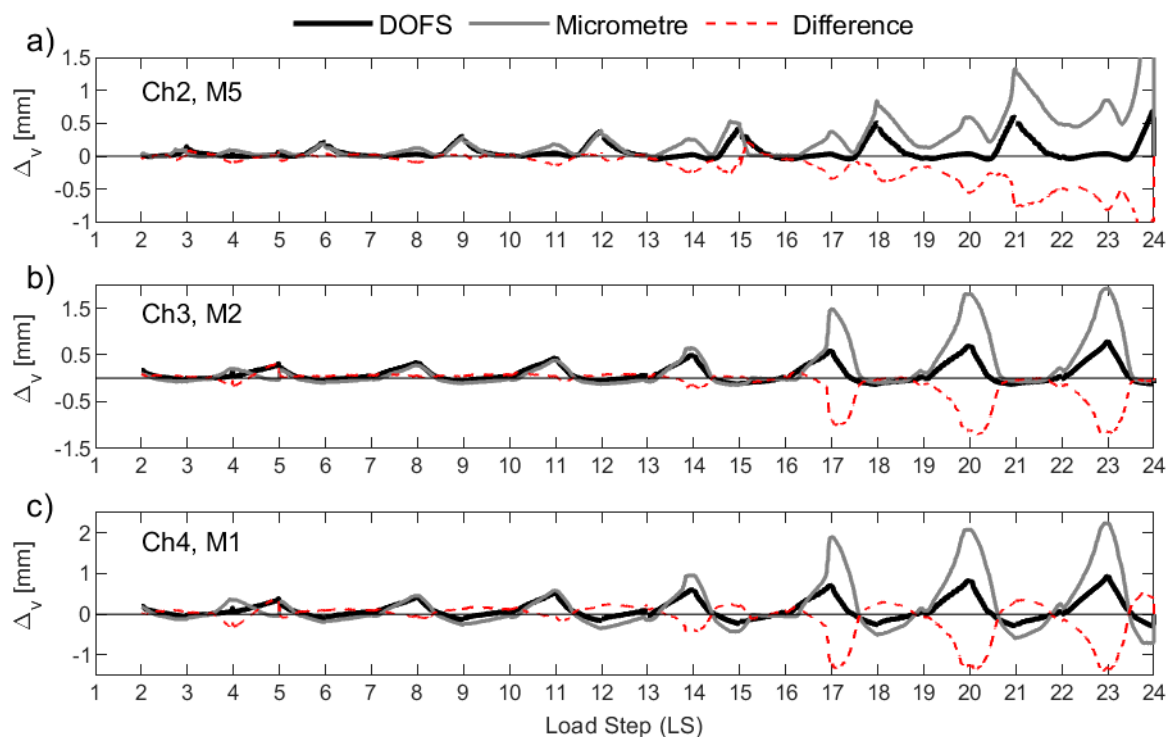
**Figure 16.** Anchorage slip ( $\Delta_v$ ) calculated from the distributed optical fiber sensor (DFOS) strain profiles compared to the micrometers for unit UW3 subjected to torsion and flexure: (a) DFOS Channel 2, Micrometer 5; (b) DFOS Channel 3, Micrometer 2; and (c) DFOS Channel 4, Micrometer 1.

Test unit UW3 was subjected to a combination of reverse-cyclic torsional rotation and translation simultaneously, corresponding to positions D– and C+ (Figure 2a). The corresponding  $\Delta_v$  measurements from the micrometers of UW3 are presented in Figure 16, which can be compared to the calculated anchorage slip using the DFOS strains. The comparisons between the core and surface sensors look reasonable up to load stage 13. At the end of LS 13 (Position D–), an increase in the measured  $\Delta_v$  by M1 and M2 (Figures 16c and 16b, respectively) can be observed, with respect to that computed from the DFOS. For each LS that follows corresponding to a wall push to Position D– (i.e., LS 16–17, 19–20, and 22–23 in Figure 16), a significant increase in the measured anchorage slip can be observed from the micrometers M1 and M2 in comparison to the computed  $\Delta_v$  from channels 3 and 4 of the DFOS. One explanation for this increase of the anchorage slip measured by the two micrometers (M1 and M2) for when the west flange boundary end is in tension (position D–) is that a flexural crack has formed and runs through the application points of the two micrometers along the inside of the flange. Photos from the experiment support this (Figure 6b), where it is possible that the concrete surface crack affects the attachment of the micrometer to the wall, causing some small uplift. As discussed in the previous paragraph for UW2, another possible explanation for these discrepancies is the obvious increase in vertical deformation as measured by the micrometer if a strain gradient across the thickness is present, which was likely, due to the imposed rotation to the wall. For example, comparing the measured strain profiles for the interior and exterior rebars from Ch4 of the DFOS for wall unit UW3 confirms that a strain gradient was present (e.g., Figure 9a). The offset distance of the micrometer from the wall surface would inherently amplify the actual anchorage slip in the presence of strain gradients through the wall thickness. Furthermore, potential slip between the tip of the micrometer and the glass plate (see Figure 6b), which was glued to the metal plate for attachment to

the wall, would only have exacerbated this behavior. On closer inspection, the glass plates were not used to support the tip of these micrometers for testing unit UW1 (i.e., compare Figure 6a with Figure 6b). While there were less discrepancies between the comparisons of the micrometer measurements and the calculated DFOS anchorage slip, the loading imposed to UW1 meant that there was negligible strain gradient through the thickness, which also made comparisons of these instruments more favorable. Another observation in Figure 16a is the larger  $\Delta_v$  as measured by micrometer M5 in comparison to the DFOS at position D- (i.e., LS 10, LS 13, LS 16, etc.). One possible explanation for this was provided in the previous paragraph regarding the same observation with unit UW2 (i.e., the twisting applied causes the neutral axis to be skewed diagonally across the thickness of the wall). One last curious observation is the increasing residual vertical deformation by M5 after LS 18 (Figure 16a), which results in a larger measured anchorage slip by the micrometer in comparison to that calculated by the DFOS. The DFOS strains corresponding to the interior rebar in this region confirm that, at the beginning of LS 18, the rebars were performing pre-yield (max strain of 2.364 mm/m). Thus, the residual deformation is unlikely to be a result of inelastic behavior from the reinforcing steel. Instead, it is again possible that flexural cracks have formed close to the fixation of the micrometer on the surface of the wall. If these cracks cannot close all the way, it is possible that the micrometer does not return to an anchorage slip measurement ( $\Delta_v$ ) of zero on return to centering the wall (at position O).
