# PD catheter malfunction due to incisional hernia entrapment

A 69-year-old male with end-stage kidney disease secondary to ischemic cardiomyopathy and peripheral arterial disease presented with early peritoneal dialysis (PD) catheter dysfunction, 14 weeks after laparoscopic insertion of a Di Paolo catheter. The patient experienced slow and incomplete effluent drainage (800 mL out of 1000 mL instilled). Clinical examination revealed a reducible, non-painful right incisional hernia at the site of a prior aortofemoral vascular bypass. Abdominal imaging, including X-ray and CT scan, identified catheter malposition in the right iliac fossa, with the catheter tip trapped in the right incisional hernia sac containing small bowel. Laparoscopic exploration confirmed adhesions and catheter entrapment. After adhesiolysis and repositioning of the catheter into the pouch of Douglas, a functional peroperative test confirmed excellent catheter function. Hernia repair was performed on both sides, with prosthetic mesh on the right and Lichtenstein repair on the left to prevent contralateral hernia development. Postoperative recovery was uneventful, and PD resumed after 3 weeks. This case illustra

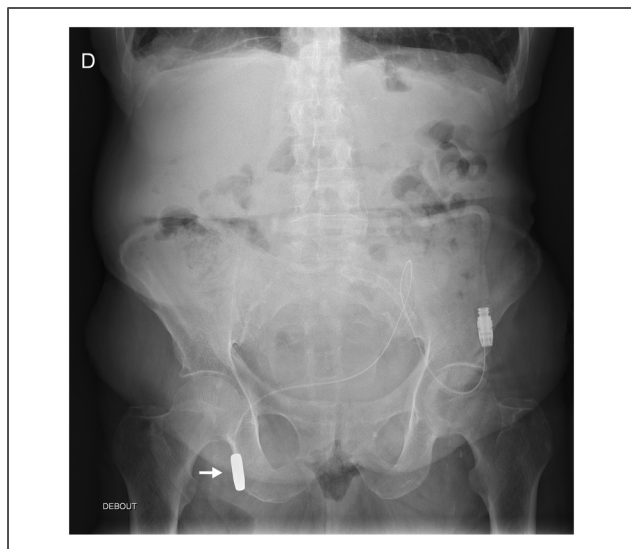
**Figure 1.** Abdominal X-ray showing malposition of the peritoneal dialysis catheter. The distal tip of the catheter is indicated by the arrow and is located in the right iliac fossa, corresponding to its entrapment in the incisional hernia sac.

Clinical examination revealed a soft abdomen and an easily reducible, not painful right incisional hernia at the site of a previous aortofemoral vascular bypass procedure at the inguinal level. An abdominal X-ray suggested catheter malposition in the right iliac fossa (Figure 1), and a subsequent CT scan confirmed that the distal tip of the catheter was trapped in a right incisional hernia sac containing small intestines (Figure 2). It also suspected a small asymptomatic left inguinal hernia that had not been seen during the initial laparoscopic catheter insertion.

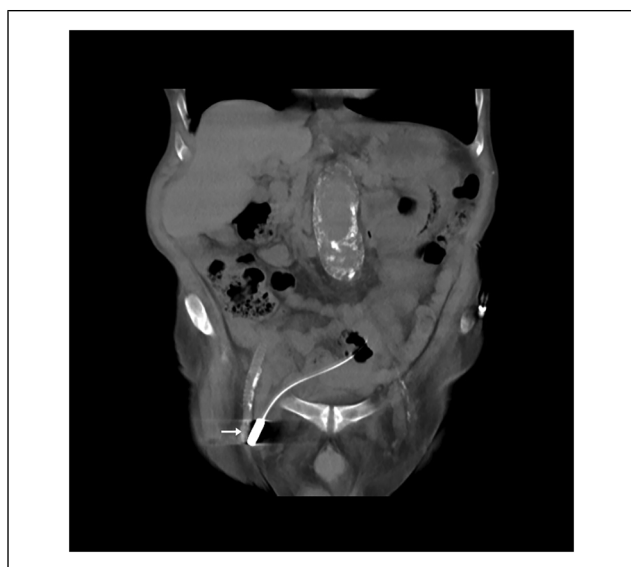
**Figure 2.** Coronal CT scan showing the distal end of the peritoneal dialysis catheter (radiopaque tip, arrow) located within a right inguinal hernia sac, which also contains a bowel loop. Catheter dysfunction resulted from this malposition.

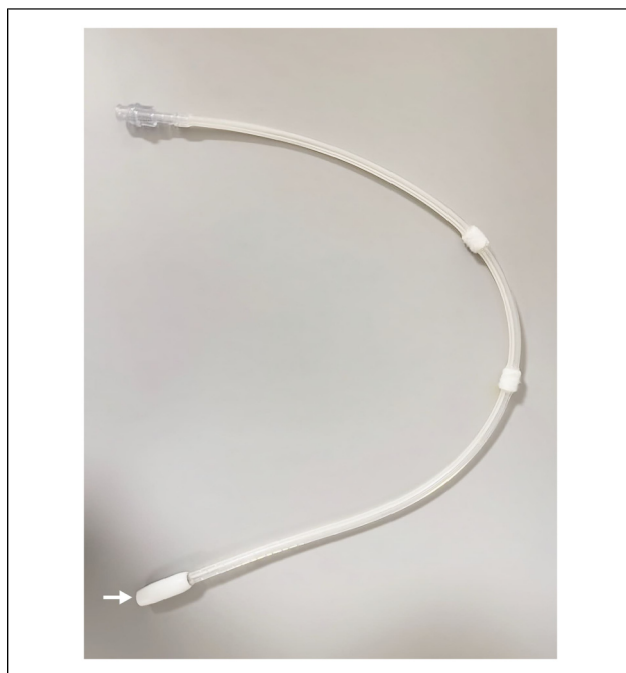
**Figure 4.** Di Paolo weighted (self-locating) Tenckhoff catheter, Fresenius, SA2447. The distal end contains a tungsten weight (arrow).

This case highlights a rare cause of an early PD catheter dysfunction due to its entrapment within a hernia sac,<sup>4</sup> a complication that has not been frequently reported.<sup>5</sup> We hypothesize that the weight of the catheter may have contributed to its migration into the pre-existing hernia.

The weighted Tenckhoff catheter (Di Paolo type) is a swan-neck catheter with a tungsten weight at the distal tip (Figure 4), designed to reduce migration and malposition. Although some reports have shown reduced dysfunction compared to straight or coiled catheters,<sup>6</sup> it is not the standard device in our center, where we routinely use a Swan Neck Curl Cath. In this case, the patient had been referred
