# Photogrammetry measurements of wave overtopping erosion on a seashore dike

**ABSTRACT:** The upward trend in construction in low-land coastal areas and loose restrictions on constructions on landside dike slopes is raising the essential need for in-depth examination of existing defense structures. In the context of the Polder2C's project and in terms of soil erodibility under wave overtopping condition, two main experimental set-ups were used to assess the strength of existing defense structures. Erosion progression of a seashore earthen dike under wave overtopping was monitored using close-range photogrammetry. Two principal experimental set-ups were considered: (1) measurement of the erosion rate and the residual strength of a clay cover layer protecting the dike sand core, the clay layer being located underneath a partially bared grass sod, (2) evaluation of the erosion resistance of lime-treated clay intended to increase soil resistance at the interface between soil and structures. The results show to applicability of the method in this challenging context.

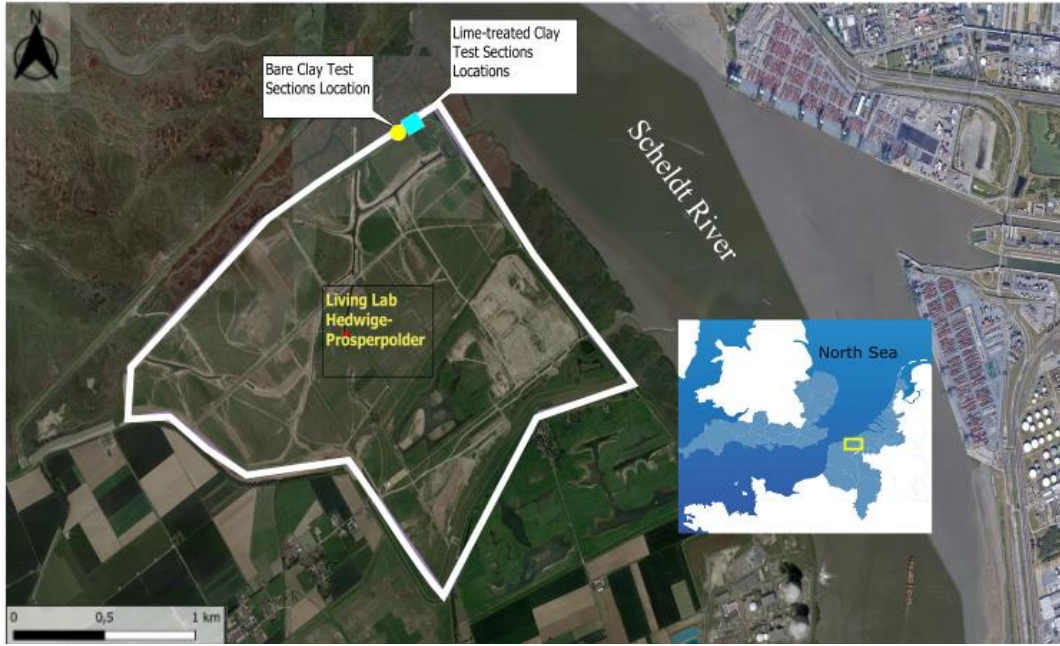
Figure 1. Aerial view of Polder2C's site and erosion experiments location

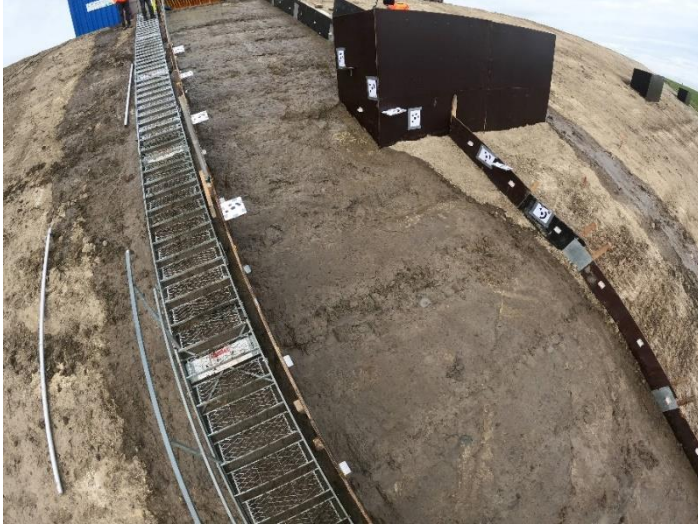
Figure 4. Test section for the lime-treated clay tests

These tests were run under irregular waves with variable discharge and height, as illustrated in Table 3. In this case, it was possible to walk around the test section after the water had left region of interest with one GoPro camera fixed on a 3 m long stick, to capture a sufficient number of images to perform the photogrammetric treatment. A typical image that was recorded during such a test is illustrated in Figure 4.
