## Excavations at Sissi IV

### Preliminary Report on the 2015-2016 Campaigns

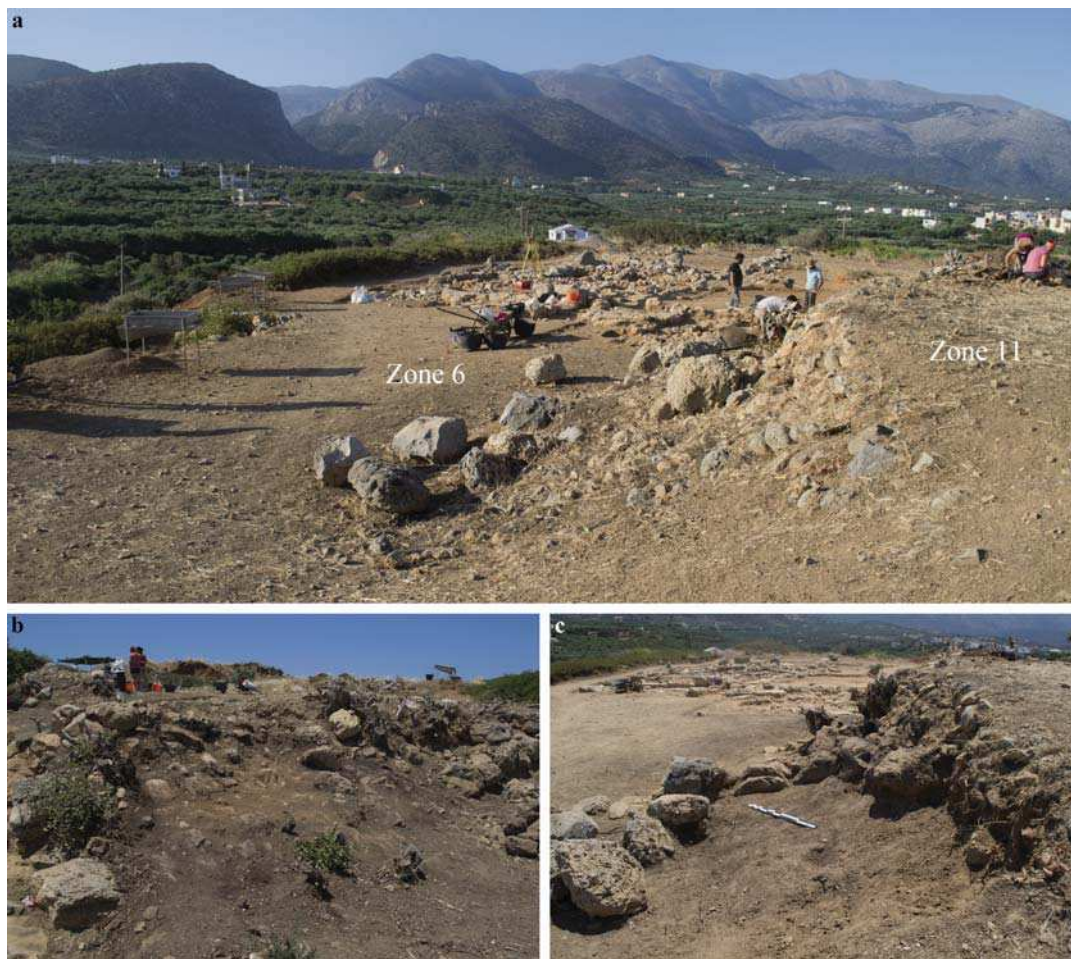
FIG. 5.2.1 (A) THE NORTH-EAST WING OF THE CCB BEFORE EXCAVATION (FROM NORTH); (B) TERRACE WALL FE107-109 DURING TOPSOIL REMOVAL (FROM SOUTH-WEST); (C) NORTH-EAST WING OF THE CCB AFTER TOPSOIL REMOVAL (FROM NORTH) (©EBSA; M. DEVOLDER)

An alignment of large limestone boulders (FE110) was visible on the surface about 12 m north of wall F48-F51 that borders the court to the north. This triggered the exploration of a 12 by 7 m area located east of a sudden change in the level of the terrain (figs 5.2.1 & 5.2.2). This drop, which is about 1.4 to 2.5 m high, marks the limit between the western (upper) and eastern (lower) terraces of the North Wing of the CCB. The western part was explored in 2015 as Zone 11 by S. Déderix and is described in chapter 5.3, while the eastern, lower part was explored as Zone 6 and is described here. Vegetation was cleared, carob trees were cut and the upper part of a dark topsoil was removed, revealing the presence of a long north-south terrace wall forming the transition between the two levels (FE107-FE109) (fig. 5.2.1b). Several large limestone and conglomerate boulders had fallen from this wall towards the east, and their considerable sizes gave some idea on the structural purpose of this once sturdy wall<sup>2</sup>. These blocks were placed aside and the dark topsoil layer was removed. This revealed a series of six rooms including a staircase and a long corridor accessed from an entrance in the eastern wall of the North Wing (fig. 5.2.2).

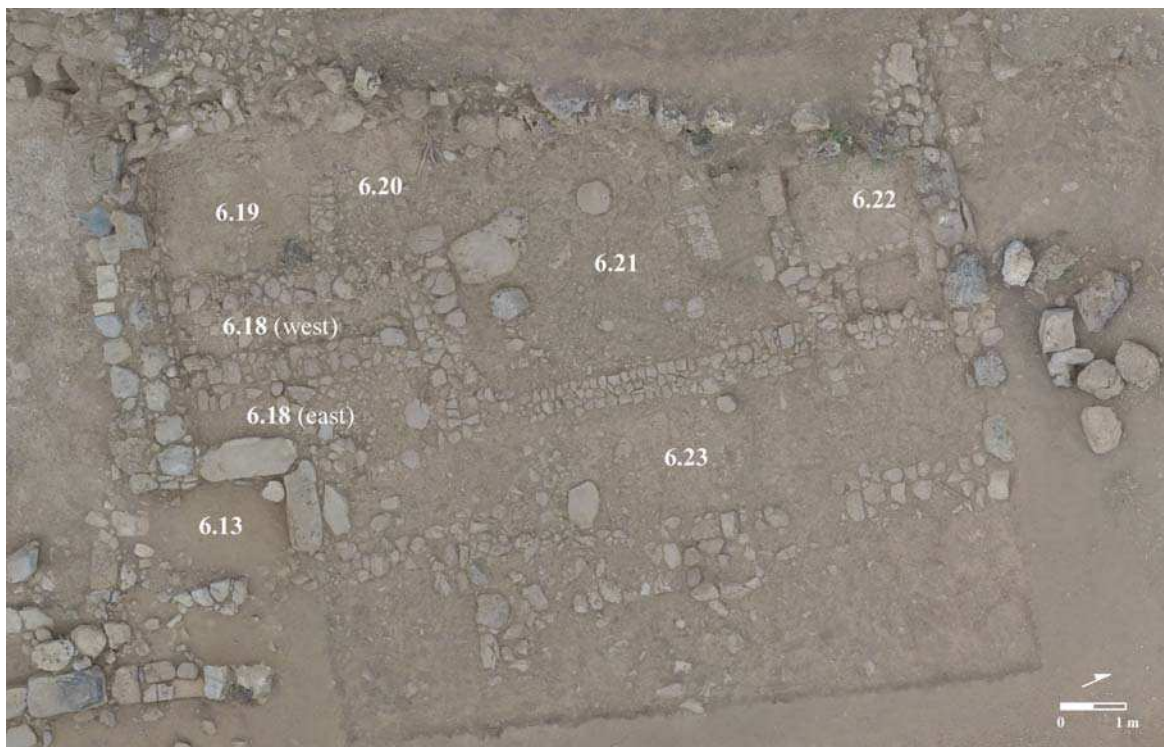
FIG. 5.2.2 AERIAL VIEW OF THE NORTH-EAST WING IN 2015, WITH SPACE NUMBERS (©EBSA; N. KRESS & M. DEVOLDER)

The excavation of rooms 6.18 to 6.23 has shown that the walls of the area immediately north of the court collapsed during the LM IA phase. Although erosion could in part be responsible for the little material found on the floors (fig. 5.2.20), it is more likely that the rooms were already mostly empty when the wall collapse occurred, either because this part of the CCB had few non-perishable items in them at all or because it had been emptied before the walls collapsed.

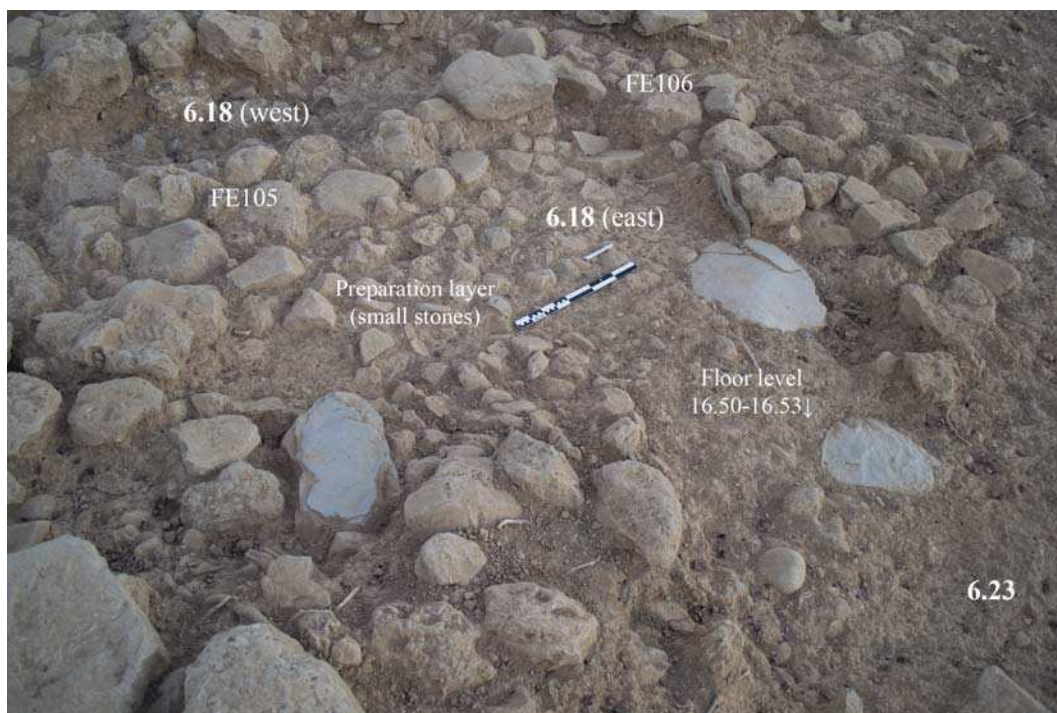
FIG. 5.2.8 ACCESS FROM CORRIDOR 6.23 AND DEPARTURE LEVEL OF STAIRCASE 6.18, FROM SOUTH-EAST (©EBSA; M. DEVOLDER)

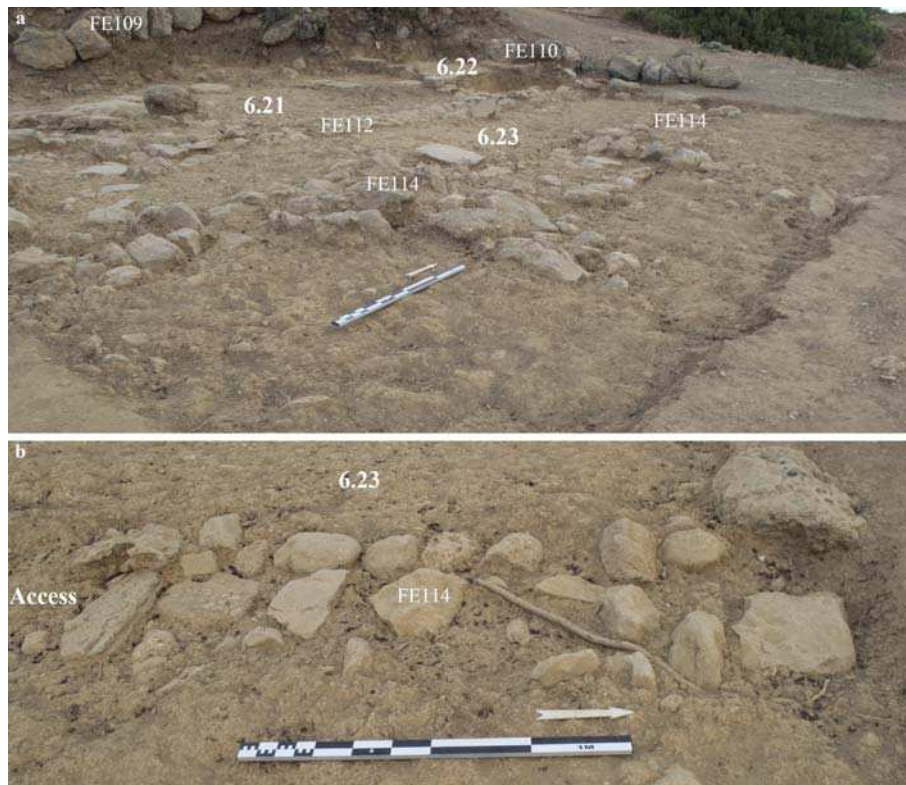
FIG. 5.2.10 (A) VIEW OF WALL FE114 TO THE EAST OF CORRIDOR 6.23 (FROM SOUTH-EAST); (B) DETAIL OF THE NORTHERN PART OF THE SAME WALL WITH THE ACCESS FROM THE EAST (FROM EAST) (©EBSA; M. DEVOLDER)

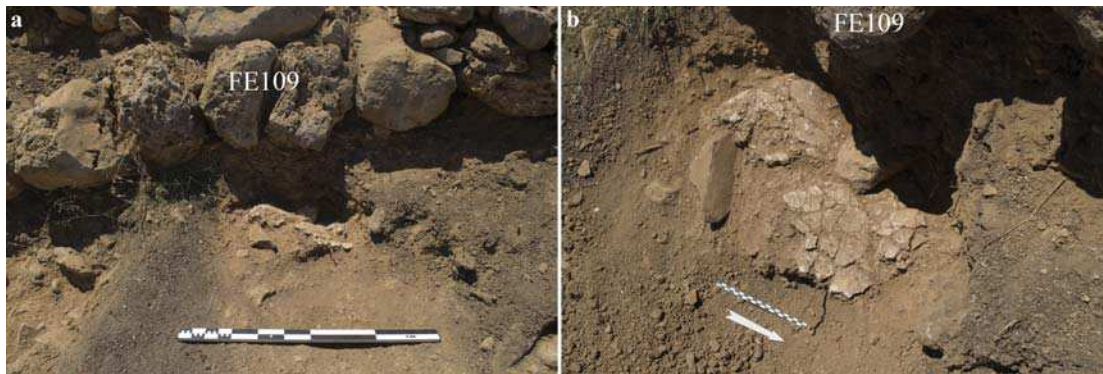
FIG. 5.2.12 FALLEN PLASTER FRAGMENTS IN THE WESTERN PART OF ROOM 6.21, ALONG TERRACE WALL FE107-FE109, APPEARING IMMEDIATELY UNDER THE TOPSOIL. VIEWS FROM THE EAST (A) AND DOWN (B) (©EBSA; M. DEVOLDER)

Rooms 6.21 and 6.22, to the west of corridor 6.23, were also heavily disturbed by erosion. This is especially the case in the eastern part of the rooms, while the western part remained largely protected by the collapse of terrace wall FE107-FE109. It seems, however, that the northern part of this terrace wall (FE109) was pushed out towards the east by the pressure of the earth it was retaining. This surely explains why some of the wall boulders are now encroaching upon the western part of room 6.22 and, to a lesser degree, of room 6.21 (figs 5.2.12 & 5.2.13). Because of the generally bad state of preservation of this area, part of the collapse layer, the floor and the floor preparation layer were already touched while excavating the topsoil layer. Moreover, this disturbed layer comprised large numbers of sherds which probably originally formed part of the preparation layer of the floors in both rooms 6.21 and 6.23. It is also worth noting that many fragments of terracotta plaques were discovered in room 6.21, similar to those discovered *in situ* in the room itself, and discussed below. Plaster, bone, shell, pumice and mudbrick were sampled and the layer also included two cups (15-06-1061-OB001 and 002), five lithic tools (15-06-1061-OB003, 15-06-1062-OB004 to OB007), a stone weight (15-06-1062-OB003), and a possible fragment of a plaster table (15-16-1062-OB003, a possible parallel for this was discovered in room 11.3 in the North-West Wing of the CCB, *i.e.* 15-11-9095-OB001). Plaster fragments were especially numerous and of considerable size in the western part of room 6.21, where they were found immediately below topsoil (fig. 5.2.12). The ceramic material in this topsoil was heavily eroded and very mixed in date, from EM II to LM III according to the preliminary study.

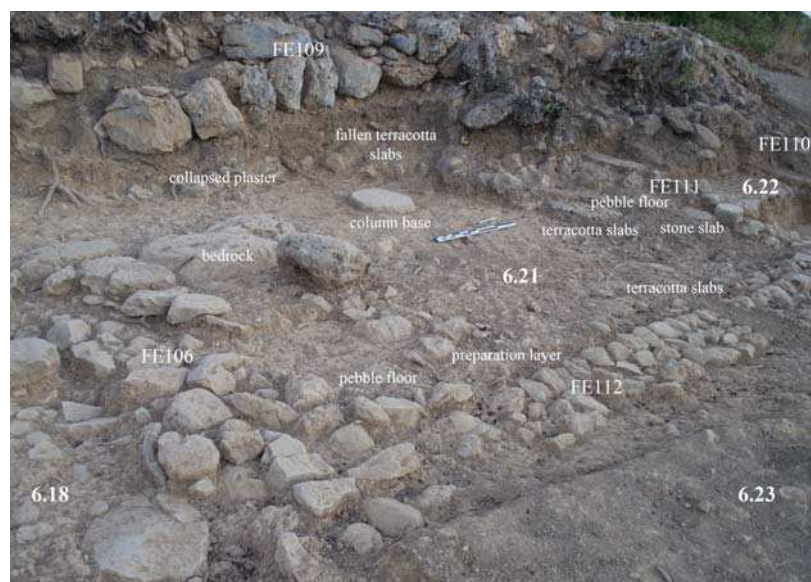
FIG. 5.2.13 ROOM 6.21 after EXCAVATION, FROM SOUTH-EAST (©EBSA; M. DEVOLDER)

The original, rectangular shape of the room is partly skewed by erosion and the eastward projection of the northern part (FE109) of terrace wall FE107-FE109, probably caused by the pressure of the more western, higher terrace. A roughly circular base in beige limestone (0.50 by 0.54 m, 16.71 m asl) was found in the central-western part of the room and probably functioned as a column base (figs 5.2.4, 5.2.13 & 5.2.14). The presence of an

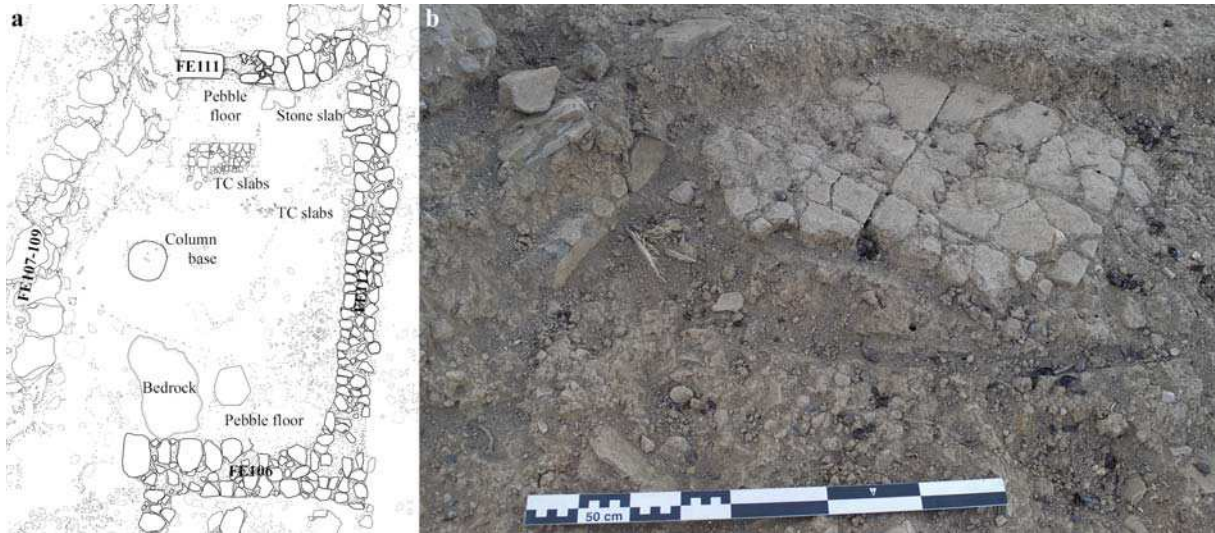
FIG. 5.2.14 ROOM 6.21: (A) PLAN INDICATING THE FLOOR REVETMENT (©EBSA; E. ZOGRAFOU) AND (B) VIEW OF THE TERRACOTTA SLABS IN THE NORTHERN PART OF THE ROOM (FROM SOUTH-EAST) (©EBSA; M. DEVOLDER)

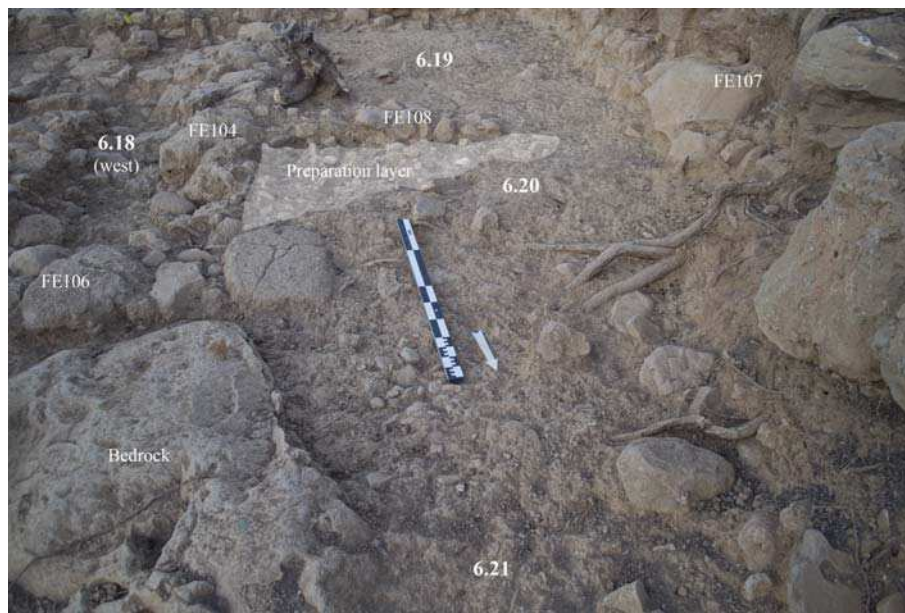
FIG. 5.2.16 ROOM 6.20 AFTER EXCAVATION, FROM NORTH (©EBSA; M. DEVOLDER)

Room 6.20, measuring only 1.10 by 1.90 m, is bordered by walls FE107 (west), FE108 (south) and FE104 (east). It opens wide to room 6.21 to the north (1.50 m), from which it can be accessed. Towards the south, it provides access to room 6.19 via a narrow doorway, 0.70 m wide, between the rubble partition wall FE108 and the sturdy terrace wall FE107-FE109 (fig. 5.2.5). While cleaning the northern extremity of wall FE104 separating rooms 6.20 and 6.18, three conical cups (15-06-1056-OB001 to OB003) were discovered together with some shell and bone (fig. 5.2.15). The cups were found upside down and on their sides, caught between the rubble. They clearly seem to have been placed here intentionally, perhaps as a foundation deposit associated with the construction of wall FE104. Such a practice is not uncommon at Sissi (e.g. *Sissi III*: 81, fig. 4.19).

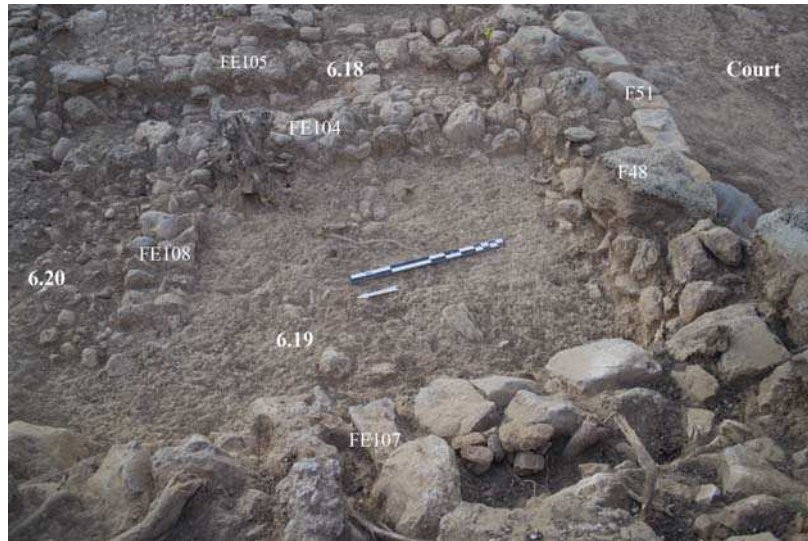
FIG. 5.2.17 ROOM 6.19 AFTER EXCAVATION, FROM WEST (©EBSA; M. DEVOLDER)

Both rooms 6.19 and 6.20 have a collapse layer of reddish-brown semi-soft to semi-hard earth. The texture

and colour, however, change closer to the bedrock that was incorporated in the terrace wall when it becomes harder and more yellowish. As suggested earlier for space 6.18, the reddish-brown layer probably derives from decomposed mudbricks and not from a fire destruction. The quantities of charcoal sampled in room 6.19 rather seem to have been produced by root decomposition, which here too contaminated the floor deposit. On the stamped earth floor were found three conical cups (15-06-1047-OB003, OB005-006), four lithic tools (15-06-1041-OB001; 15-06-1047-OB002 and OB007; 15-06-1067-OB001) (fig. 5.2.20), an obsidian flake (15-06-1047-OB001) and an obsidian blade (15-06-1047-OB004). Bone, shell and pumice were also sampled, but in general the room contained little else and room 6.19 was probably already empty when its walls collapsed.

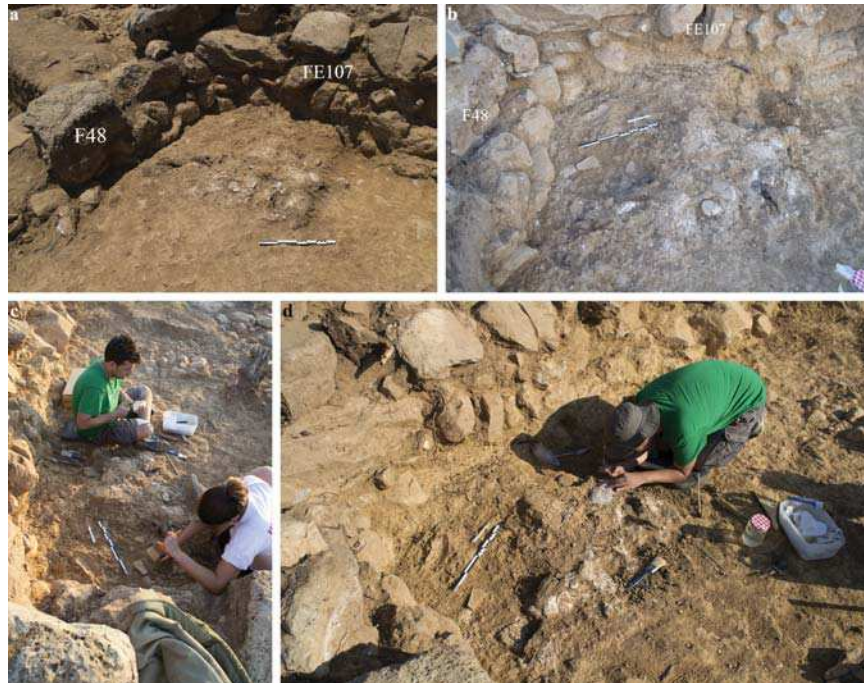
FIG. 5.2.18 FALLEN PLASTER IN THE SOUTH-WEST CORNER OF ROOM 6.19: (A) ON DISCOVERY (FROM NORTH-EAST), (B) DURING EXCAVATION (FROM EAST), (C) DURING CONSERVATION (FROM SOUTH), AND (D) FROM SOUTH-EAST (©EBSA; M. DEVOLDER)

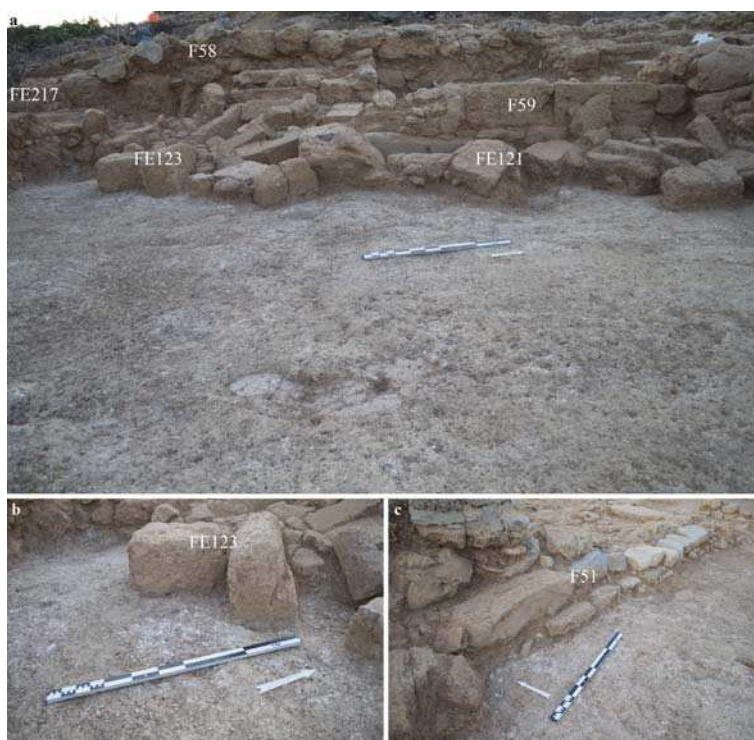
FIG. 5.2.22 TARAZZA COURT (A) FROM EAST, (B) FROM SOUTH-EAST AND (C) FROM SOUTH-WEST (©EBSA; M. DEVOLDER)

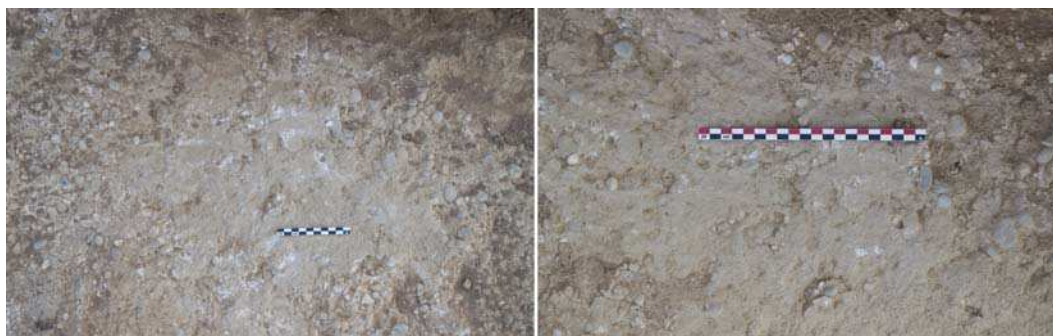
FIG. 5.2.23 DETAILED VIEWS OF THE PEBBLE AND PLASTER SURFACE OF THE COURT: THE FINE COAT OF WHITE PLASTER IS CLEARLY VISIBLE ON TOP OF THE TARAZZA (©EBSA; M. DEVOLDER)

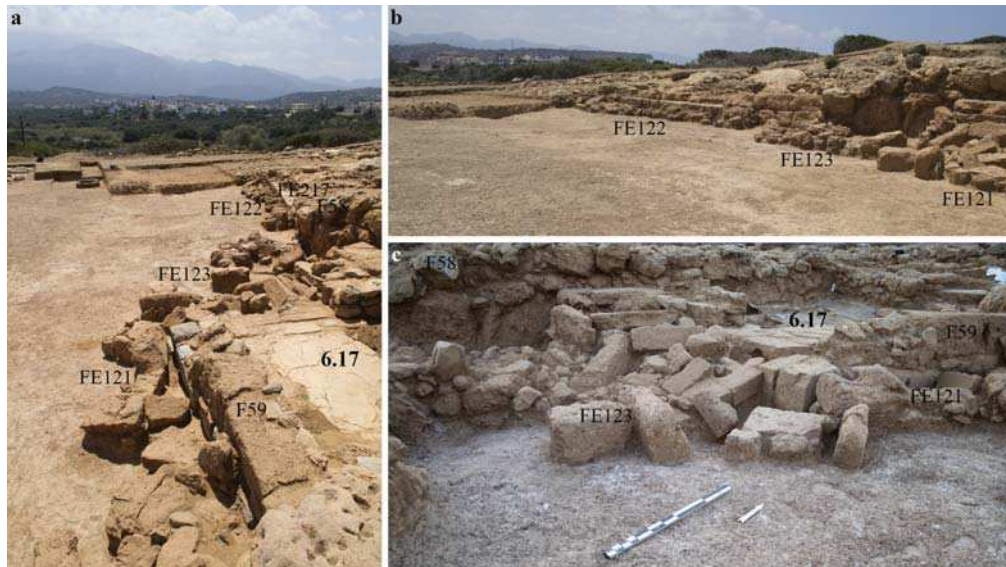
FIG. 5.2.26 CONCENTRATIONS OF STONE TUMBLE FE121, FE122 AND FE123 ON THE COURT ALONG ITS WEST FAÇADE F59, F48 AND FE217 (A) FROM NORTH, (B) FROM NORTH-EAST, (C) FROM SOUTH-EAST (©EBSA; M. DEVOLDER)

The stone tumble (FE121, FE122 and FE123) found along the west façade of the court (F59, F48 and FE217) (*i.e.* the east façade of what is probably the West Wing) testifies to the first of a series of processes and events related to the progressive abandonment of the court (**figs 5.2.25a & 5.2.26**).

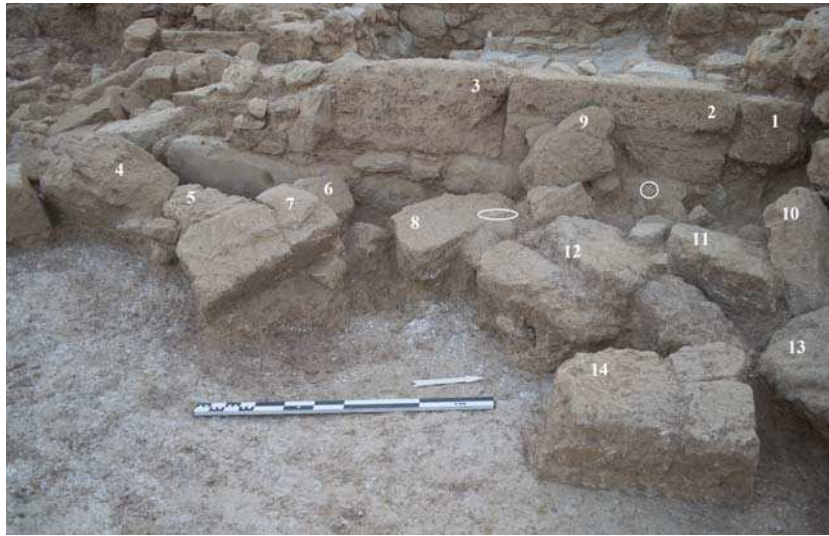
FIG. 5.2.27 COLLAPSED SANDSTONE BLOCKS AT THE FOOT OF WALL F59 IN THE NORTH-WESTERN CORNER OF THE COURT, FROM NORTH-EAST. TRACES OF PLASTER COATING ARE VISIBLE ON BLOCK 8 AND THE IRONSTONE LOWER COURSE (IN WHITE OVALS) (©EBSA; M. DEVOLDER)

When numerous plaster fragments were found amongst the tumble, we started to look closer at the surface of the ashlar blocks, to see whether the façade may initially have been plastered. Faint remains of plaster were indeed found on one of the ironstone blocks of the lower course, as well as on the edge of one of the large surfaces of block 8 (fig. 5.2.27). The presence of a plaster coat on what seems to have been the upper surface of this block of the third course of wall F59 may indicate the existence of an opening above it – perhaps the window we suggested? Another possibility would be that the wall showed a setback, making part the upper face of block 8 visible. The traces of plaster on one of the ironstone blocks of the lower course could also indicate that either only this course or the entire façade was once plastered<sup>7</sup>.

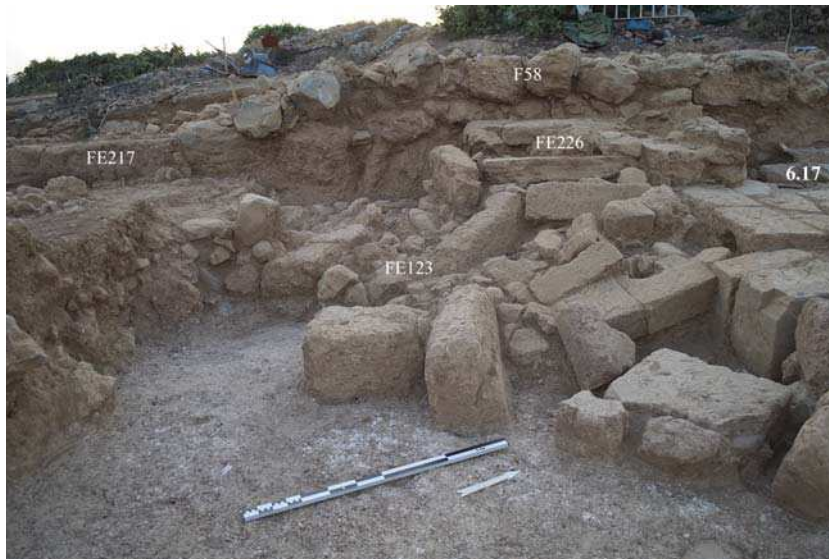
FIG. 5.2.28 TUMBLE FE123 OF STEPS FE226 ON TOP OF THE TARAZZA COURT, FROM SOUTH-EAST (©EBSA; M. DEVOLDER)

The tumble FE123 on the court in grid square 6.8H represents the collapse of a series of steps FE226 and of terrace wall F58 (see **fig. 5.2.21**, top at 17.10 m asl). It consists of limestone and conglomerate rubble and some boulders (0.25 to 0.40 m) which cover several fallen sandstone ashlars. Some of these cut sandstone blocks rest directly on the court level (16.70 m asl) (**fig. 5.2.28**), suggesting that the sandstone steps FE226 fell before the limestone and conglomerate terrace wall F58 collapsed. These stones were within a matrix of brown to light reddish-brown soil with small stones (0.05 m) and gravel (0.015 to 0.02 cm), mudbrick debris, *tarazza* and plaster fragments, pumice, charcoal, burnt clay and some possible *domatochoma*<sup>8</sup>. The tumble also included four lithic tools (16-06-1231-OB001-002; 16-06-1244-OB001-002), as well as a number of rolled and eroded sherds. The diagnostic ones are mainly Protopalatial but some Postminoan fragments could also be identified.

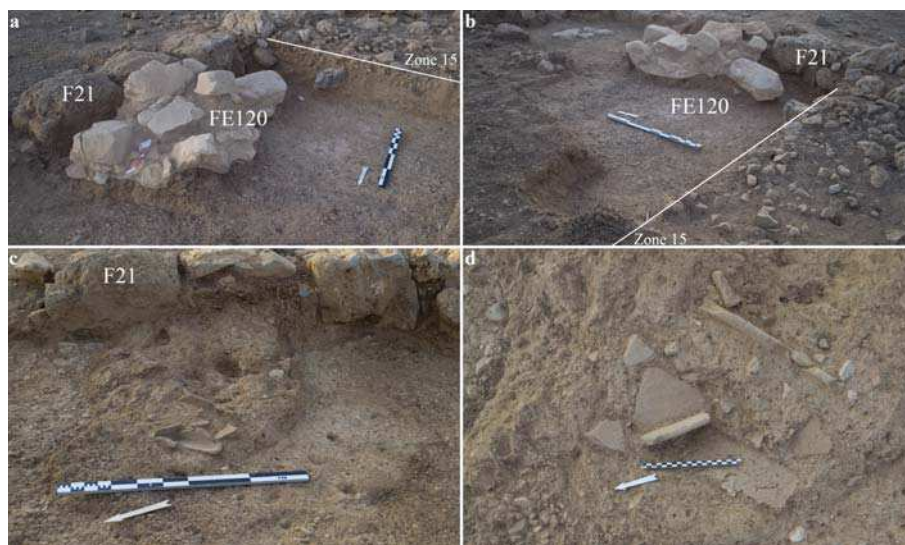
FIG. 5.2.34 STONE TUMBLE FE120 (EVENT 4) ON TOP OF FINE SEDIMENT LAYER (PROCESS 3) ALONG FAÇADE F21 (A) FROM NORTH AND (B) FROM SOUTH-EAST, AND FRAGMENTS OF A CLAY DRAIN 16-06-1233-OB001 IN THE SEDIMENT LAYER (C AND D, FROM WEST) (©EBSA; M. DEVOLDER & A. LEGENDART)

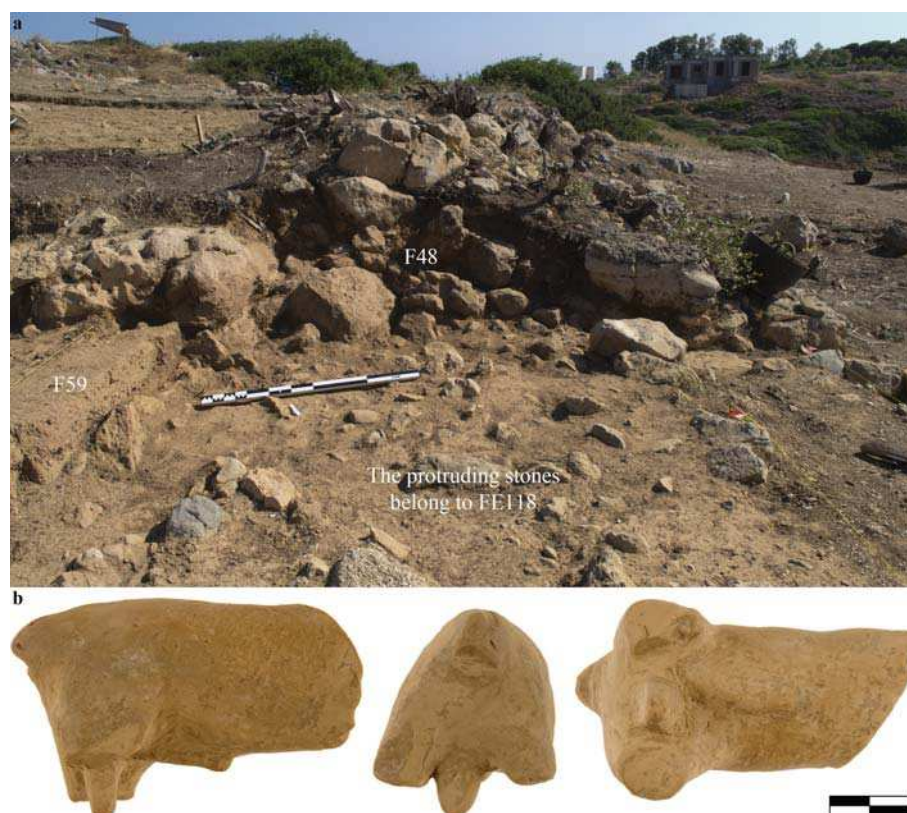
FIG. 5.2.36 (A) VIEW FROM THE SOUTH-WEST OF COLLAPSED WALL F48 BEFORE THE EXPLORATION OF HEAP FE118 IN GRID SQUARE 6.8A (THE NORTH-WESTERN QUADRANT OF THE COURT) WHERE SEVERAL FIGURINES WERE FOUND (©EBSA; M. DEVOLDER); (B) SIDE, REAR AND BOTTOM VIEWS OF BULL FIGURINE 15-06-1016-OB004 (©EBSA; C. PAPANIKOLOPOULOS)

Some late activities seem to have taken place in the north-western corner of the court which included the deposition of figurines within the collapse of wall F48 and immediately south of it, on top of stone heap FE118 (fig. 5.2.36). Of the four fragmentary figurines found (15-06-1016-OB004; 15-06-1008-OB005-007), one is that of a bull of which only the hindlegs are preserved (15-06-1016-OB004, fig. 5.2.36). The absence of similar finds around the court (and especially from the northwest, Zone 11) suggests that the figures did not roll down from the upper terrace but were probably intentionally deposited in the north-western corner of the court, most likely after the clearing event 5.

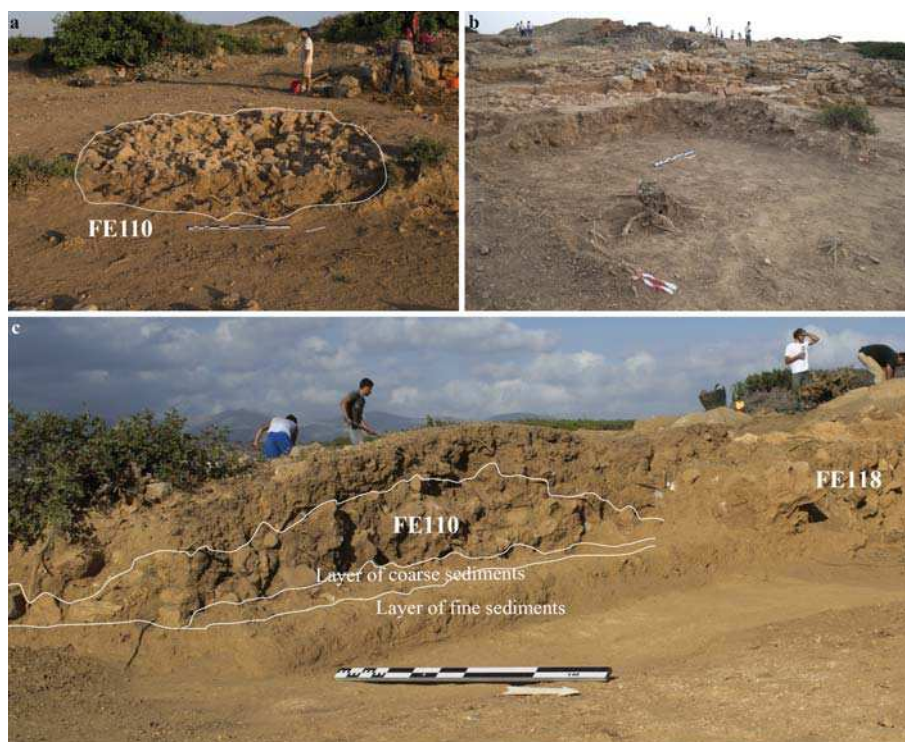
FIG. 5.2.38 THE CIRCULAR STONE PILE FE100 DURING AND AFTER EXCAVATION (A) AND (B) FROM SOUTH-EAST, AND THE SUCCESSION OF LAYERS VISIBLE WHEN EXCAVATING THE BAULK SOUTH OF GRID SQUARE 6.8A (C) FROM EAST. NOTE THE ACCUMULATION OF FE100 ON TOP OF THE COARSE AND FINE SEDIMENT LAYERS IN THE COURT (©EBSA; M. DEVOLDER)

In 2015 and 2016, we excavated a circular pile of stones in the north-centre of the court (top at 17.64 m asl). The pile is a 3.80 by 3.90 m accumulation of limestone rubble that ranges in size between 0.15 and 0.70 m in a matrix of brown, soft soil (proportion soil to stones 15/85). The large number of modern snails in between the stones in the upper part of the pile indicates the recent date of the pile, probably connected to further clearing of the area for agricultural purposes. Initially, we assumed that the circular pile FE100 was the remains of a gun-post of WW II because some larger stones were sloping down towards the centre of the pile as if the stones had accumulated into some sort of large pit. This seemed not to be the case and excavation showed that the stones were piled up in an open area slowly filled with sediments. The material associated with this pile is again very mixed, from MM to Venetian but also comprising some bullet cases (15-06-1007-OB001; 15-06-1009-OB001) and a metal strip (perhaps part of a hand grenade, 15-06-1009-OB002) (*cf. Sissi II*: 25), remains of the Italian occupation of the hill during the 1940s. It is likely that the size of the pile progressively increased during post-WW II agricultural and pastoral activities.

Once the stones of pile FE100 were removed, it was obvious that it rested on top of the coarse sediment layer on the court (16.86 m asl) which consisted of material eroded from stone heap FE118 in the western part of the court. The layer, explored in grid squares 7, 8, 12, 13, 14, 18, 19 and 20, comprised many small stones (0.05 to 0.10 m) and the sherd material was again very mixed, from MM to Postminoan. Pile FE100 most likely represents a long-term process that started after the erosion of FE118 and probably lasted until the second half of the 20<sup>th</sup> century.
