# XV Congreso Internacional AIPMA

### The wall decoration of Baths of Buticosus in Ostia: a palimpsest of the Ostian painting

*Maria Bartoli, Bernhard Blümich,  
Anna Borzomati, Eleonora Del Federico, Giancarlo Di Gaetano,  
Tiziana Sorgoni, Claudia Tempesta, Paolo Tomassini*

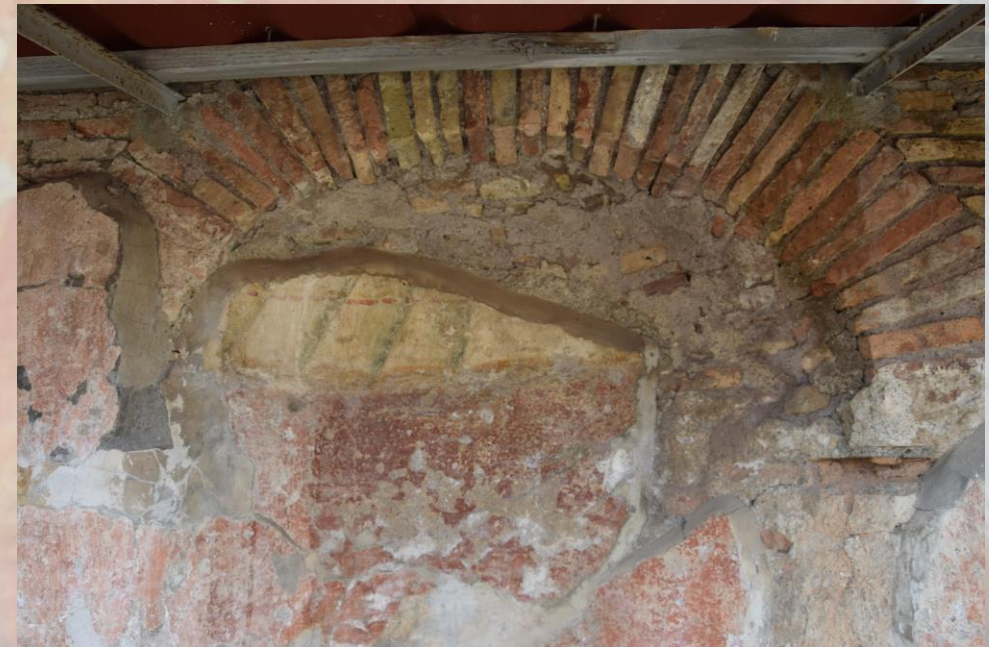
White decoration from earlier phase (end 2° century?)

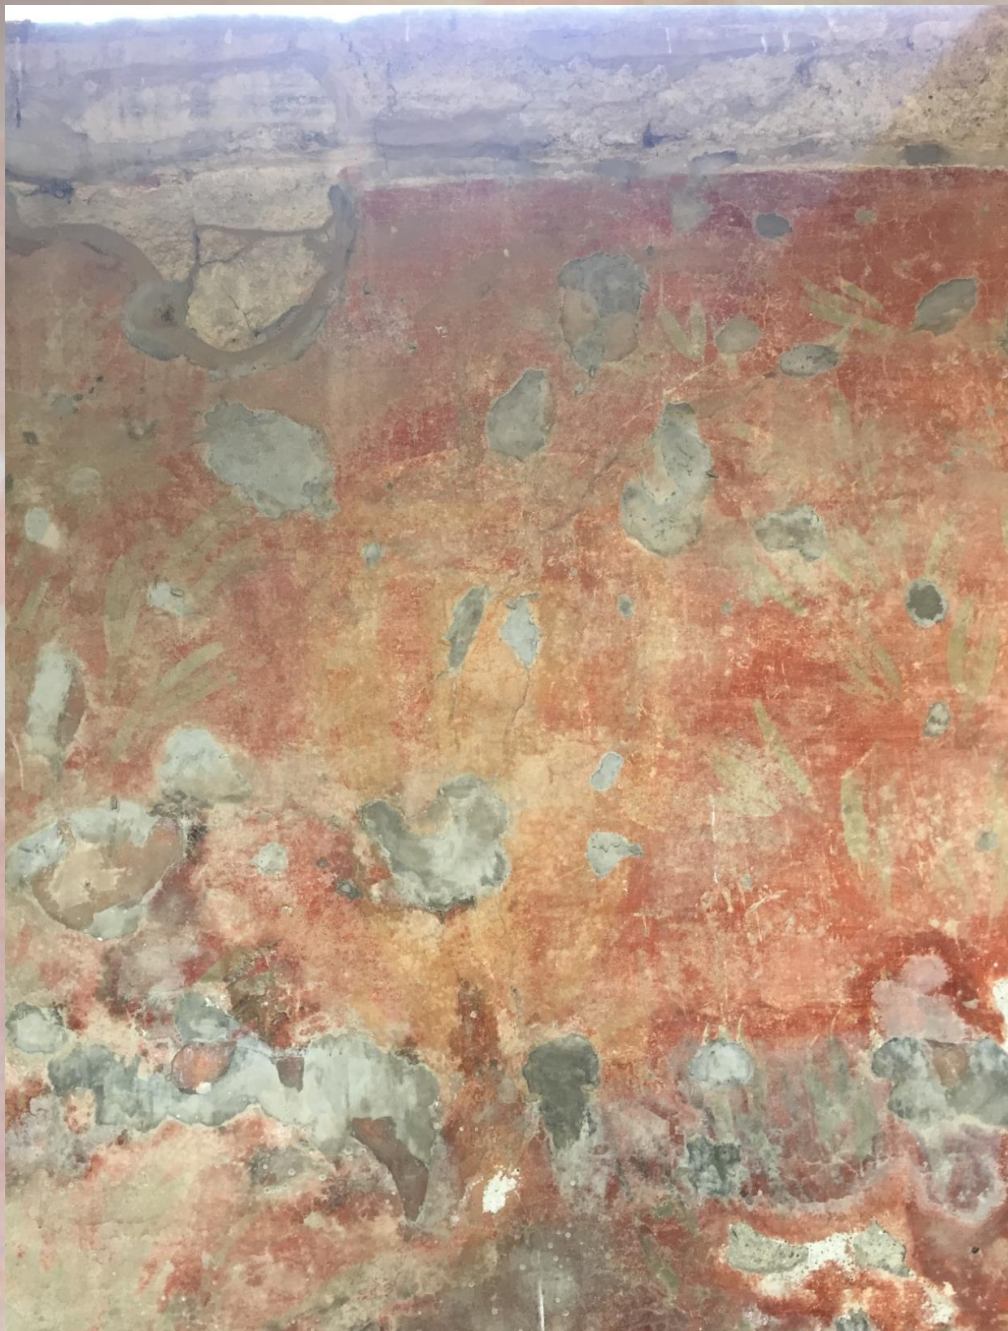
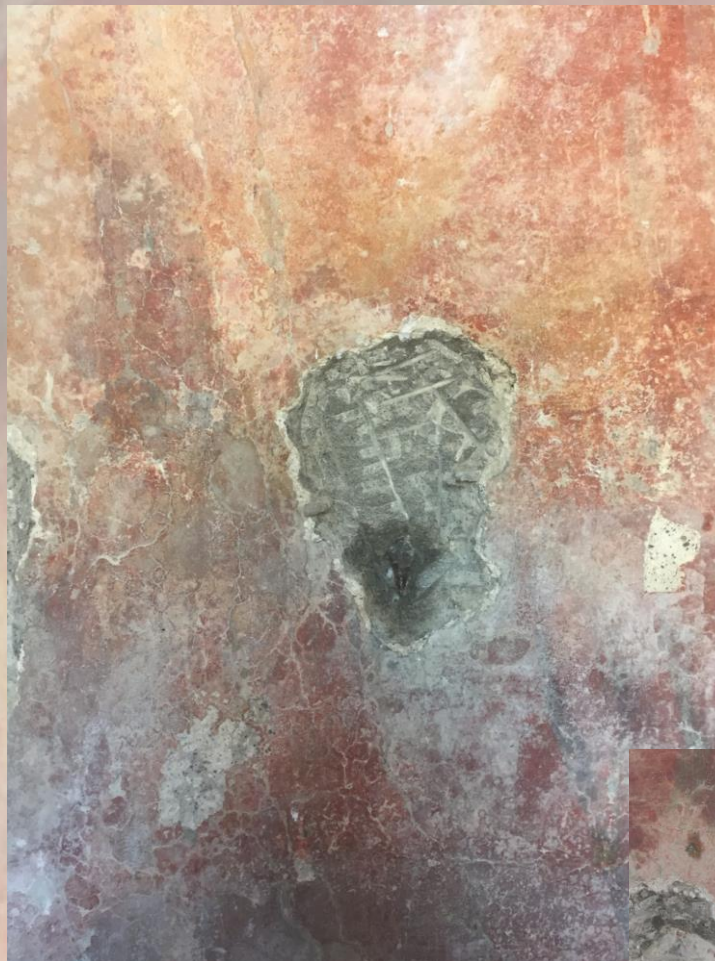
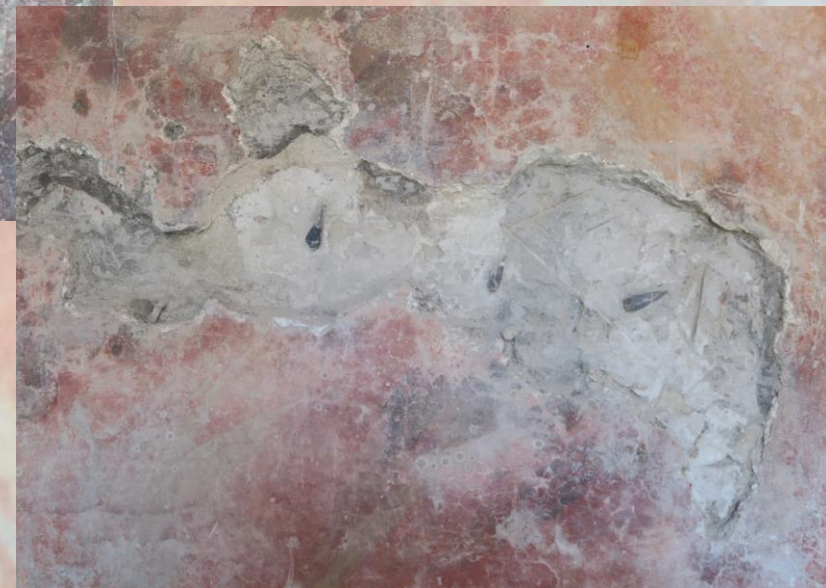
# **2019: Before the restoration**

**Degradations due to  
the large use of  
cement, reinforced by  
metal elements (nails  
and grid)**

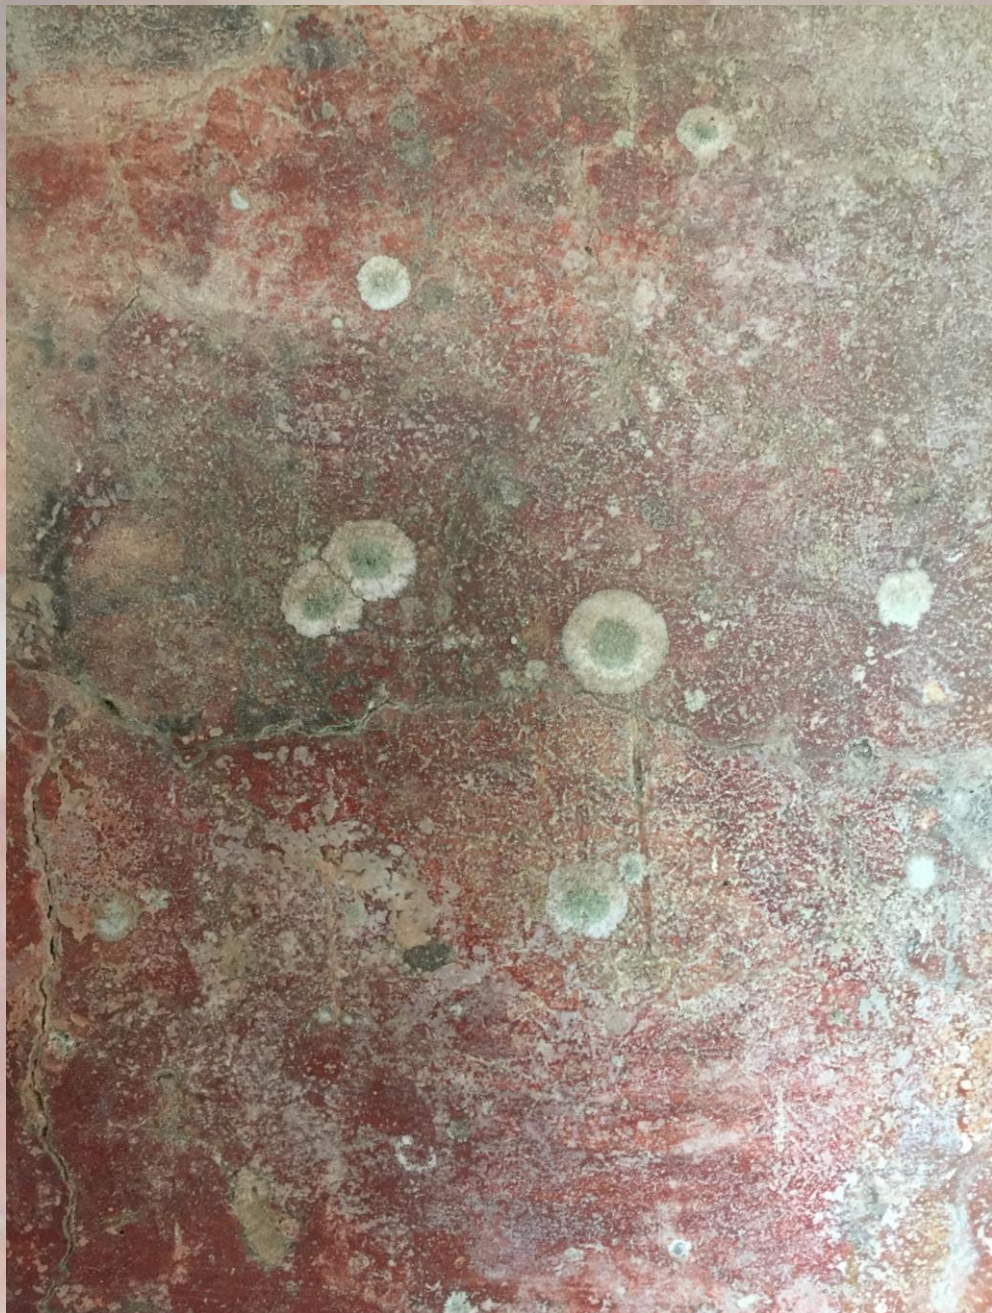
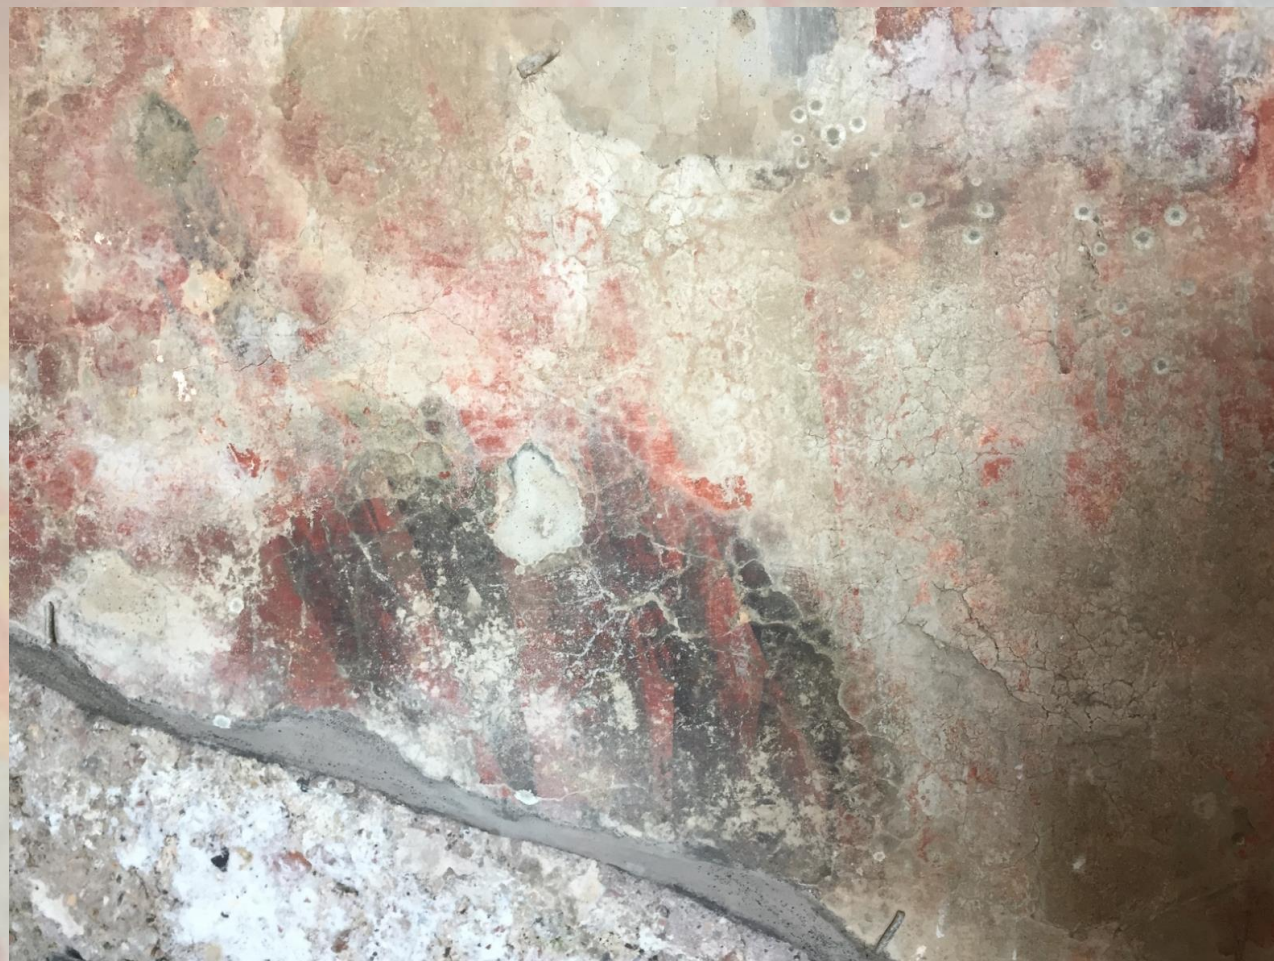
**2019: Before  
the  
restoration**

**Thick biological patina and  
saline efflorescence**

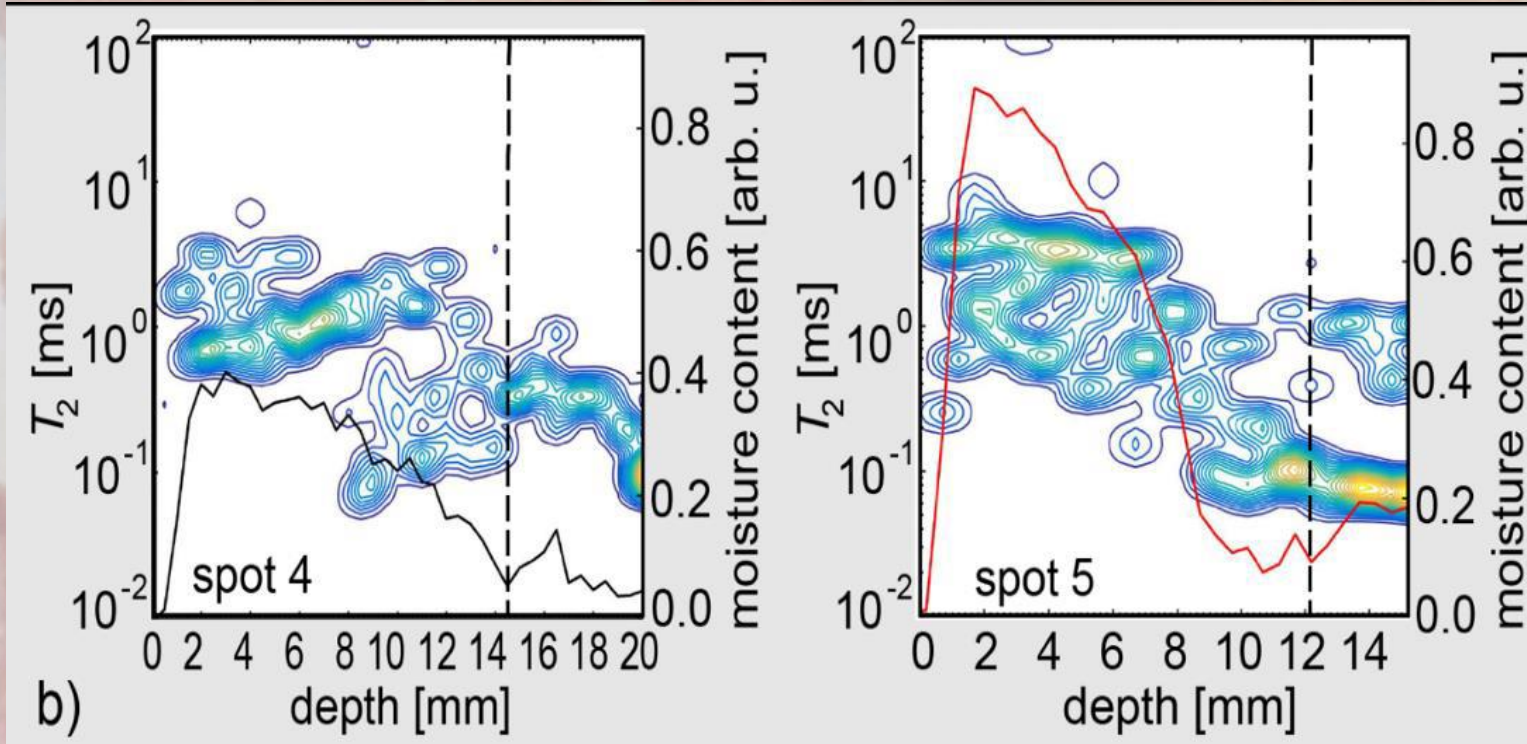
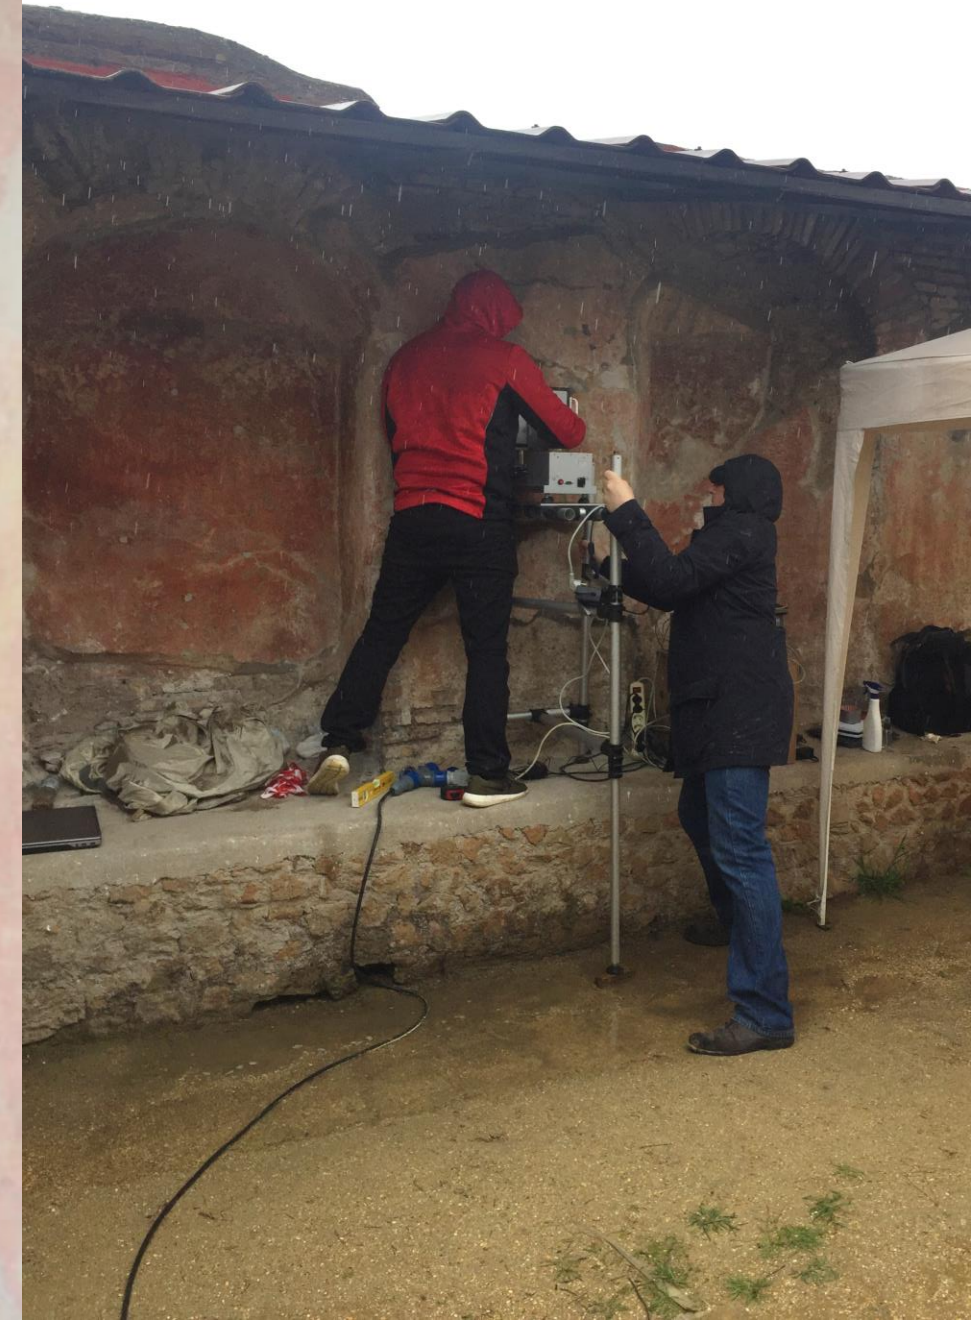
# Nuclear Magnetic Resonance (NMR)

Revealed hidden decoration in room 1, after 1.2-1.4 cm from the surface

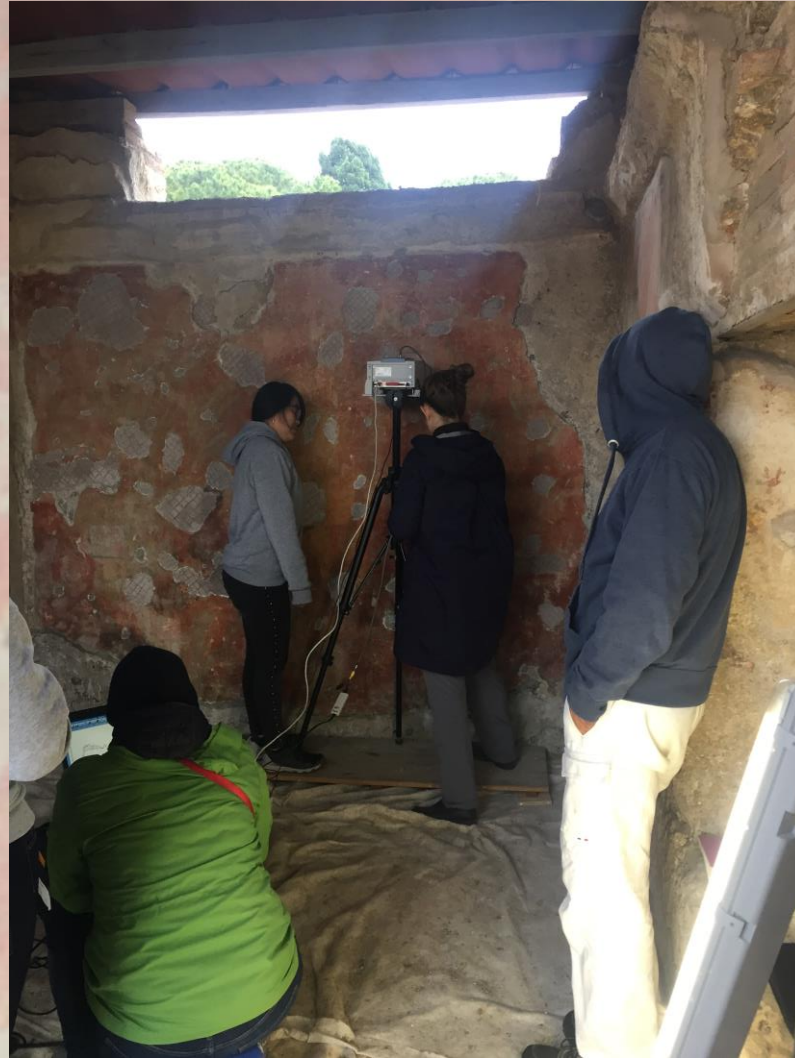
FT-IR

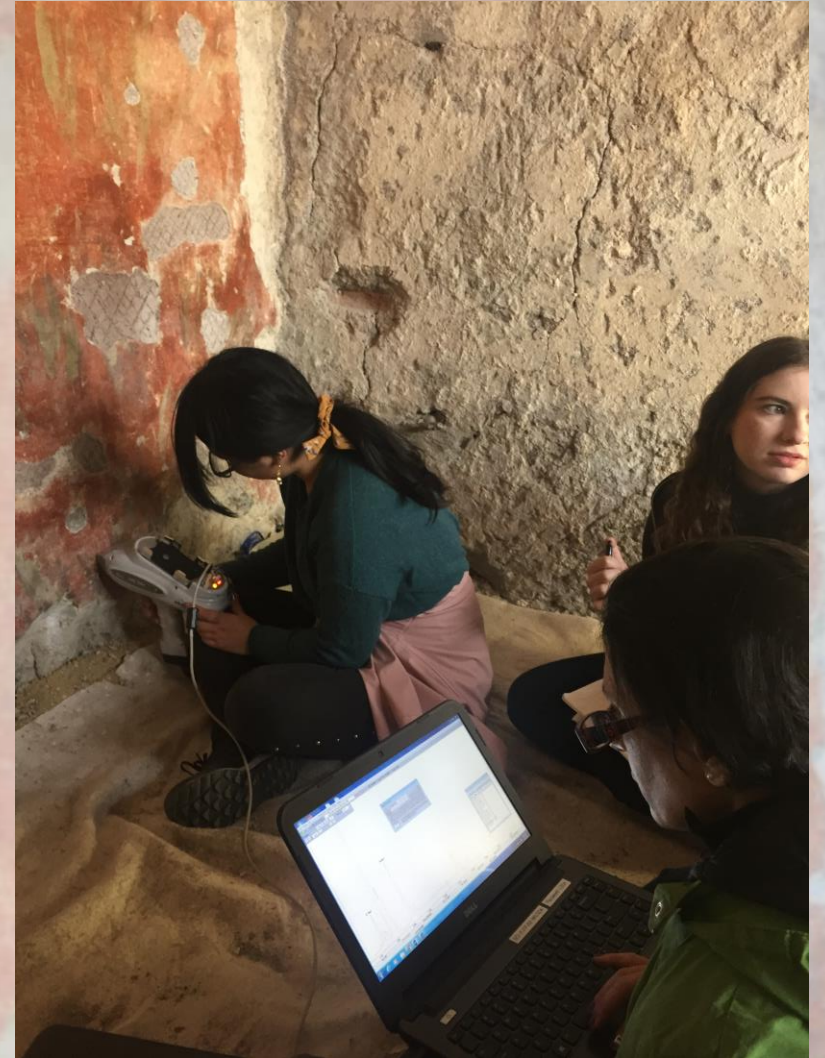
XRF

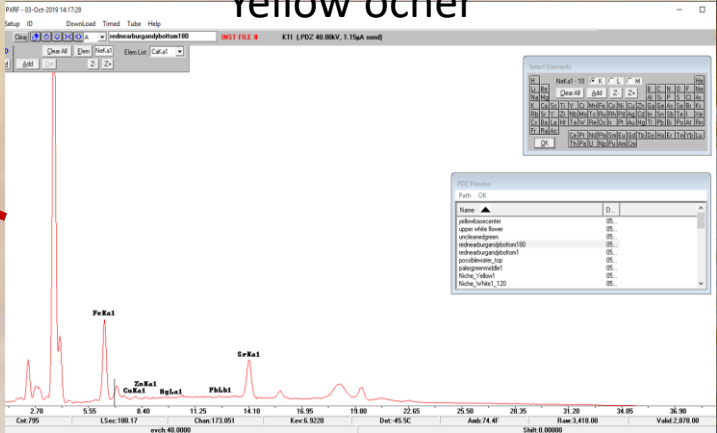
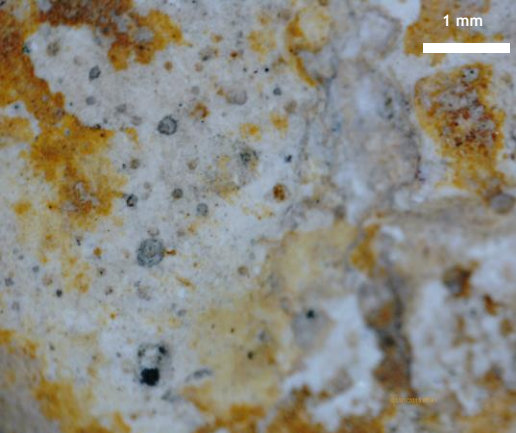
Yellow ocher

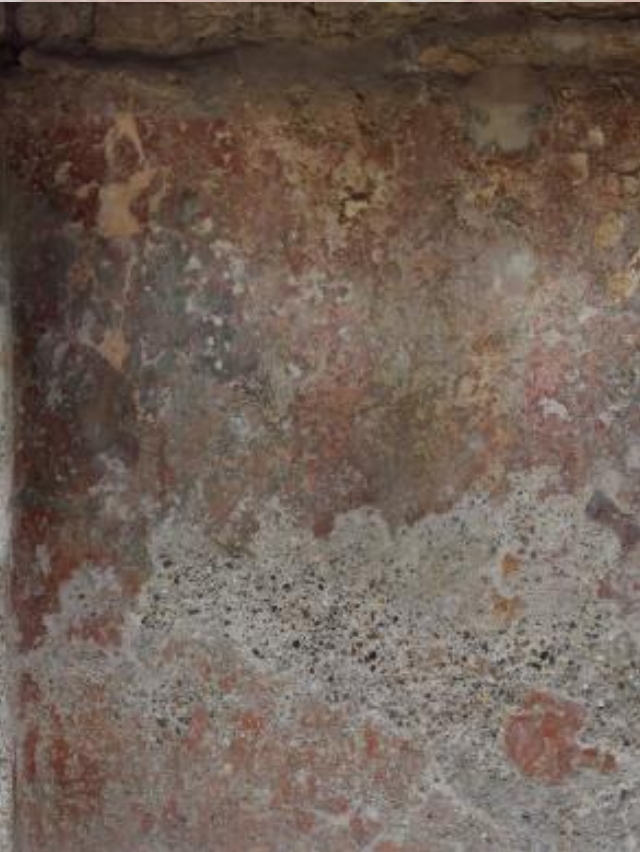
**Actual state (2019)**

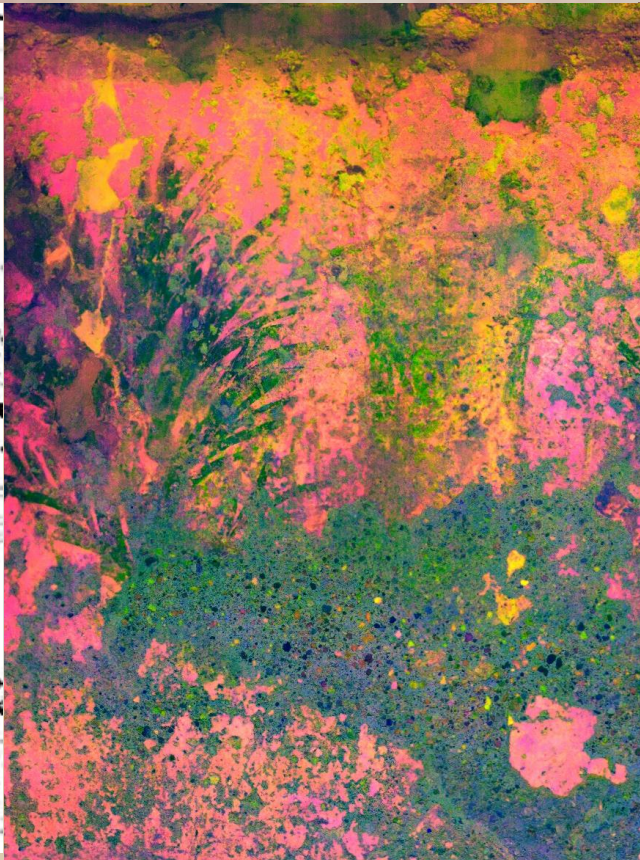
**Alteration of colours with  
Dstretch software**

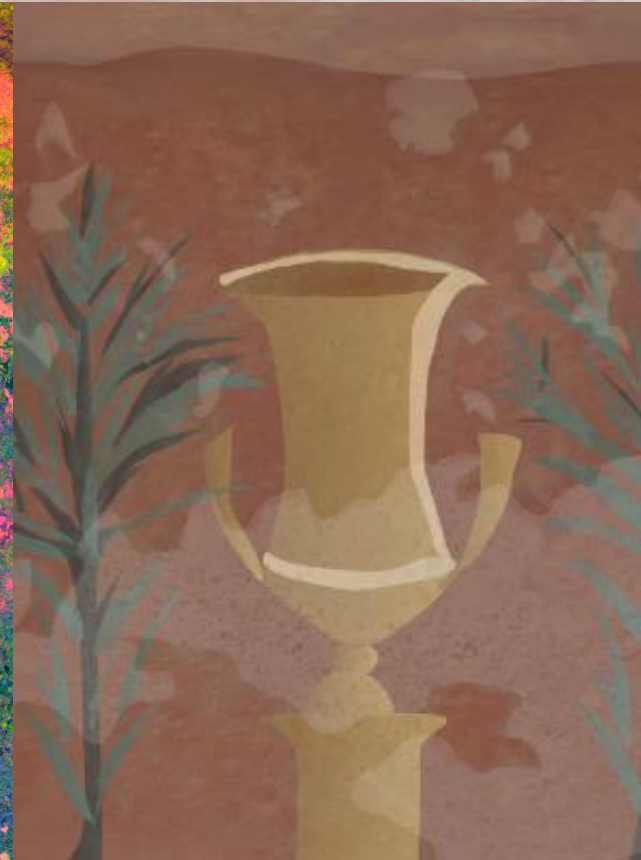
**Digital restoration**
