**HY13897**

# **Close-Range Photogrammetry Application to Monitor Levee Erosion in Case of Wave Overtopping**

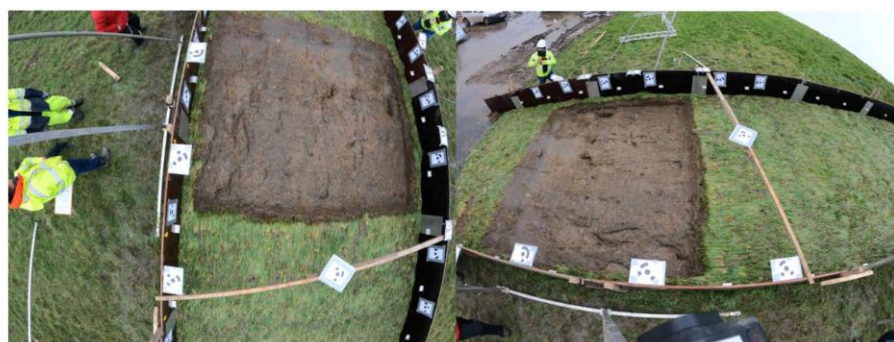
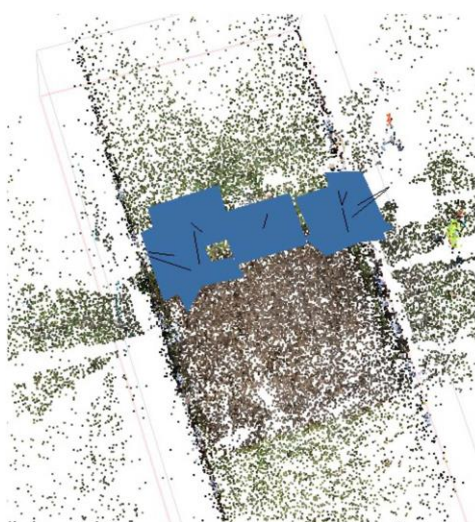
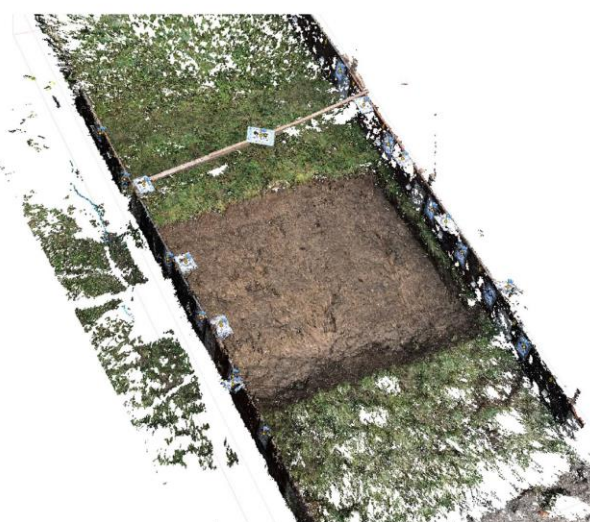
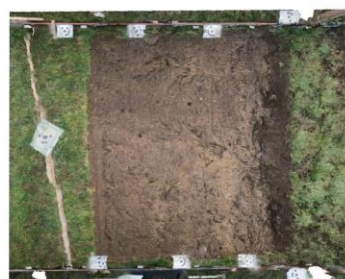
Fig. 11. Photogrammetry processing: (a) Importing raw photos, (b) Aligning Photos, Generating (c) Dense Point Cloud, (d) Digital Elevation Model (DEM), and (e) Orthophoto.

ple, using the commercial software Agisoft Metashape. The principles of close-range photogrammetry and recent advancements in this field i.e., ‘Structure-from-Motion’ (SfM) are discussed by Lane (2001), Snavely (2008) and Westoby et al. (2012). In contrary to traditional photogrammetry, the SfM method does not require the exact position of cameras or the 3D location of some known points to resolve the 3D structure. However, to represent the results in a global coordinate system, Ground Control Points (GCP) with known coordinates were positioned around the scene and visible on the images (see Fig. 2). The photogrammetric processing (Agisoft Metashape User Manual 2022) is summarized in Fig. 11 as an example taken from the BC tests: after loading raw images (Fig. 11 (a)), these were orthorectified and aligned using the identification of the GCPs (Fig. 11 (b)); a dense point cloud was produced (Fig. 11 (c)). Finally, the georeferenced Digital Elevation Model (DEM) was constructed on a regular grid (Fig. 11 (d)) and corresponding orthophotos were created (Fig. 11 (e)).

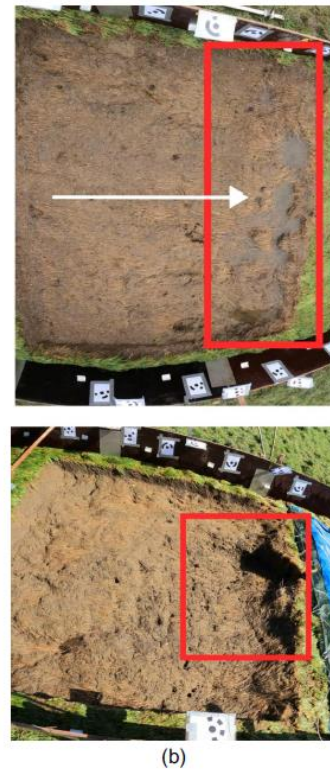
Fig. 13. (a) Photogrammetric verification versus RTK measurements for multicamera set-up at section BC2-2; (b) water-shadow negative effects.

The accuracy of the photogrammetric measurements was evaluated by comparing them to the manual measurements conducted using the RTK system. Fig. 13 (a) presents the comparison between the two methods throughout the wave overtopping experiments at BC2-2 test section. The results indicate a good correspondence between two methods, with a Mean Absolute Error (MAE) of 0.04 m at this section. Overall, the photogrammetry tends to underestimate the levee erosion by overestimating the elevations. This discrepancy was attributed to the estimation of lens and

The comparison between Fig. 13 (a), derived for a multicamera system, and Fig. 14 (c), resulting from a single mobile camera setup, suggests that increasing the number of images does not automatically result in more accurate DEMs. The key factors influencing the accuracy are the overlap and configuration of the images, as demonstrated by Bakker and Lane (2017).

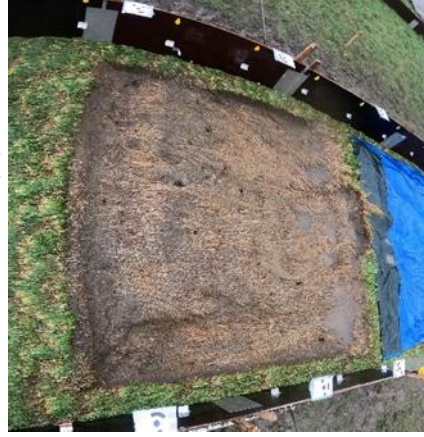
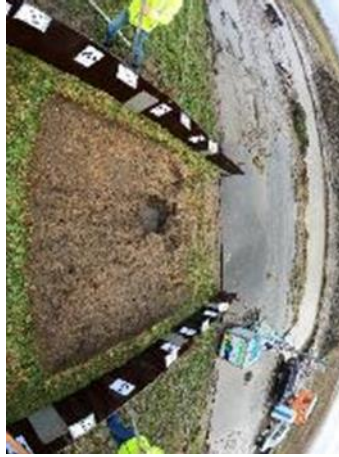
Fig. 15. Total erosion depth at test sections (a) BC1-1, (b) BC1-2, (c) BC1-3, (d) BC2-1 and (e) BC2-2 and corresponding GoPro photos. Flow direction is from left to right.

locally restricted. In fact, as soon as a relatively weak point in the prepared soil became affected, the erosion concentrated around this point. This is illustrated in Fig. 15 showing the final state of bare-clay tests and the bed changes ( $\Delta Z$ ) at the end of experiment. In the BC1-1, BC2-1 and BC2-2 sections, the erosion concentrated at some spots that developed more rapidly and got dominant afterward. In BC2-1 test, the erosion grew upward while it remained more restricted in the BC1-1 and BC2-2 sections. This evolution is depicted in Fig. 16 for BC2-2, which showed that the erosion was not evenly distributed along the width, and that a localized erosion pit formed. This observation is in accordance with the large-scale experiments conducted by Hanson et al. (2005) emphasizing the development of an initial scour hole into a steep headcut migrating upstream from the test section. Another interesting point is the slope steepening of the levee side at the end of tests. Regarding test BC1-3, located close to the levee crest and thus close to the WOS, the erosion depth was observed to be more uniformly distributed, and on average larger than for the other test sections located further downstream. This is due to the strong increase in wave volumes at the beginning and end of the test (Fig. 9 (c)). Interestingly, even after generating waves at maximum capacity of the simulator i.e., 3000 l/m, the erosion did not penetrate as deep as at the lowest sections BC1-2 and BC1-1. This is explained by the way how waves attack the slope i.e., normal, or tangential. The dominant load direction close to the crest is normal to the levee slope and it progressively turns into tangential with high shear stresses as the wave travels towards the levee toe. At those location where the wave front changes direction due to a local change in levee slope, the normal stresses increase significantly again (see Fig. 17).
