# Observation of the failure mechanism of brick masonry doublets with cement and lime mortars by X-ray CT

R. Hendrickx, K. Bruyninckx, L. Schueremans,  
G. Kerckhofs, E. Verstrynge, M. Wevers,  
K. Van Balen

International Micro-CT symposium, KULeuven, 9th June 2009

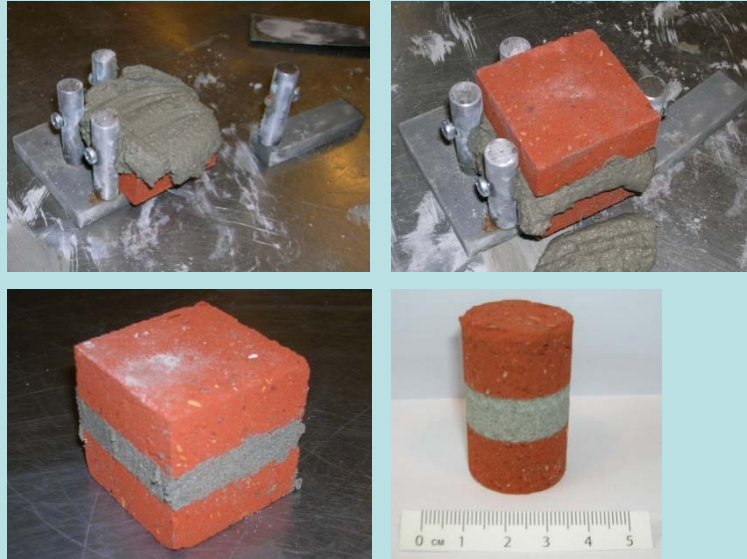
↑ faces made parallel by grinding

- $H_{\text{max,press}}=50\text{mm}$ ,  $t_{\text{joint}}=12\text{mm}$ ,  $d_{\text{core}}=29\text{mm}$ , press: 30kN
- Importance of parallel and smooth top and bottom face.
- High strength mortar can be cored after assembly, low strength mortar can not.

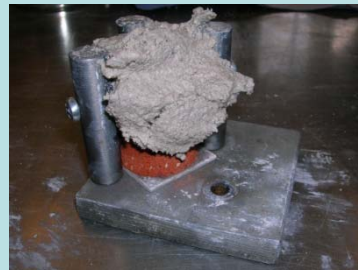
capped with epoxy resin  
(problems with gypsum),  
leads to strong  
confinement

- Samples would break when drilled.
- Assemble cylindrical pieces, and add epoxy layer under press to make faces parallel.

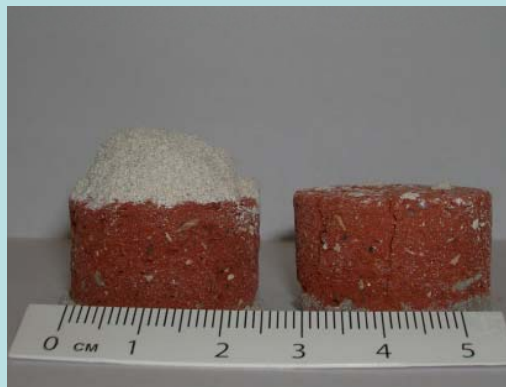
Carbonated lime mortar, doublet 4

- More “plastic” failure: large deformations in mortar.
- Sometimes defective bonding observed after test, especially for natural hydraulic lime.
