DOI: 10.7759/cureus.78686

# Neodymium-Doped Yttrium Aluminum Perovskite (Nd:YAP) Laser in the Elimination of Endodontic Nickel-Titanium Files Fractured in Rooted Canals (Part 2: Teeth With Significant Root Curvature)

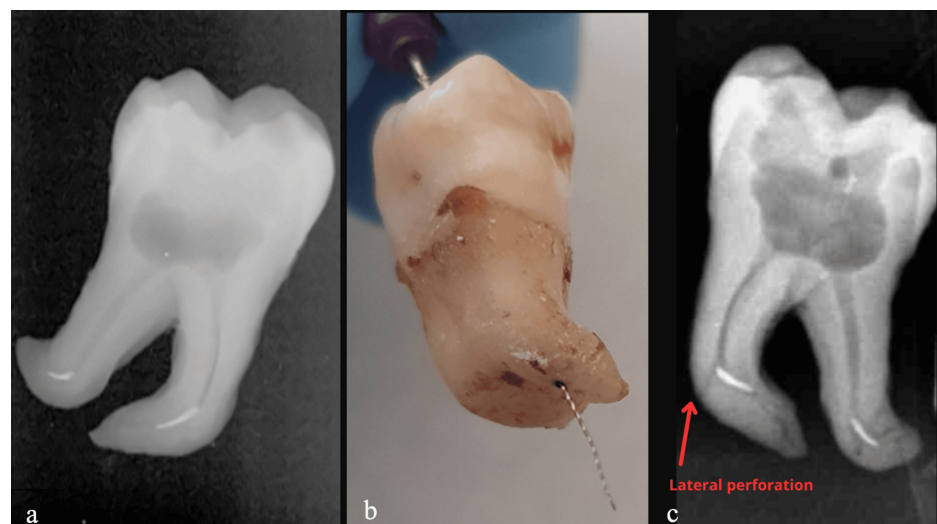
**FIGURE 1: Illustration of a sample with lateral perforation obtained after the suggested treatment protocol: (a) Illustration of broken instruments inside the root canal. (b) Clinical representation of a case with lateral perforation. (c) Radiographic illustration of a lateral perforation.**

At the conclusion of each irradiation cycle, a 10 K-file (VDW GmbH) was used to evaluate the results, including complete removal, bypassing, or failure of the fractured instrument. The results were classified as either success or failure based on the criteria detailed in section 2.1. To verify the outcomes, all teeth were sectioned for a second visual confirmation of the results (Figure 1).

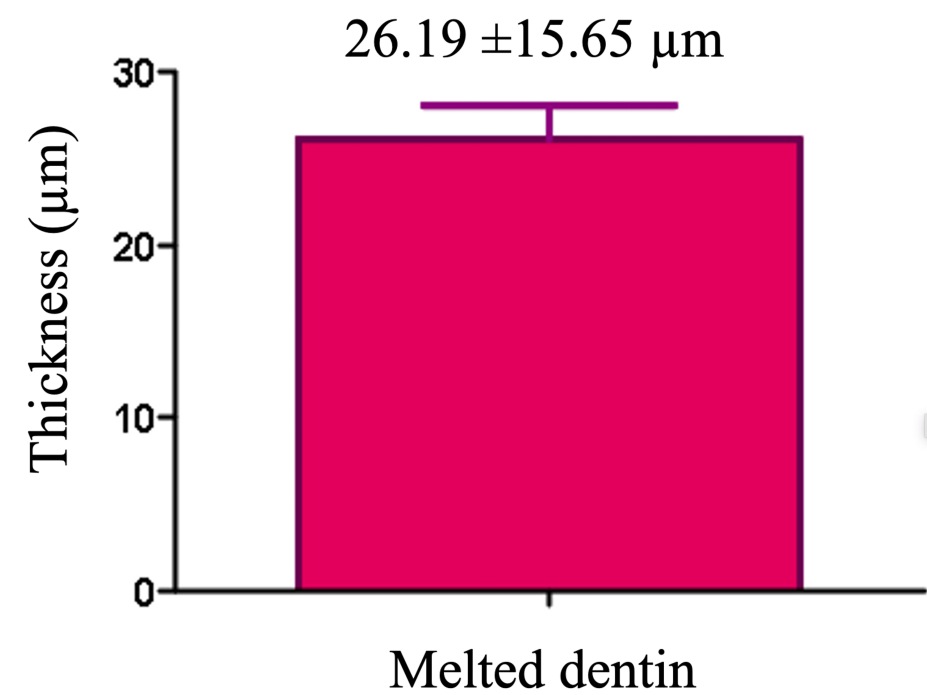
**FIGURE 2: Mean value of the thickness of the melted dentin after the suggested treatment protocol with the Nd:YAP laser.**

The results obtained from SEM revealed distinct areas of melted dentin, characterized by a smooth, glass-like surface indicative of thermal alteration. Upon detailed measurement, the average thickness of the melted dentin layer was found to be 26.19 ± 15.65 µm, reflecting variability across the observed samples (Figure 2). To provide a visual representation of these findings, Figure 3 presents a cross-sectional view of one of the analyzed samples, clearly illustrating the morphological changes in the dentin caused by the thermal effects. This figure highlights the extent and uniformity of the melted layer, supporting the quantitative data.

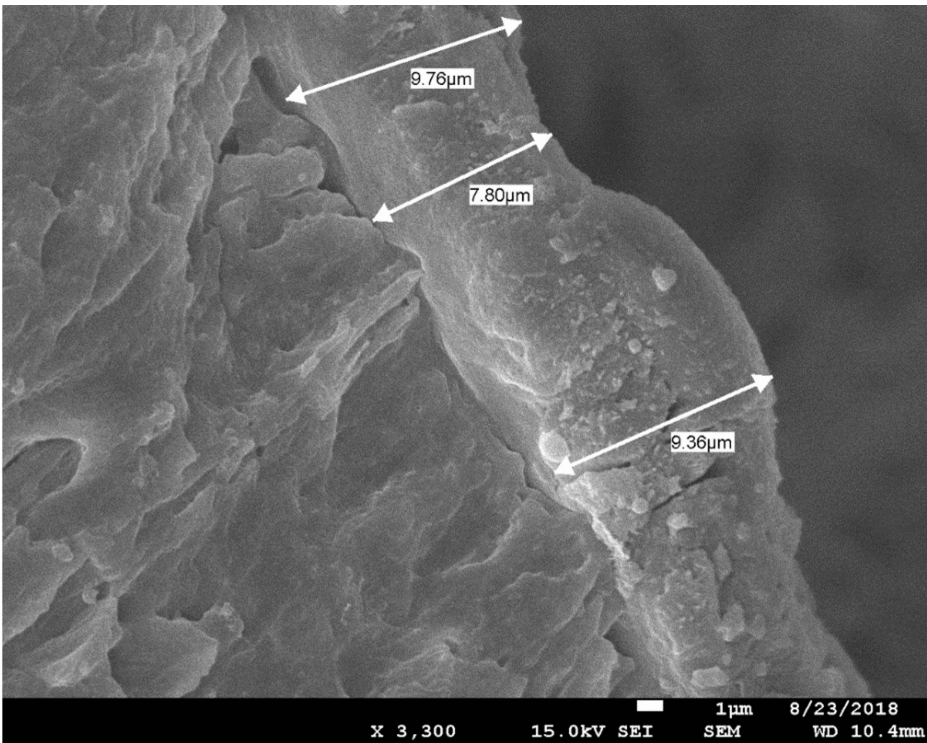
**FIGURE 3: Illustration of a sample showing a clear layer of melted dentin after irradiation with the suggested Nd:YAP treatment protocol.**

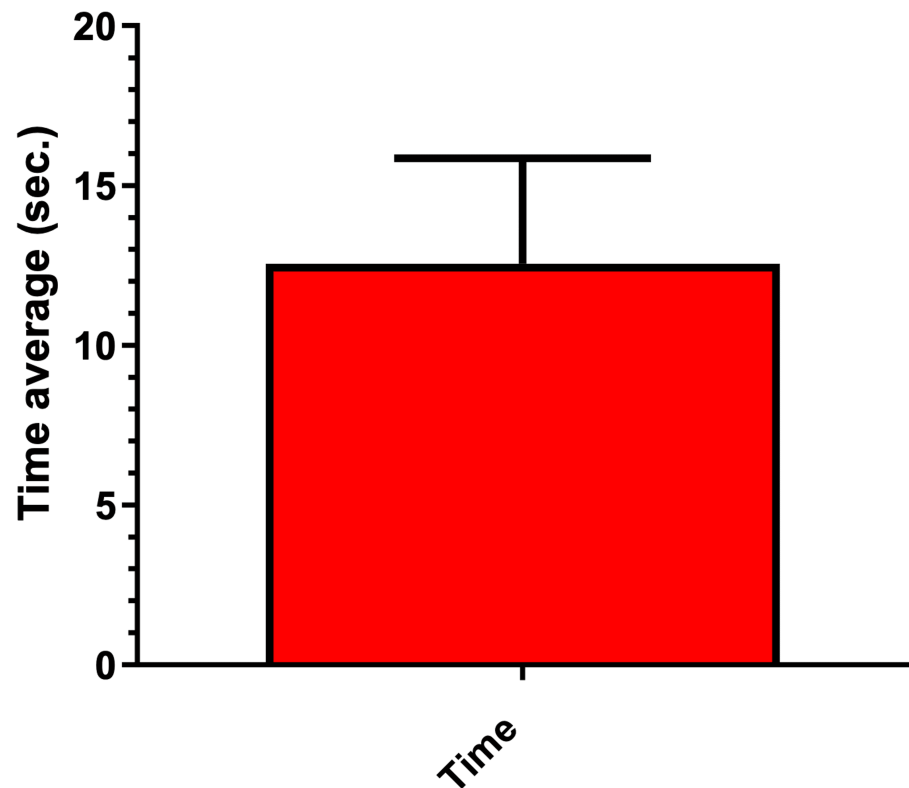
**FIGURE 4: Mean time in seconds required for the complete removal and/or bypass.**

When the bypass procedure was successfully performed (7%), the process proved to be relatively efficient, with an average completion time of  $12.56 \pm 3.29$  seconds. These findings indicate that, under favorable conditions, the procedure can be carried out within a short time frame. The variation in timing reflects that, although most cases were resolved quickly, certain situations required additional time due to complexities or technical difficulties encountered during the process (Figure 4).

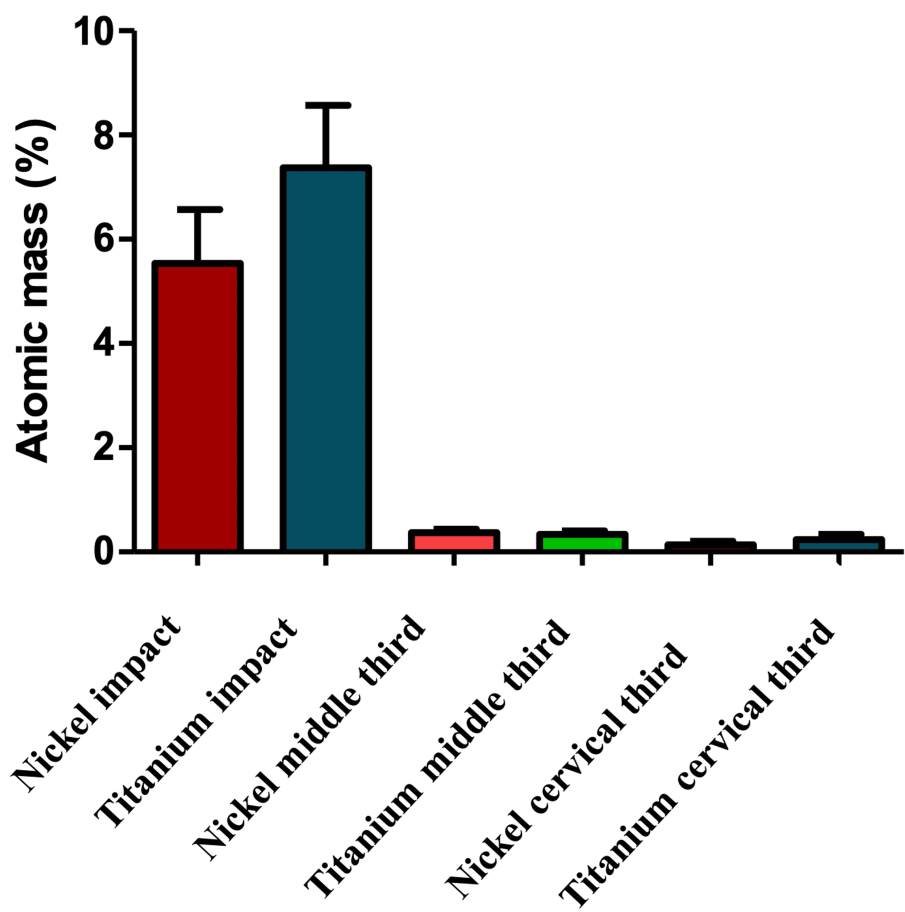
FIGURE 5: Chemical composition in Ni and Ti at different parts of dentinal canal walls.

Values are expressed in atomic mass percentage (%).

The mean and SD values for Ni and Ti detected on the dentinal canal walls of all studied samples were  $5.54\% \pm 4.62$  and  $7.37\% \pm 5.39$ , respectively, within the irradiation area at the apical third. The presence of Ni and Ti traces decreased along the root canals to the cervical direction. At the cervical third and middle third of treated canals, the levels of Ni and Ti were  $0.53\% \pm 0.23$  and  $0.31\% \pm 0.27$ , respectively, while apical to the impact area, they measured  $0.13\% \pm 0.17$  and  $0.22\% \pm 0.26$ , respectively (Table 2, Figure 5).
