# Characterizing soil piping networks using ground-penetrating radar

J.-B. Got, C. Bielders, S. Lambot

EGU 2019

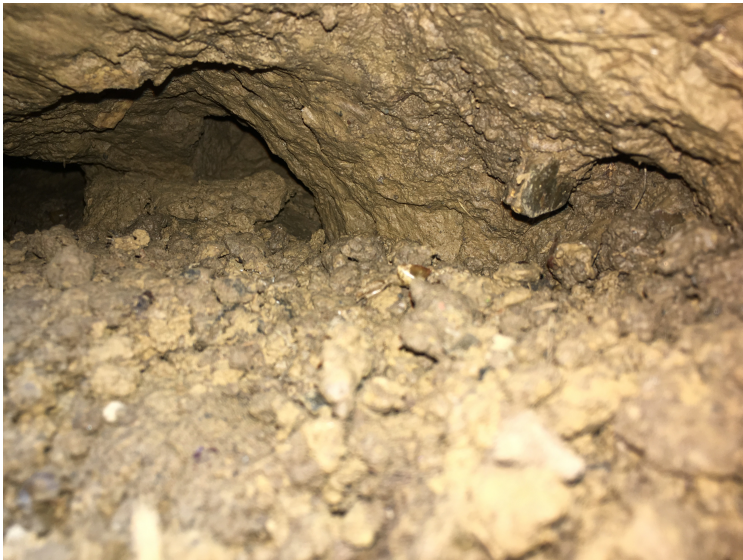
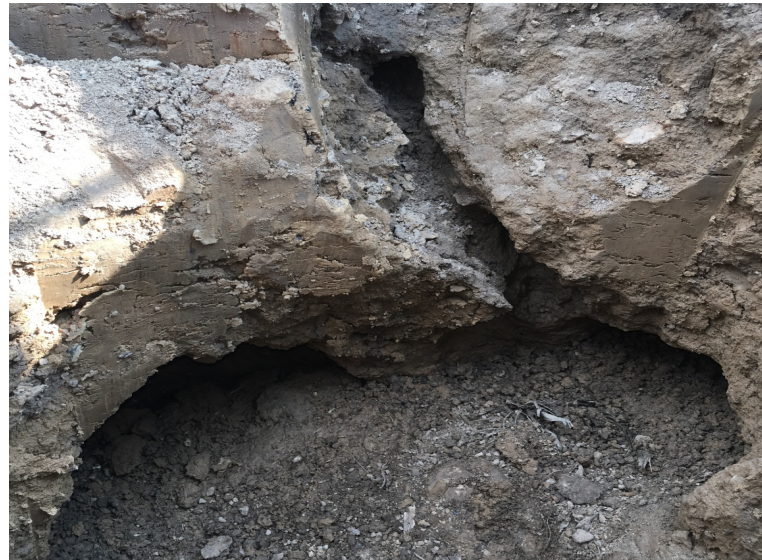
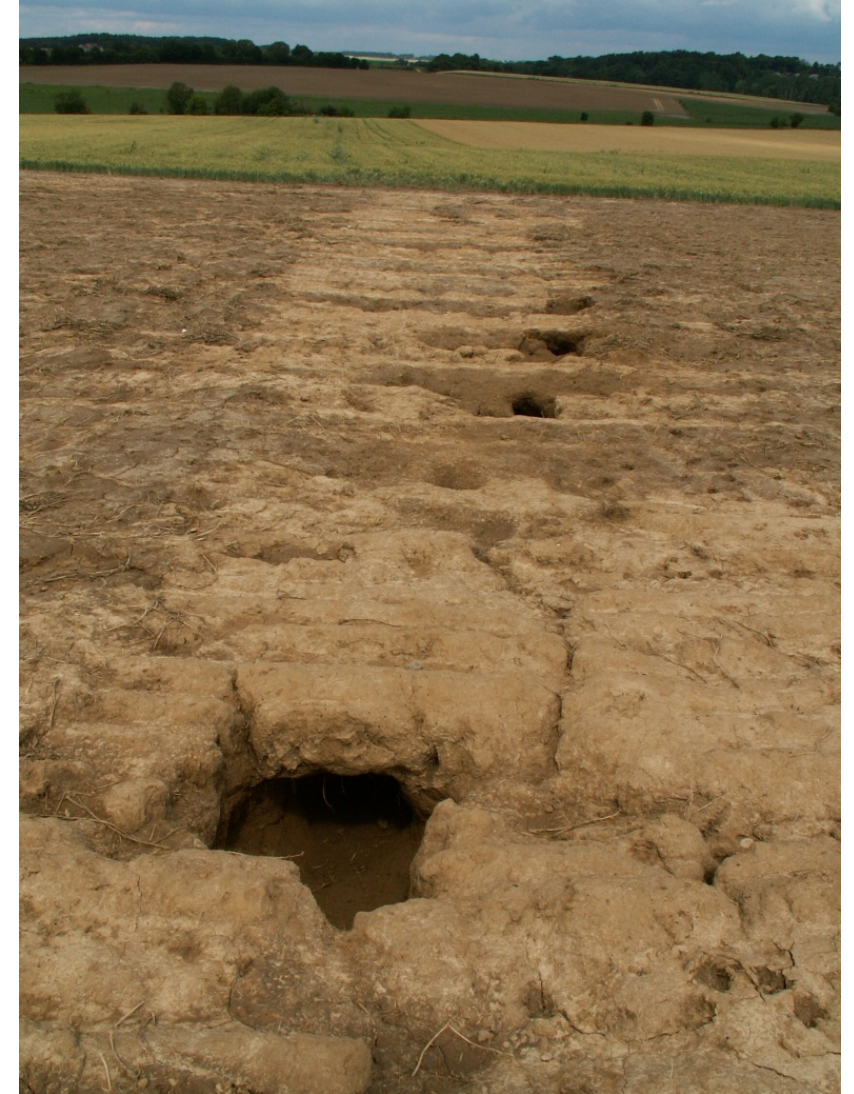
Geomorphological mapping:

→ Underestimate pipe length  
and network densities

Geophysical mapping:

→ Able to detect soil pipes, not yet  
to characterize networks

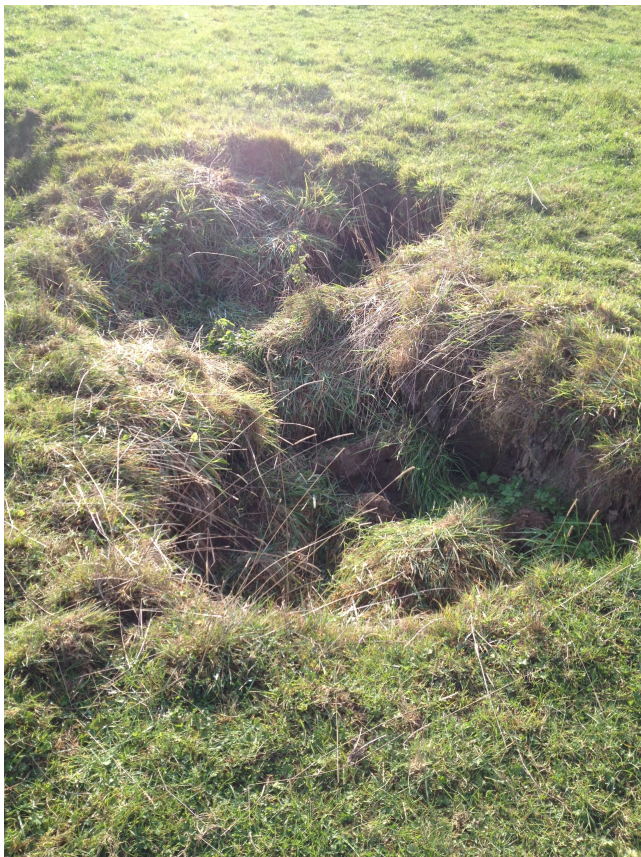
# Study site: Khuisbergen (Belgium)

- Loess-derived soil
- One active pipe located near the talweg
