## Historic roof structures: Life-cycle assessment and selective maintenance strategies

**ABSTRACT** Many industrial and military constructions built between the end of the XIX century and the first years of the XX century show long span roof structures constructed using slender steel truss members. This characteristic makes the structures almost invisible and the interior space appears larger than it is. After 100 years or more, structures like these are still in good conditions although they may have fallen into disuse and neglect. Usually these buildings are protected by Cultural Heritage regulations. Therefore, it would be interesting to define suitable intervention strategies to maintain, conserve and possibly reuse them. This paper compares three different steel roof trusses, covering some buildings of a military installation in Pavia (Northern Italy), built from the end of the XIX century. The residual capacity has been probabilistically evaluated in order to check the efficiency of the most vulnerable members of the structures and investigate systems' robustness in case of sudden failure of the critical components. The method proposed can be considered as a reliable approa

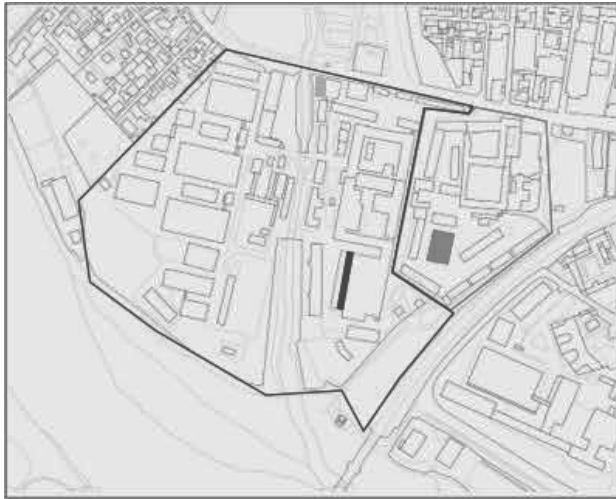
Figure 1. Arsenal (blue perimeter) and Rossani barrack complex (red perimeter) planimetry in Pavia. Case study 1, Rossani's Pavilion in red; Case study 2, Arsenal Building 65 in yellow; Case study 3, Arsenal Building 15 in blue.

The three case studies analysed here refer to the roof structures of two pavilions of the Arsenal complex and one pavilion of Rossani barracks (Fig. 1).

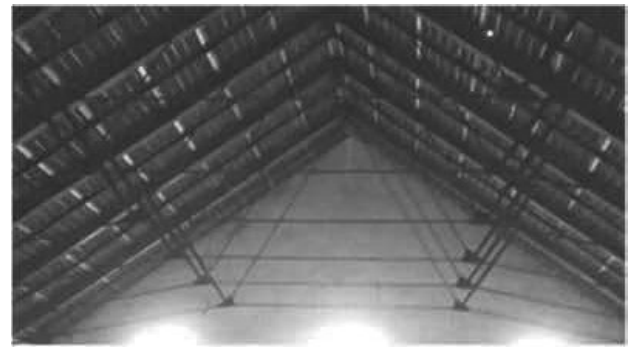
Figure 2. Pavilion in Rossani barracks.

The case study structure is a Polonceau truss made by small tension and compression iron and timber bars (Fig. 2; Tab. 1).

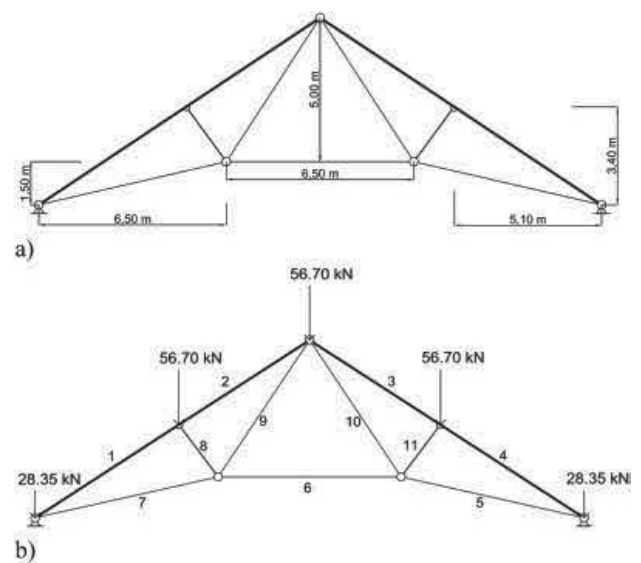
Figure 3. (a) Truss geometry (in metres); (b) Truss static model.

The original load on the structure has been estimated as approximately 9.7 kN/m<sup>2</sup> on a 60-sm influence area. Figure 3 shows the truss geometry and the forces applied to each node. Monte Carlo simulation

refers to the static model in Figure 3(b). Members 1–4 in timber and members 5–11 in iron have different geometries.

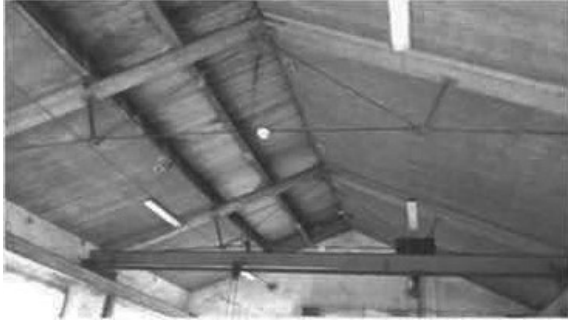
Figure 4. Arsenal Building 65.

The structure is a Polonceau truss made by small tension and compression iron and timber bars (Fig. 4; Tab. 2).

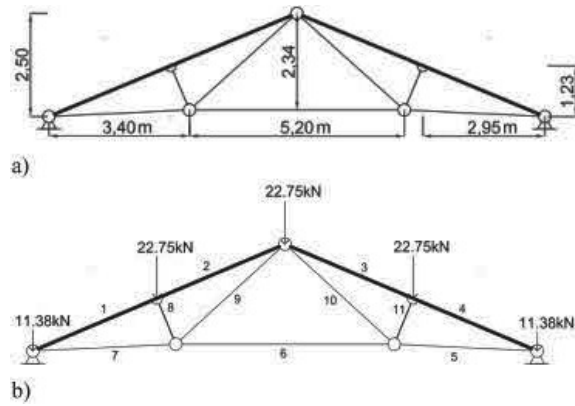
Figure 5. (a) Truss geometry (in metres); (b) Truss static model.

The original load on the structure has estimated to be approximately 2.0 kN/m<sup>2</sup> on a 42-sm influence area. Figure 5 shows the truss geometry and the forces applied to each node. Monte Carlo simulation refers

to the static model in Figure 5(b). Members 1–4 in timber, and members 5–11 in iron present different geometries.

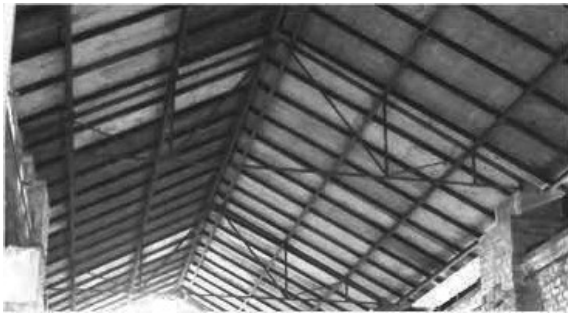
Figure 6. Arsenal Building 15.

The structure is composed by a classic truss with small tension and compression iron bars (Fig. 6; Tab. 3).

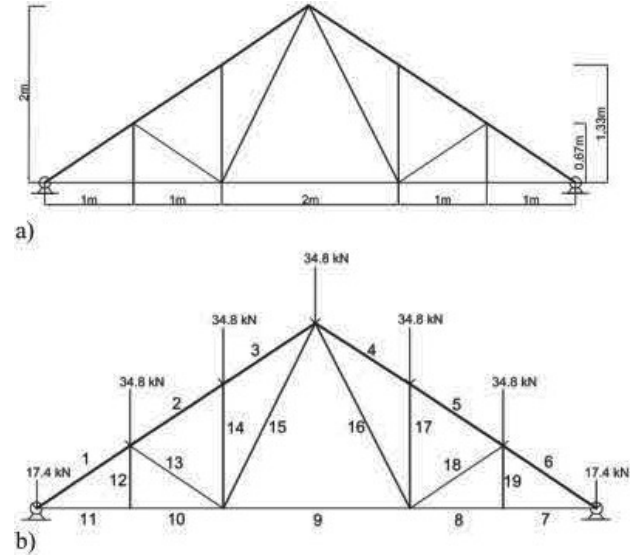
Figure 7. (a) Truss geometry (in metres); (b) Truss static model.

The original load on the structure was about 2.0 kN/m<sup>2</sup> on an influence area of 35 m<sup>2</sup>. Figure 7 shows the truss geometry and the forces applied to each node. Monte Carlo simulation refers to the static model in Figure 7(b).

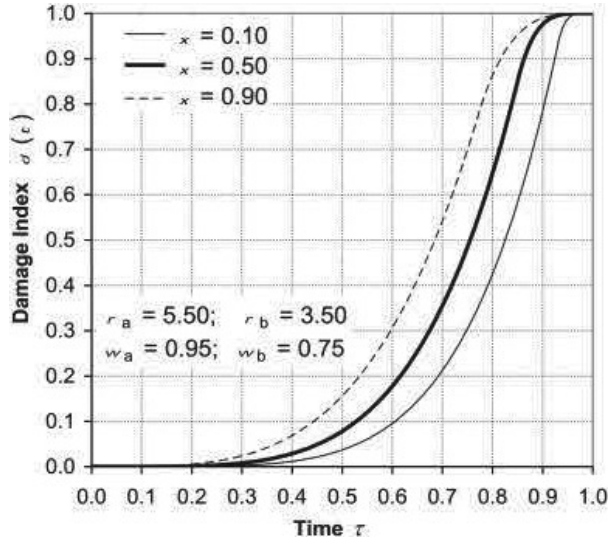
Figure 8. Damage index  $\delta$  versus normalized time  $\tau = t/T_f$  related to different performance loss percentage  $\xi$ .

where  $\tau = t/T_f$ ,  $T_f$  is the  $n$ -instant of time at which the failure threshold  $\delta = 1$  is reached,  $\rho$  and  $\omega$  are parameters defining the damage curves (Fig. 8).

Figure 8 describes the decay law affecting the structure. Deterioration is assumed uniform on the whole element surface. Environmental aggressions and variation in loading conditions are both considered.

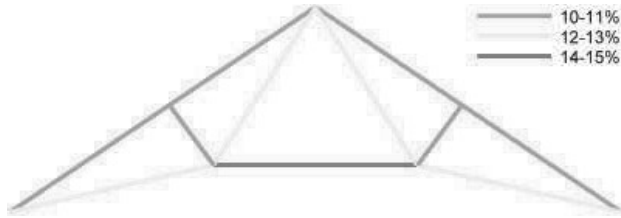
Figure 9. Damage percentage member by member.

Monte Carlo simulation shows a 10% to 15% damage spread over the entire structure. Although the overall deterioration level doesn't seem to compromise the

structural stability yet, member 6 critical conditions shouldn't be underestimated (Fig. 9).

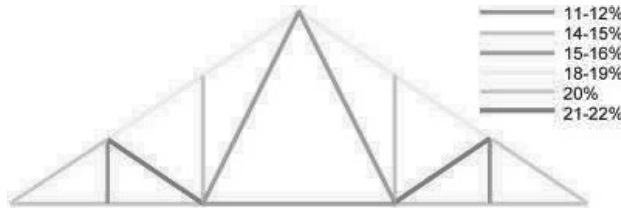
Figure 11. Damage percentage member by member.

Once again, there is an overall deterioration. However, comparing Case Study 3 with the previous ones, because of the smaller dimension of its elements, the damage appears to be more consistent and it has been estimated in the range from 11% to 22% (Fig. 11).

Monte Carlo simulation proves the structure to be still strong enough to withstand current loading and environmental aggressions, though the slenderest members (i.e. elements 13th and 18th) have lost a significant portion of their original cross sectional area.

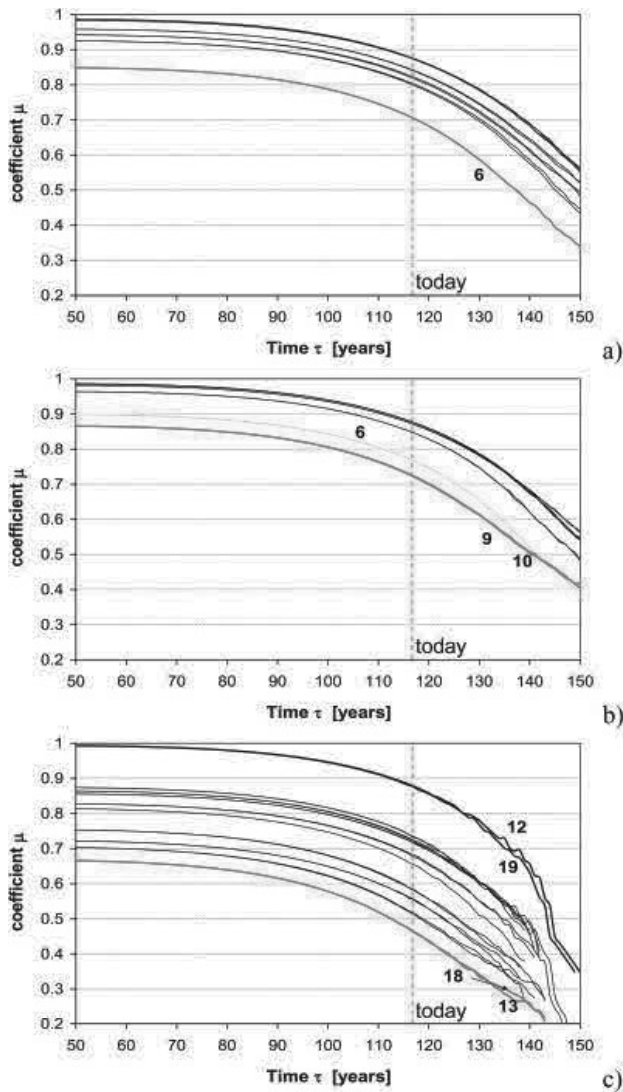
Figure 12. Comparison between index  $\mu$  evolution over time for all the members of each roof truss: a) Case 1; b) Case 2; c) Case 3. The most vulnerable components have been highlighted in red and yellow.

where  $\delta(t)$  is the damage obtained by Eq. 2,  $\sigma(t)$  is the level of stress at time  $t$  and  $\bar{\sigma}$  is the ultimate stress (i.e. allowable/permissible stress). Figure 12 compares the time evolution of index  $\mu$  for the three case studies.

Figure 12 shows which component is most likely to fail. Furthermore, it appears clear that Case 3 truss system (Fig. 12c) is characterised by a lower reliability level than the other structures (Fig. 12a and b).

A selective maintenance would require an urgent intervention to restore the volume loss or replace the critical elements and the members with an index  $\mu$  close to 0.4. Otherwise, when it comes to components characterised by a higher index  $\mu$ , maintenance actions may be postponed.

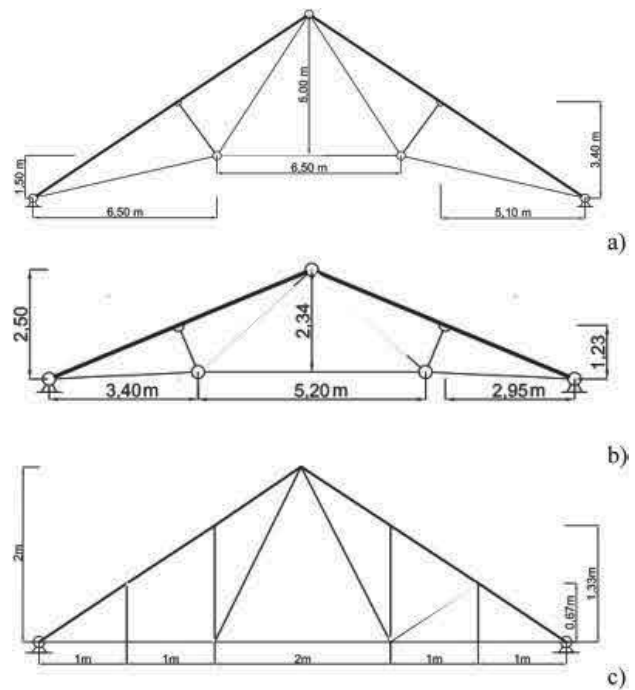
Figure 13. Case studies analysed without considering the members affected by possible failure (dashed lines): a) Case 1; b) Case 2; c) Case 3.

evaluated considering 117 years as actual instant time, and without the critical members' support (Fig. 13).

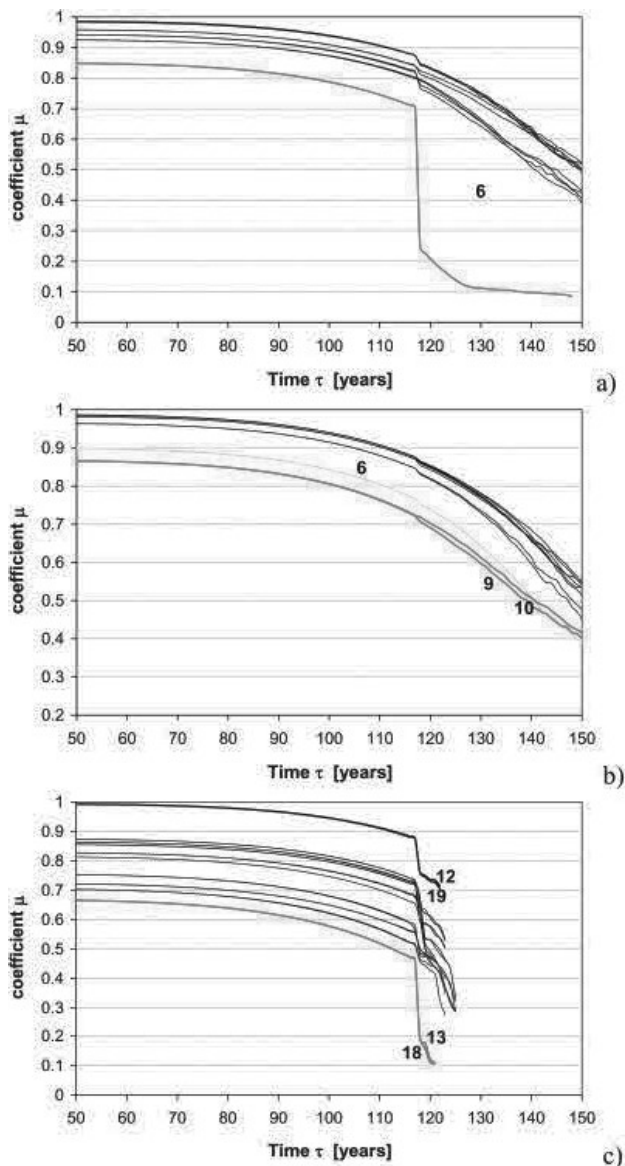
Figure 14. Comparison between index  $\mu$  evolution over time for all the members of each roof truss: a) Case 1; b) Case 2; c) Case 3. The most vulnerable components have been highlighted in red and yellow.

Figure 14 shows the results of the second analysis. In Case 3, index  $\mu$  evaluation reveals that the system redundancy has not a significant impact on the stress distribution in the undamaged members, while a diffuse deterioration affects the whole structure with a failure time estimation of approximately 125 years (Fig. 13c; Tab. 5). Therefore, extensive maintenance actions over the whole roof structure would be necessary to protect the truss system and prevent it from failures.

In Case 1, member 6 failure has a low impact on the overall deterioration. Index  $\mu$  evolution suggests that element 6 should undergo urgent maintenance, while the rest of the structure could be maintained in the long term (Fig. 14a; Tab. 5).

In Case 2, members 9 and 10 failure doesn't affect the overall structural response very much. The time evolution of index  $\mu$  in Figure 14b is close to the one in Figure 12b. The failure time results in Table 5 again confirm the previous assertions. Case 2 truss system appears to be characterised by appreciable robustness values, which indicates no urgent maintenance is needed.

Furthermore, this methodology can be very helpful in defining the robustness level of a structure. In particular, in Case 3 (i.e. 33 constraints), Table 5 and Figure 14 show that constraint redundancy has no positive effects on robustness. On the other hand, proper cross section and thickness design of roof truss components ensure a better structural response to sudden collapse of the most vulnerable members.
