## A breathing pacemaker

**Benoit Robaye**

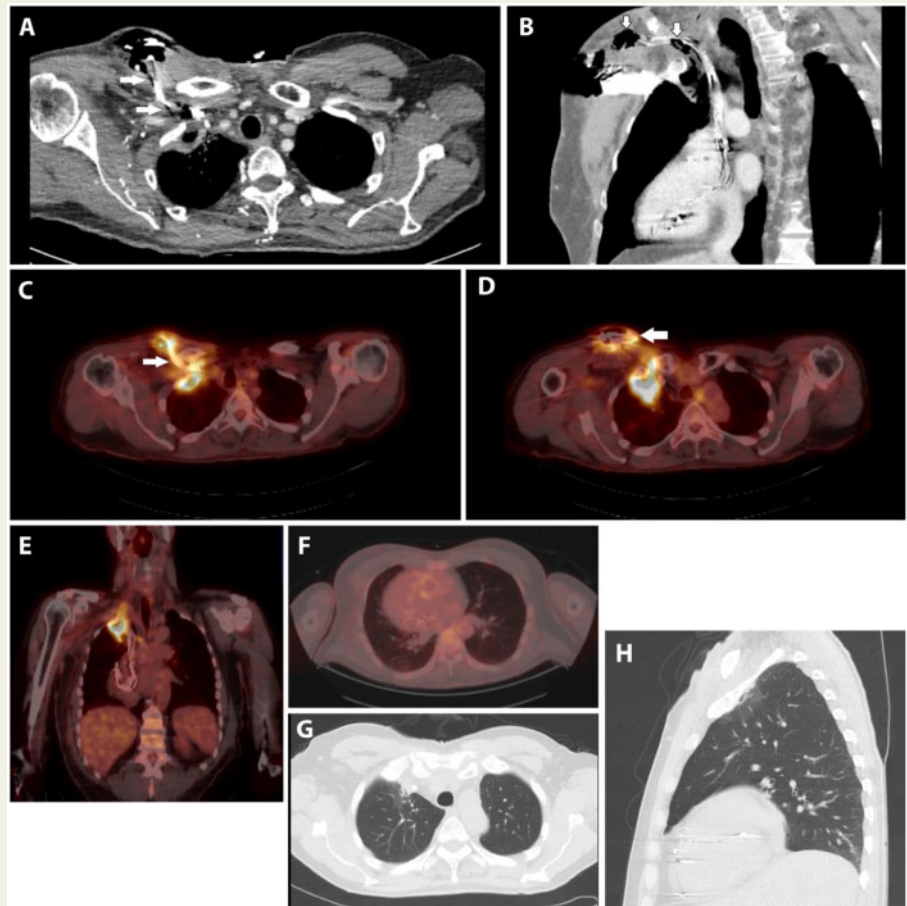
The pocket of the pacemaker was inflamed, inflated, and grew in size when the patient coughed or expired against resistance. Chest computed tomography (CT) scan showed an aerial fistula (Panels A, axial plane and B, sagittal plane arrows) between an abscess of the upper segment of the right lung and the pocket of the pacemaker, along the extravascular path of the leads. Echocardiographies were of poor quality but didn't show any significant valvular regurgitation or mass on the leads. Combined positron emission tomography (PET)-CT scan showed hypermetabolism of the proximal part of the leads (Panel C) and the pocket (Panel D) but no argument for valvular dissemination or distal lead infection (Panel E, coronal view) or lung septic emboli (Panel F). Blood cultures remained sterile.

A new intra-abdominal pacemaker was implanted, with epicardial leads. Then the ancient pacemaker was removed. Clinical and radiological post-operative evolution was favourable (Panels G and H, chest CT-scan performed after 3 months with no residual fistula or significant pneumonia).
