# Complications after aortic valve repair and valve-sparing procedures

Michel Van Dyck<sup>1</sup>, David Glineur<sup>2</sup>, Laurent de Kerchove<sup>2</sup>, Gébrine El Khoury<sup>2</sup>

<sup>1</sup>Department of Acute Medicine, Division of Anesthesiology, <sup>2</sup>Cardiovascular Department, Division of Cardiothoracic and vascular Surgery, Cliniques Universitaires St-Luc, Université catholique de Louvain, Brussels, Belgium

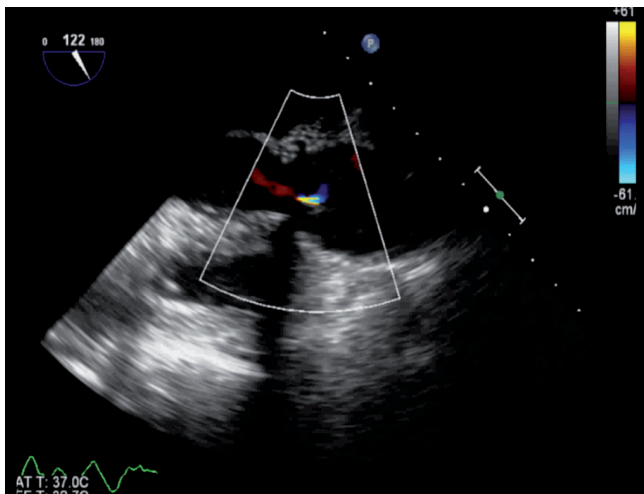
**Figure 1** Transesophageal echocardiographic midesophageal aortic valve long-axis (TEE ME AV LAX) view with color Doppler performed after aortic valve reimplantation surgery, showing mild aortic insufficiency (AI) immediately after release of the aortic cross-clamp. Note that the ECG (green trace) shows ventricular fibrillation. Magnitude of the AI at that moment, with pressure applied by the cardiopulmonary bypass (CPB) flow into the aortic root, is close to the magnitude of the AI that will be observed after CPB separation with normal hemodynamics

Immediately after aortic unclamping, TEE will disclose any residual defect of coaptation. The pressure applied by the CPB flow through the arterial cannula into the aortic root will cause regurgitation into the left ventricle if the repaired cusps do not coapt adequately (10). The severity of the regurgitation at that moment is close to the one that will be

observed after weaning of CPB (*Figure 1*).

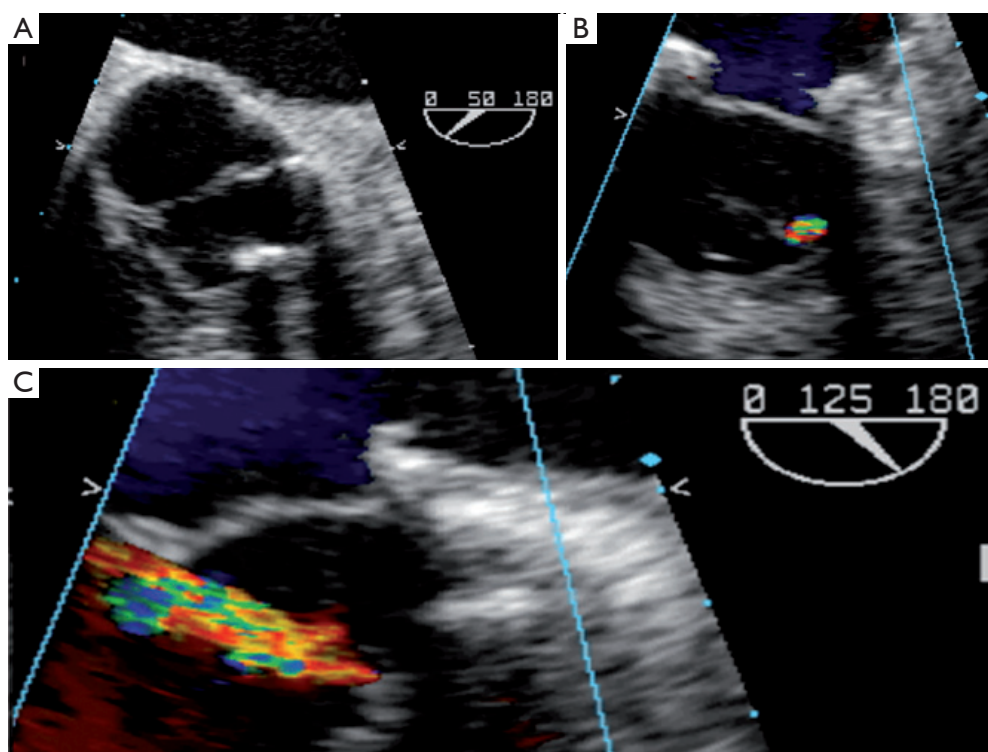
**Figure 4** Calcification of the conjoint cusp of a bicuspid aortic valve. (A) Midesophageal aortic valve short-axis (ME AV SAX) view before repair; (B) ME AV SAX and (C) long-axis (ME AV LAX) views of the aortic valve after reimplantation procedure, showing a residual perforation at the level of the removed piece of calcium

Removal of a fibrotic raphé or a piece of calcium from a cusp can leave a perforation that, if uncorrected, will appear as a residual jet originating both in the short and the long axis from the body of one of the aortic cusps (*Figure 4*). Depending on the size of the perforation, either a direct suture or a pericardial patch can be used for closure.

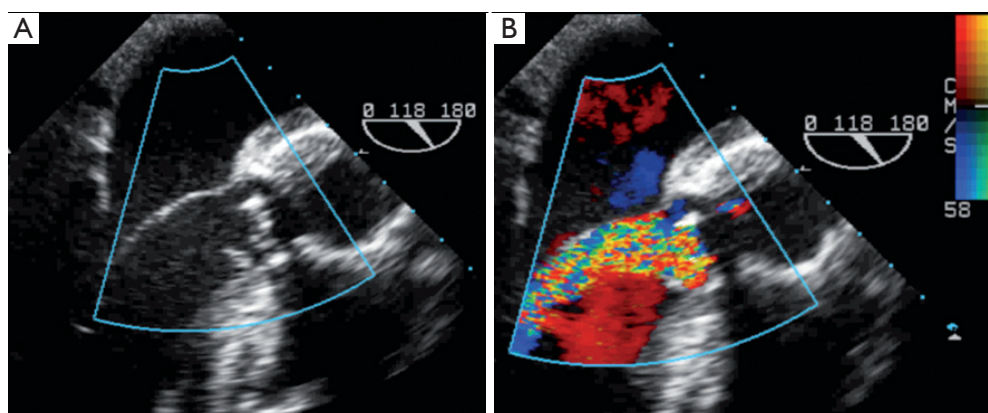
**Figure 5** Midesophageal aortic valve long-axis (ME AV LAX) view showing dehiscence of the autologous tricuspid patch used to repair a bicuspid aortic valve. This complication occurred 10 days after the valve repair, necessitating redo surgery with reattachment of the patch

and repaired the valve with a tricuspid autologous patch. Unfortunately, dehiscence of the patch occurred in the early postoperative period, necessitating an early reintervention 10 days after the initial repair (*Figure 5*). In this case, the patch was reattached. The repair lasted for 8 years, after which calcification of the valve necessitated its

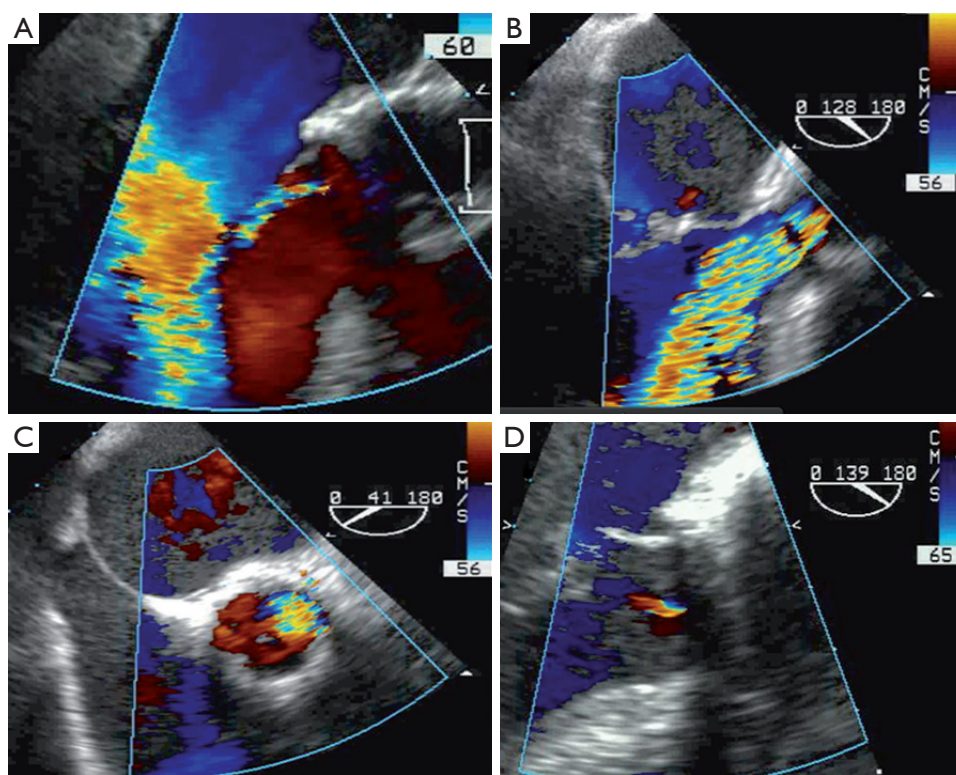
**Figure 6** Tethering of the left coronary cusp by a hemostatic stitch placed near the origin of the left main coronary artery. (A) Midesophageal aortic valve long-axis (ME AV LAX) view with color Doppler showing mild aortic insufficiency immediately after a reimplantation procedure in a tricuspid aortic valve. Persistent bleeding close to the origin of the left main coronary artery necessitated addition of a felted suture at that level. Fortuitous analysis of the aortic valve in the ME AV LAX (B) view disclosed a sudden severe aortic insufficiency. (C) Midesophageal aortic valve short-axis (ME AV SAX) view helped in localizing the origin of the jet at the level of the left coronary cusp. (D) ME AV LAX view after removal and repositioning of the causative felted stitch, showing only mild residual aortic insufficiency

the tube graft. Bleeding sometimes occurs at the level of this anastomosis. In a patient presenting continuous bleeding precluding sternal closure after a reimplantation procedure, an additional stitch was placed at the level of the left main coronary artery suture on the tube graft, correcting the problem. By chance, a rapid TEE overview before probe removal disclosed a severe AI due to retraction of the left coronary cusp by the recently added hemostatic stitch (*Figure 6*). The patient was placed back on CPB, the causal stitch was removed, rendering a normal motion to the left coronary cusp.

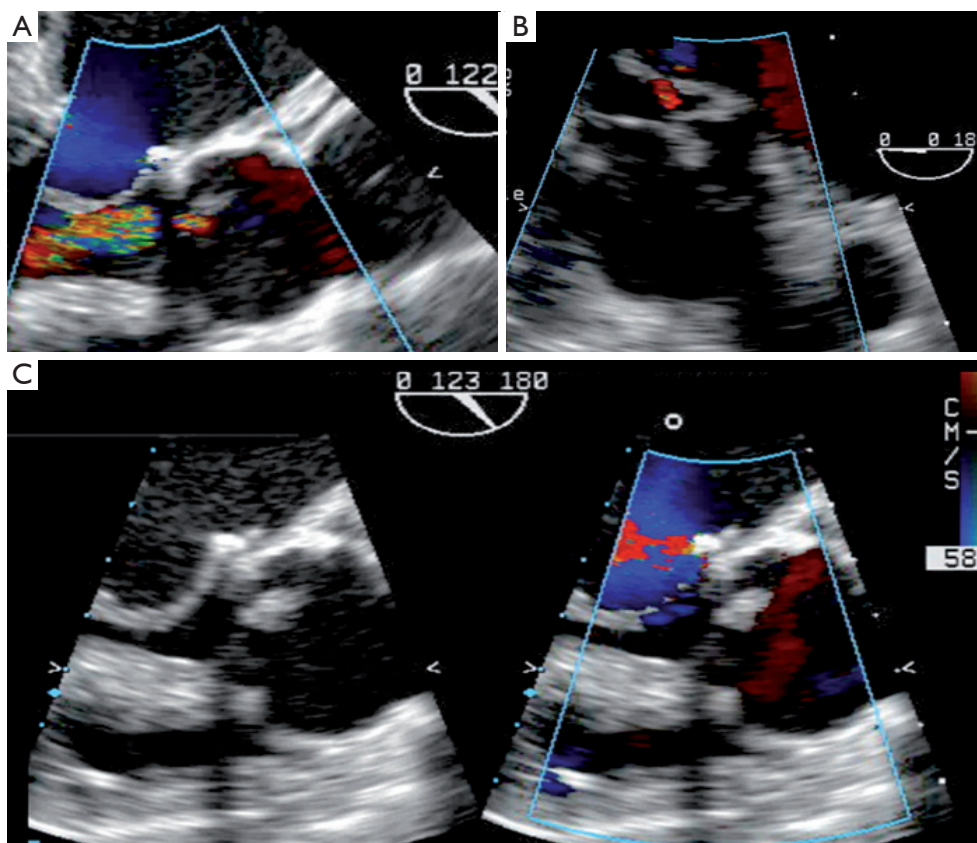
**Figure 8** Repair of a rheumatic tricuspid aortic valve associated with mitral and tricuspid valve repairs. Aortic surgery consisted of shaving of the free margins of the 3 cusps and 2 subcommissural annuloplasties (SCA) between the non-coronary cusp (NCC) and the left coronary cusp (LCC) and between the NCC and the right coronary cusp (RCC). (A) Transesophageal echocardiographic midesophageal aortic valve long-axis (TEE ME AV LAX) view with color Doppler showing an unsatisfactory result with moderate residual aortic insufficiency (AI). (B) Transesophageal echocardiographic transgastric long-axis (TEE TG LAX) view with color Doppler and (C) ME AV LAX view: after an additional annuloplasty stitch placed lower in the same 2 intercommissural triangles, the coaptation is good and the valve shows only trivial AI

Subcommissural annuloplasties (SCAs) are felted sutures applied at the mid-level of the intercommissural triangles, with the aim of reducing and stabilizing the VAJ. These sutures can also help to increase cusp coaptation (*Figure 8*).

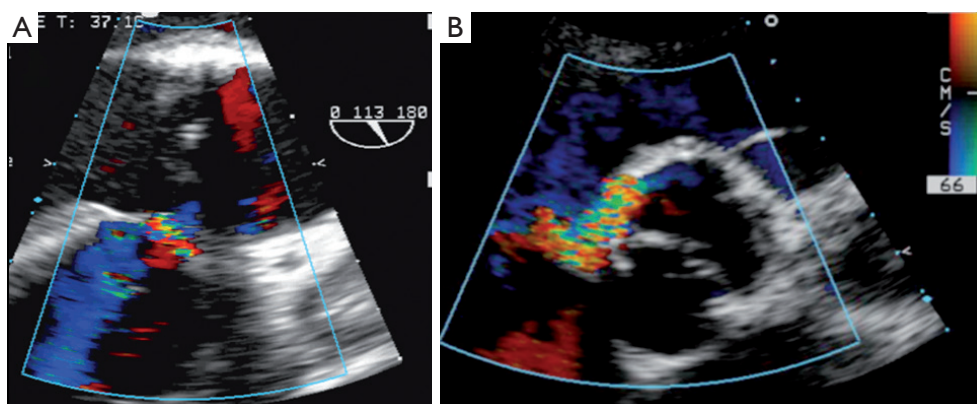
**Figure 9** Fistula between the aorta and the right ventricle after bicuspid aortic valve repair. This complication was caused by the subcommissural annuloplasty (SCA) stitch placed at the anterior commissure and was discovered at patient discharge on postoperative day 6. Midesophageal aortic valve long- (ME AV LAX) (A) and short- (ME AV SAX) (B) axis views with color Doppler on transesophageal echocardiography (TEE) performed at reoperation. Direct closure of the fistula with redo of the SCA was performed

SCAs can also provoke a tear or a fistula if the aortic wall tissue is abnormally fragile. A patient with bicuspid aortic valve presented with an aorta to right ventricle fistula at the anterior commissure 6 days after repair. At the immediate post-CPB intraoperative TEE the fistula was not observed, but at discharge transthoracic echocardiography disclosed a severe left to right shunt (*Figure 9*). The patient was immediately reoperated. The fistula was directly closed and the SCA redone.
