# Historicizing Natural Hazards and Human-Induced Landscape Transformation in a Tropical Mountainous Environment in Africa: Narratives from Elderly Citizens

**Abstract:** Studying natural hazards in the context of human-induced landscape transformation is complex, especially in regions with limited information. The narratives of the elderly can play a role in filling these knowledge gaps at the multi-decadal timescale. Here, we build upon a citizen-based elderly approach to understanding natural hazard patterns and landscape transformation in a tropical mountainous environment, the Kigezi Highlands (SW Uganda). We engaged 98 elderly citizens (>70 years old) living in eight small watersheds with different characteristics. Through interviews and focus group discussions, we reconstructed historical timelines and used participatory mapping to facilitate the interview process. We cross-checked the information of the elderly citizens with historical aerial photographs, archives, and field visits. Our results show that major land use/cover changes are associated with a high population increase over the last 80 years. We also evidence an increase in reported natural hazard events such as

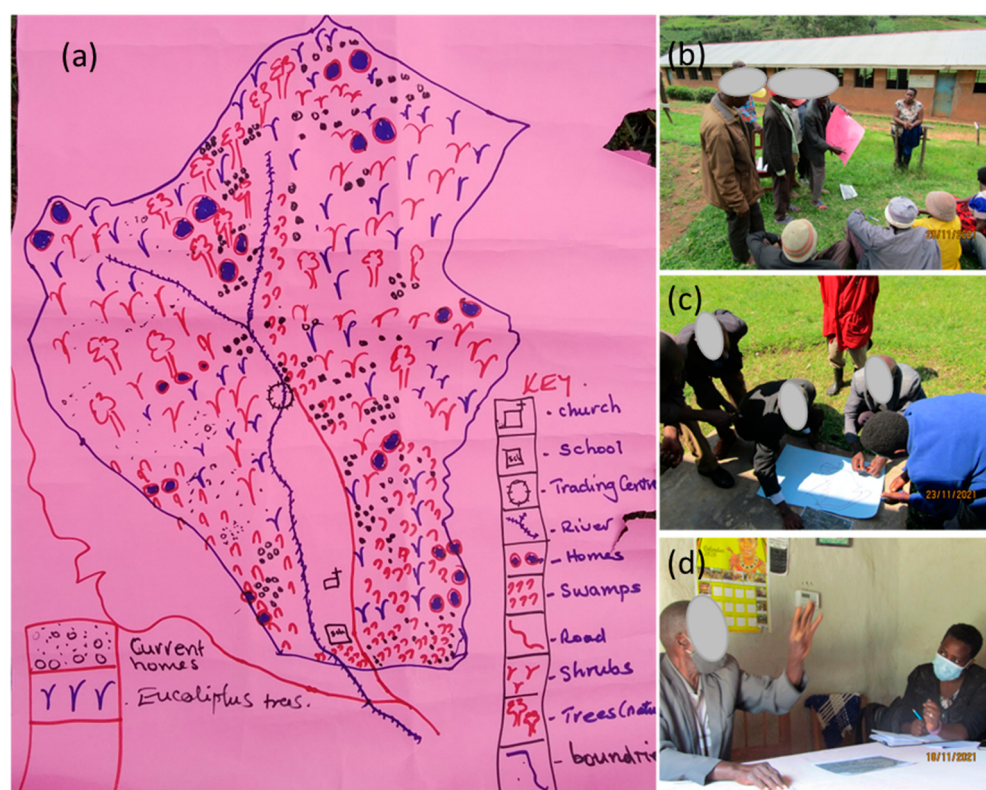
**Figure 4.** Interviews and participatory mapping with the elderly citizens. (a) One of the maps drawn by the elderly citizens during an FGD in W6, showing past (blue marker) and current (red marker) land use and cover. (b,c) Participatory mapping during FGDs with elderly citizens in W2 and W5, respectively. (d) An individual interview session with an elderly citizen in W8. Photos taken by David Mubiru in September 2022.

For the eight FGDs, we applied the participatory mapping technique, where the elderly drew on manila papers the past (i.e., from the 1940s) and current (2021) land use/cover of their land (Figure 4). The mapping was guided by providing the exact delineation of the watershed boundaries as background information. The elderly citizens indicated (1) the locations and numbers of buildings and roads, and (2) the extent of croplands, tree cover, wetlands, and water bodies. Colored markers were used to distinguish between past and present land use/cover (Figure 4).
